NOTICE OF PROPERTY MANAGEMENT AND GENERAL PURPOSES COMMITTEE MEETING

Thursday 5th March 2026 7pm

AGENDA

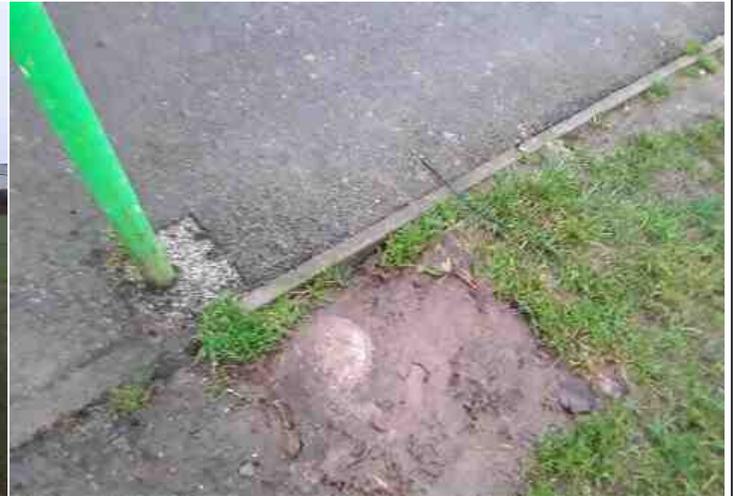
Finding: There are trip hazards present over the edgings

Action: Remove trip hazard

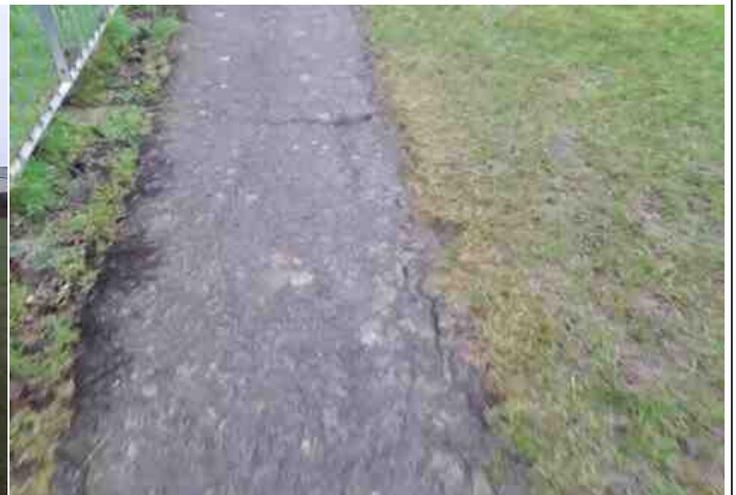
Finding: There is wear damage to the access footpath creating trip hazards and unforeseen changes in levels

Action: Repair the damaged areas of bitmac to provide a uniform surface

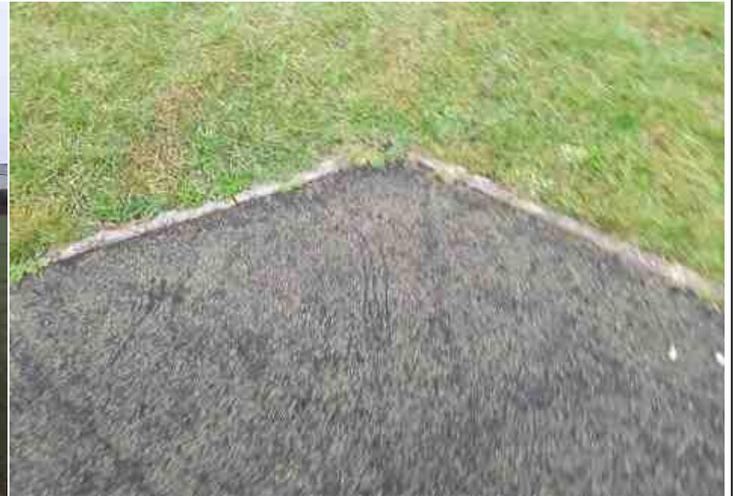
Finding: There is algae, silt or moss growth on the safety surface resulting in slippery conditions

Action: Clean and treat appropriately

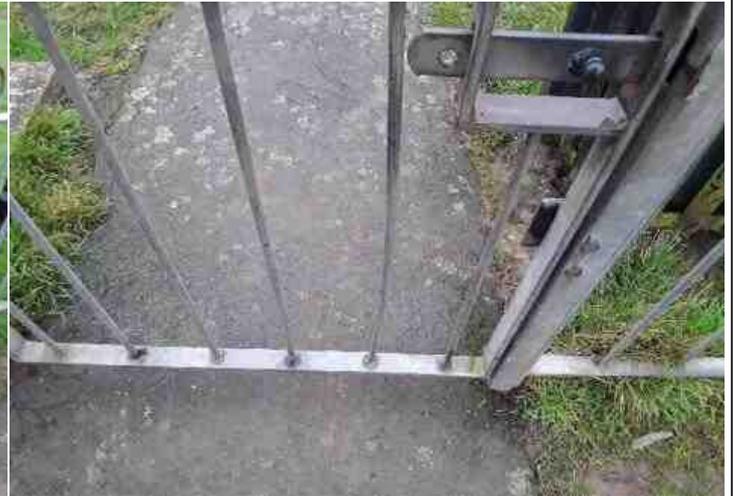
Finding: There is minor damage to the infill sections

Action: Monitor for any further deterioration and repair as required

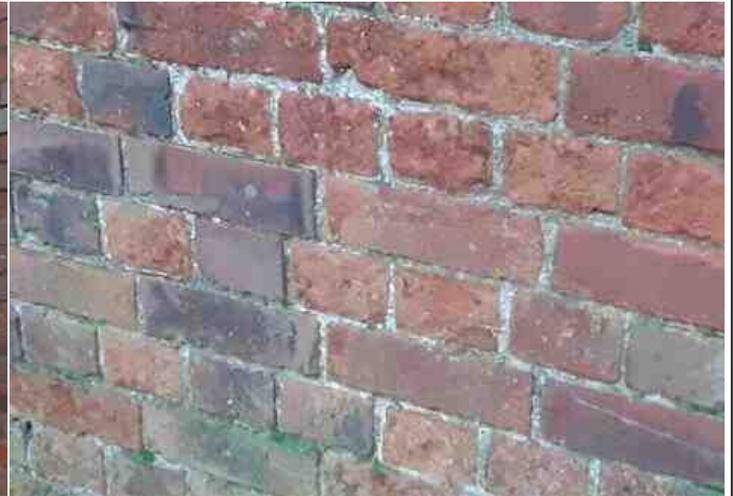
Finding: There is frost damage to the wall

Action: Monitor and repair if required

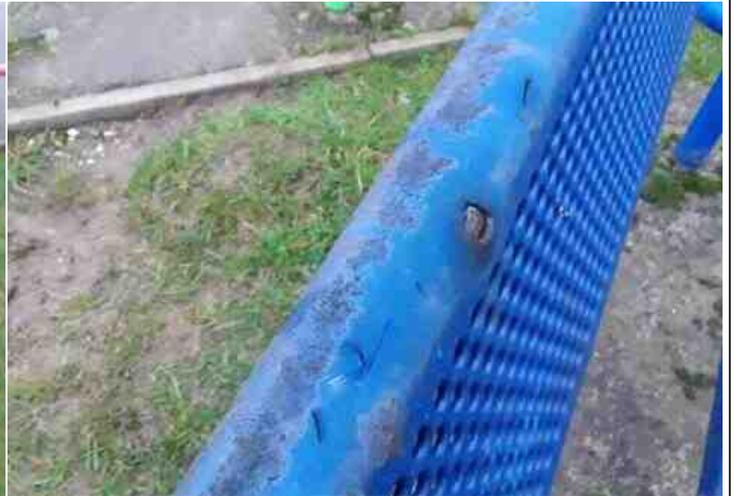
Finding: There is minor damage to the protective coating

Action: Monitor and repair if required

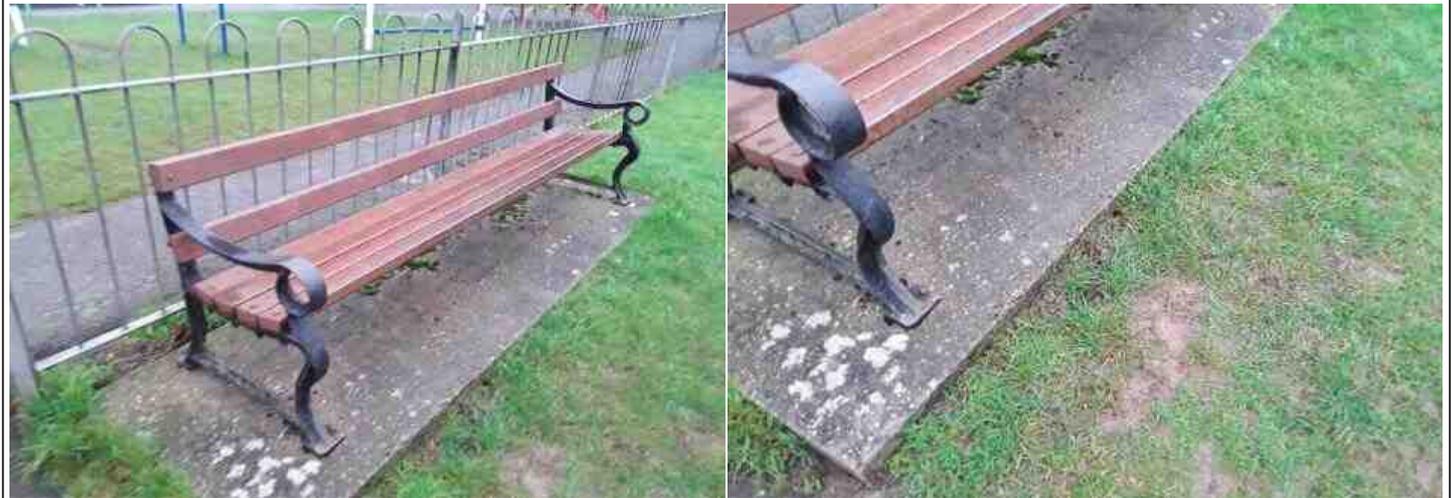
Finding: There are trip hazards present over the concrete base
Action: Remove trip hazard

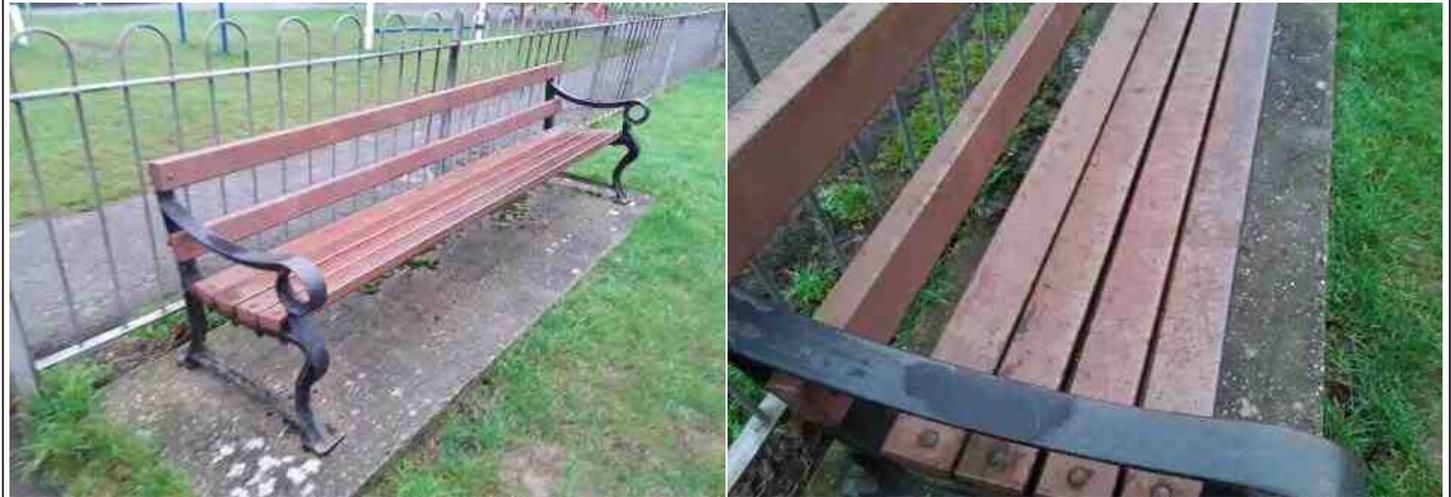
Finding: There is surface corrosion / rust present on the item
Action: Consider treating the item

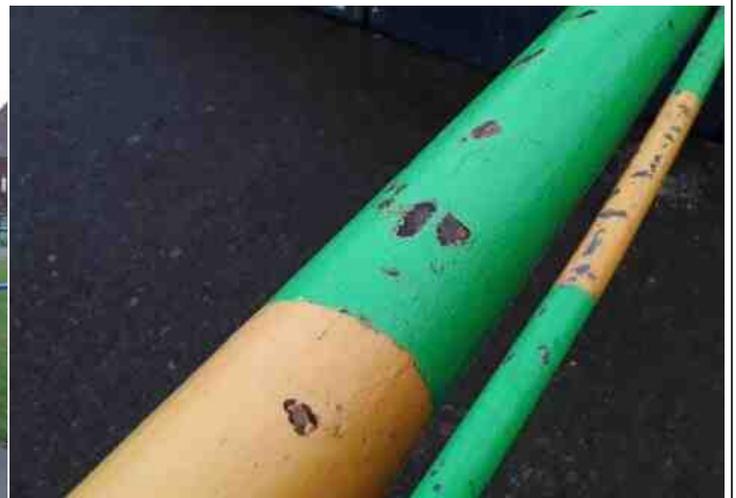
Finding: The paintwork on this item has been damaged or worn exposing the metal underneath which is rusting / corroding
Action: Treat affected areas and repaint

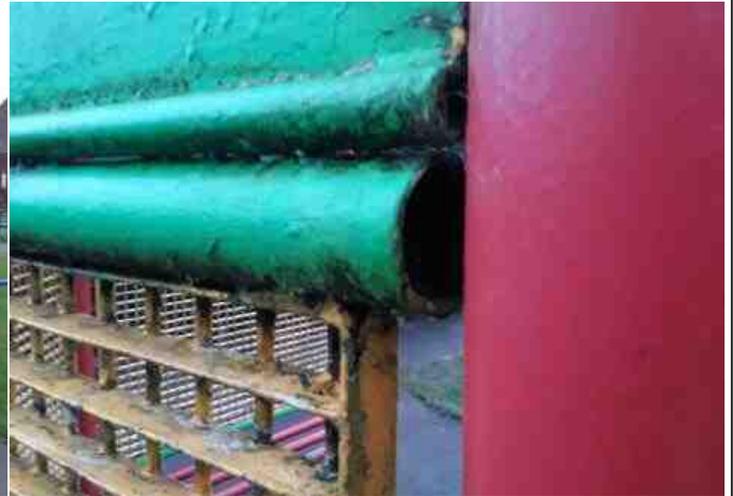
Finding: There is / are post or end caps missing / damaged on the item
Action: Replace missing / damaged post or end caps

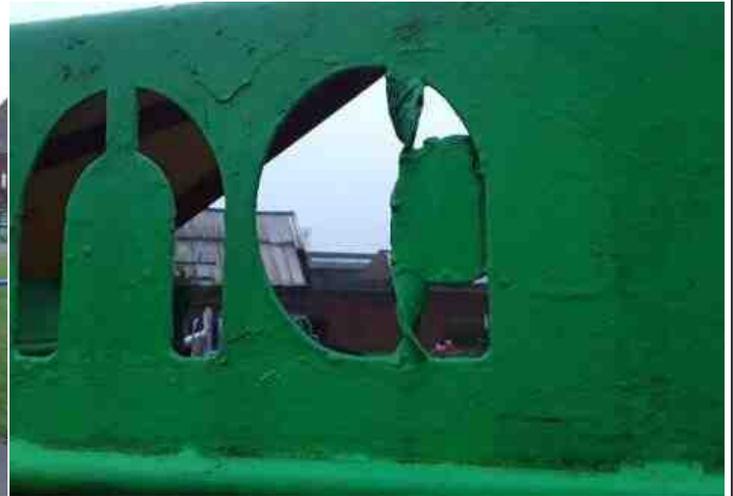
Finding: There is minor damage to the item

Action: Monitor and repair if required

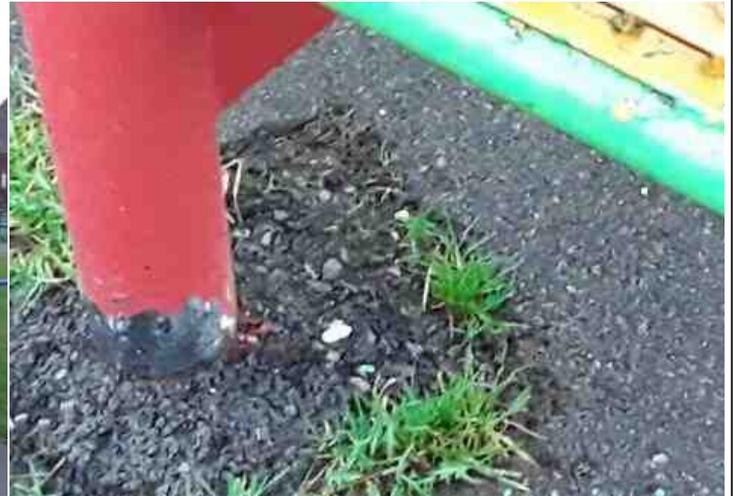
Finding: The reinstated surface is breaking up

Action: Repair the damaged areas of bitmac

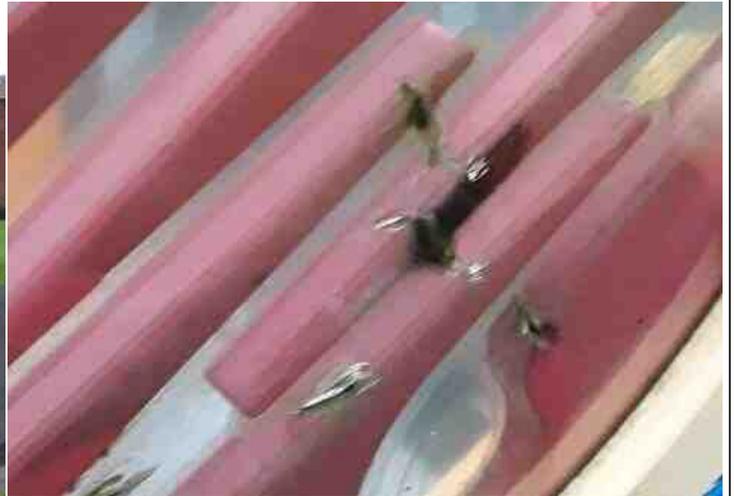
Finding: There is some evidence of fire damage to the side panel

Action: Monitor for any further deterioration and repair as required

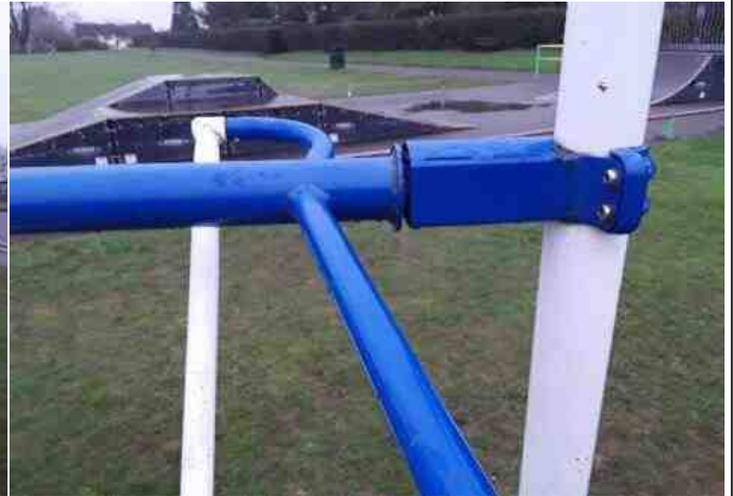
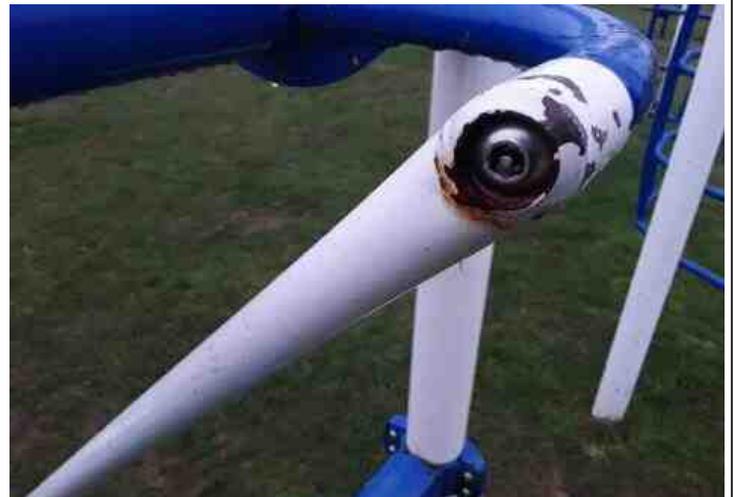
Finding: The dampening mechanisms are worn

Action: Replace the dampening mechanisms

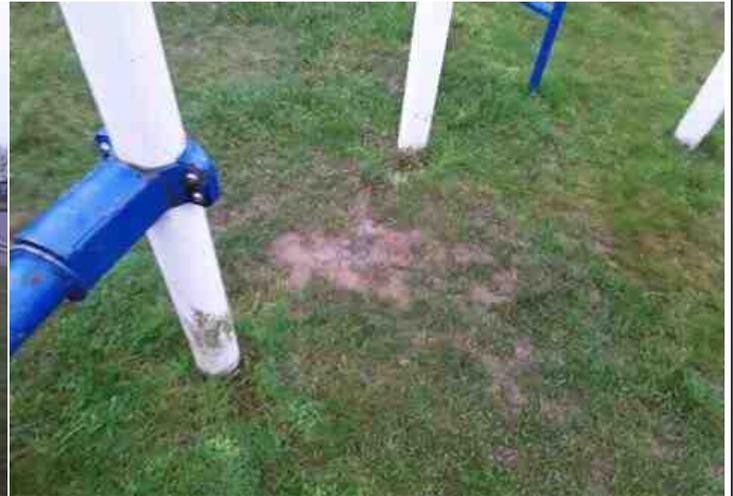
Finding: The surface has subsided in some areas

Action: Monitor for any further deterioration and repair as required

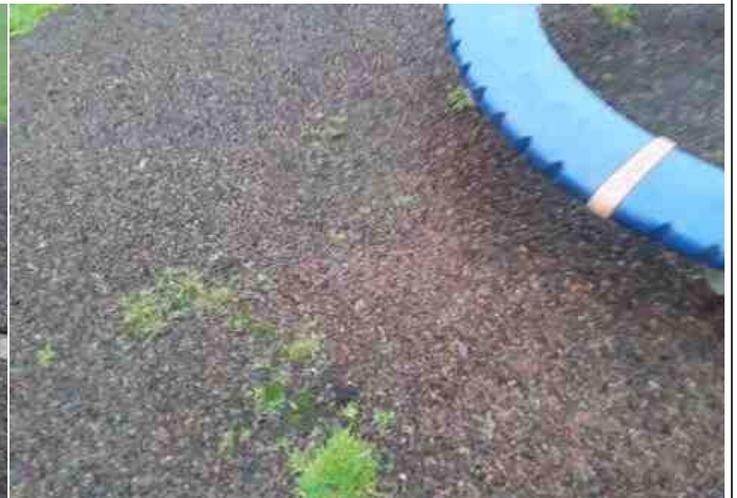
Finding: The surface has subsided in some areas
Action: Monitor for any further deterioration and repair as required

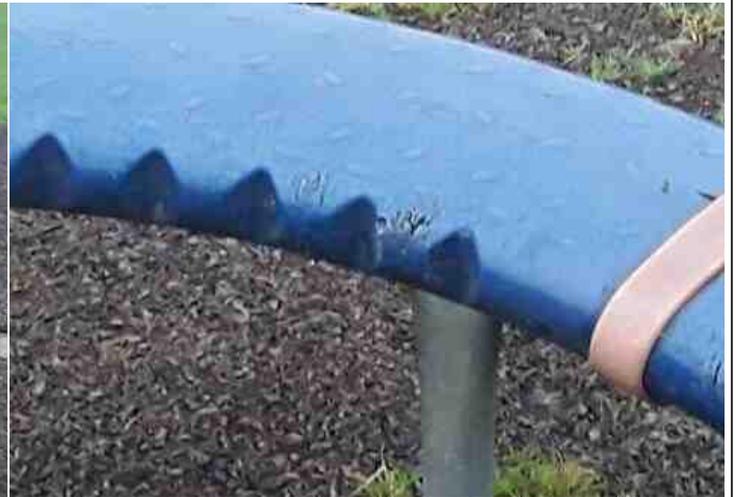
Finding: There is minor damage to the casing
Action: Remove the sharp protrusions

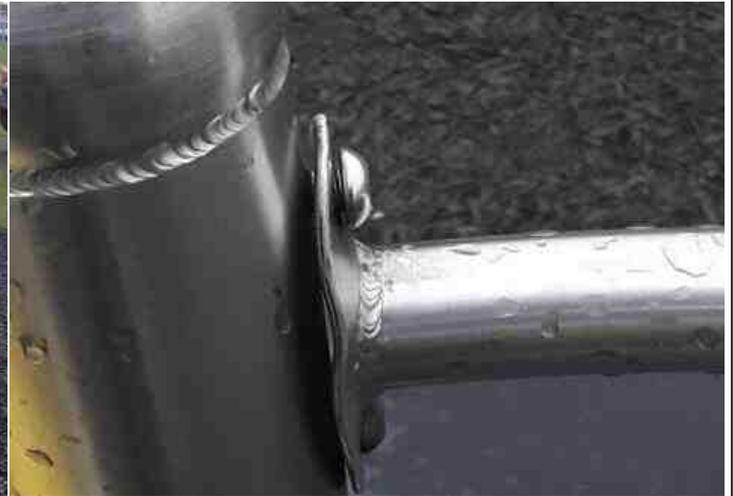
Finding: A number of fixing(s) have worked loose

Action: Secure all loose fixings

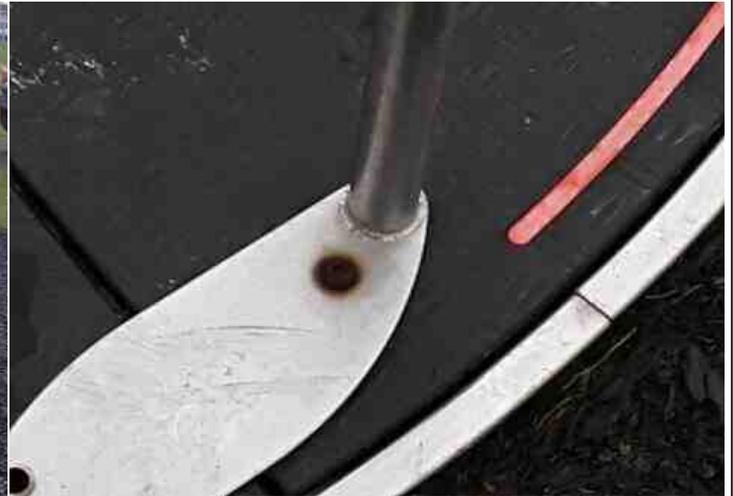
Finding: The fixings have corroded

Action: Replace all corroded fixings

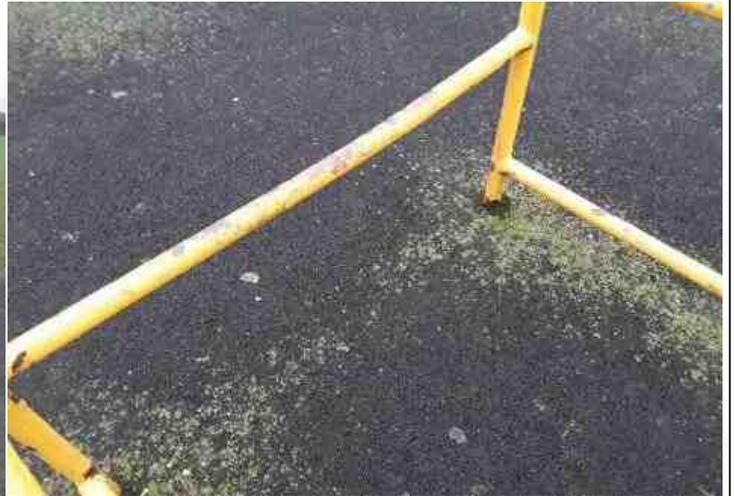
Finding: There is minor distortion damage to the item

Action: Monitor and repair if required

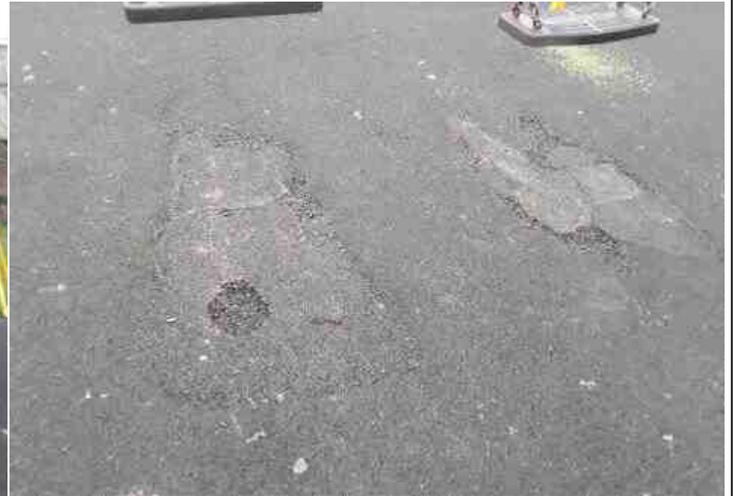
Finding: The surfacing is damaged

Action: Repair damaged areas of surfacing

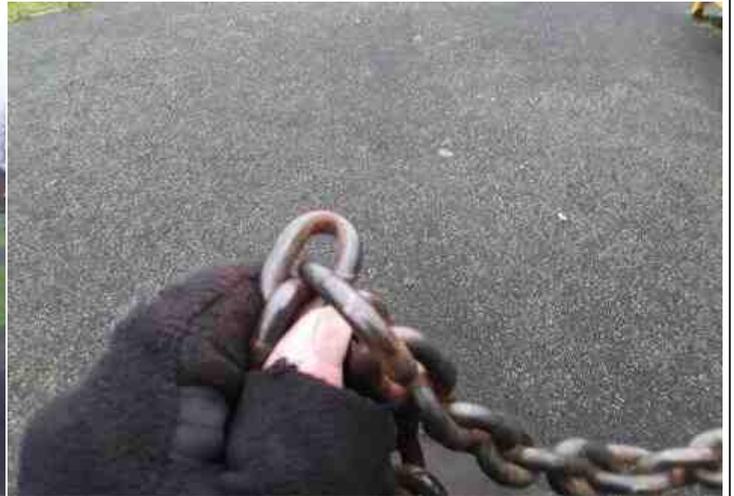
Finding: There is some notable evidence of chain wear

Action: Monitor for any further deterioration and replace when 40% worn

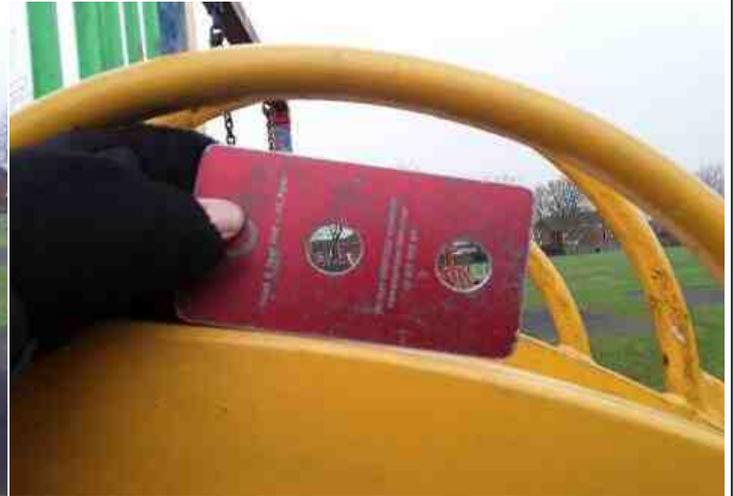
Finding: The item fails to meet the requirements of BS EN 1176 Part 1 4.2.7.2 for head and neck entrapment in the framework

Action: Monitor - No action given the risk assessment

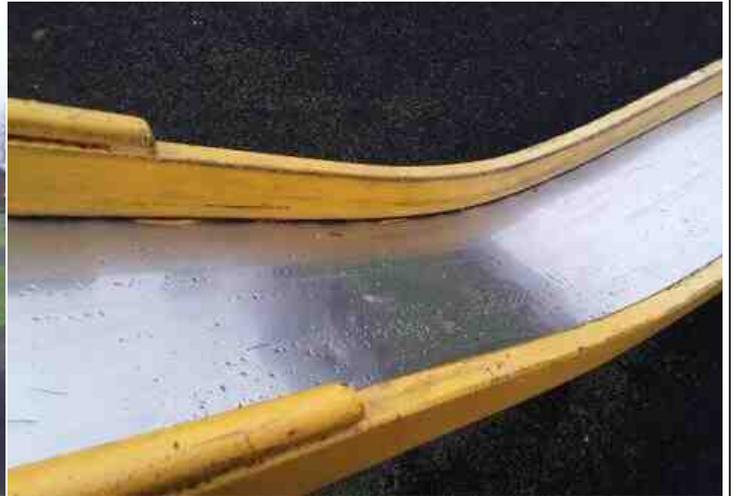
Finding: There are a number of dents in the slide surface

Action: Monitor for any further deterioration and repair as required

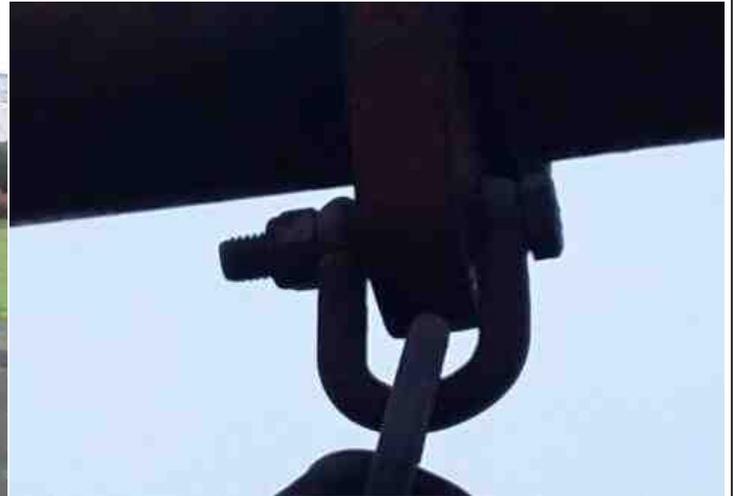
Finding: The bush / bushes is / are worn or missing

Action: Replace worn or missing bushes

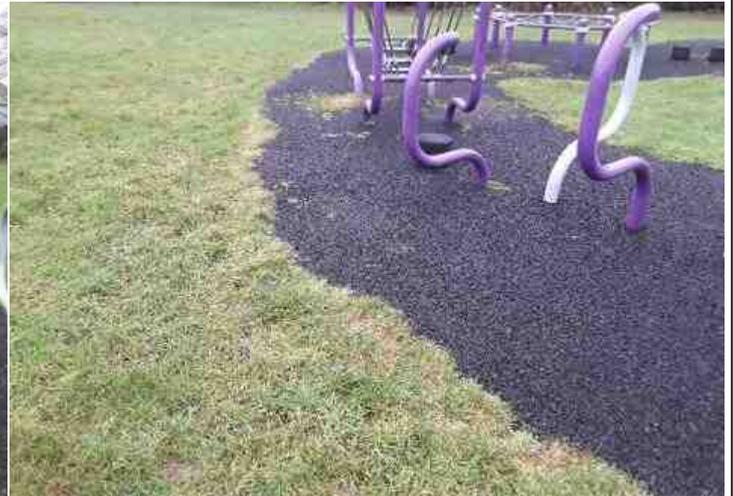
Finding: The surface has subsided in some areas

Action: Monitor for any further deterioration and repair as required

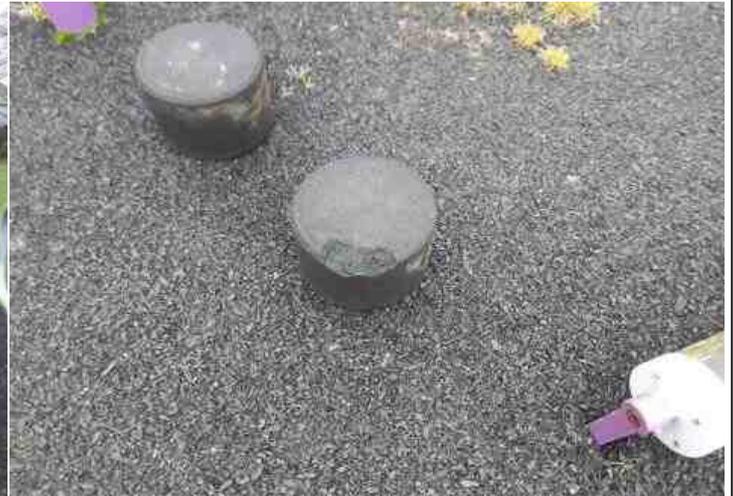
Finding: There is minor damage to the stepping posts

Action: Monitor and replace if required

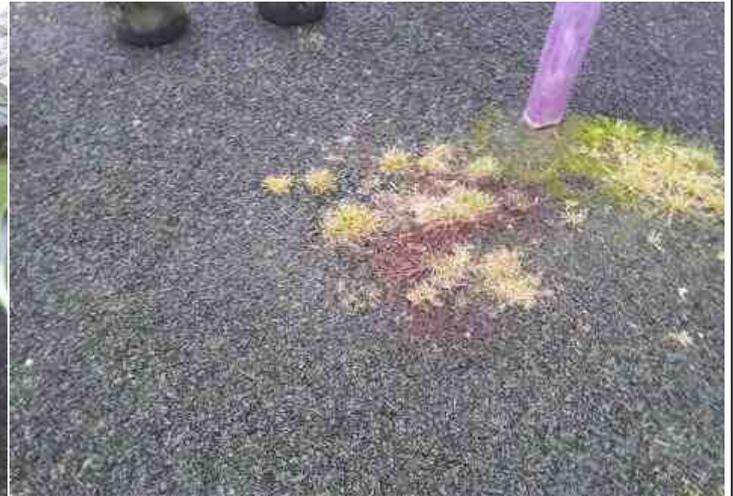
Finding: The surfacing is damaged

Action: Repair damaged areas of surfacing

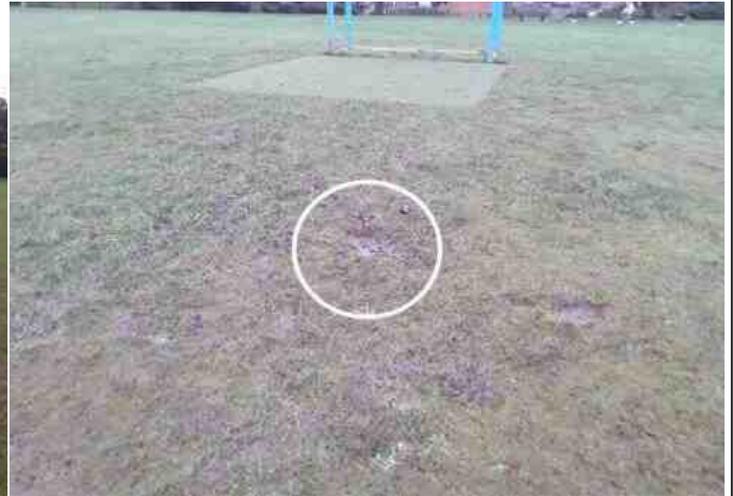
Finding: There are holes in the playing surface that may cause users to trip or roll ankles

Action: Infill to provide a sound reasonably level surface.

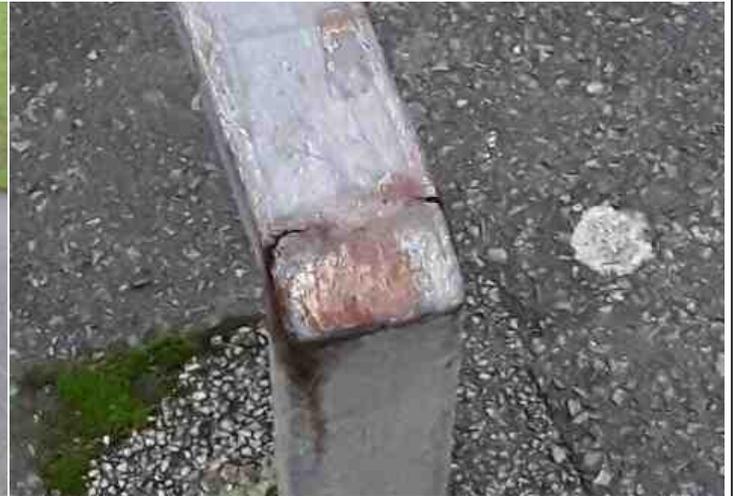
Finding: The weld(s) on this item have failed

Action: Repair item

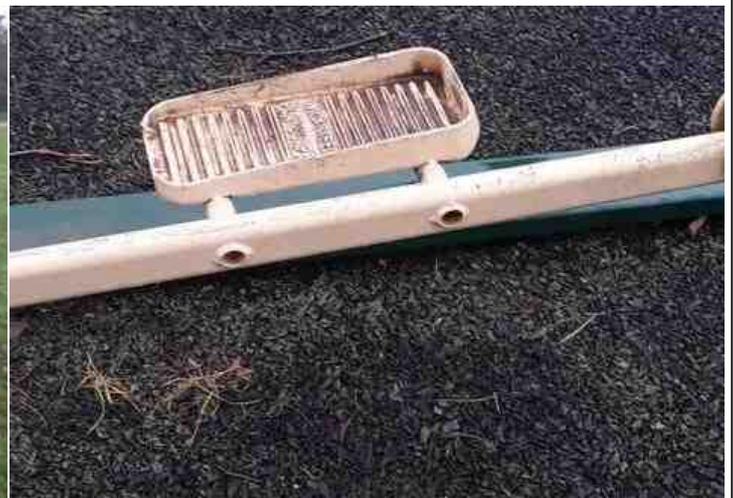
Finding: There is/are inserts missing

Action: Replace missing inserts

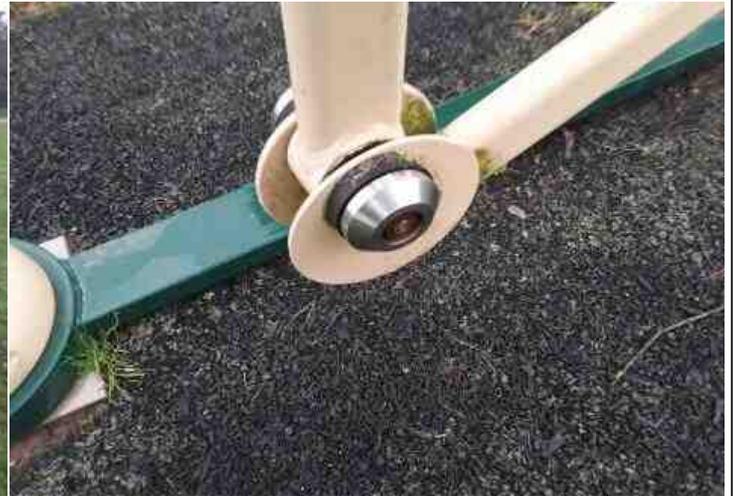
Finding: There is/are bolt cap covers missing or damaged on the item **Action:** Replace missing or damaged bolt cap covers

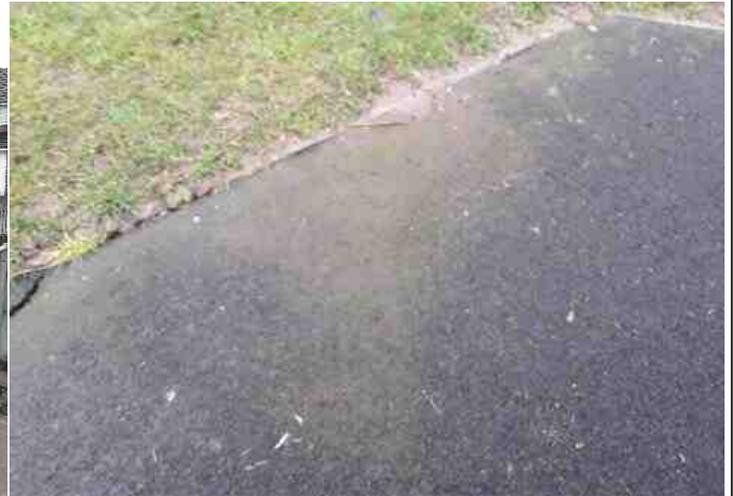
Finding: There is algae, silt or moss growth on the surface resulting in slippery conditions
Action: Clean and treat appropriately

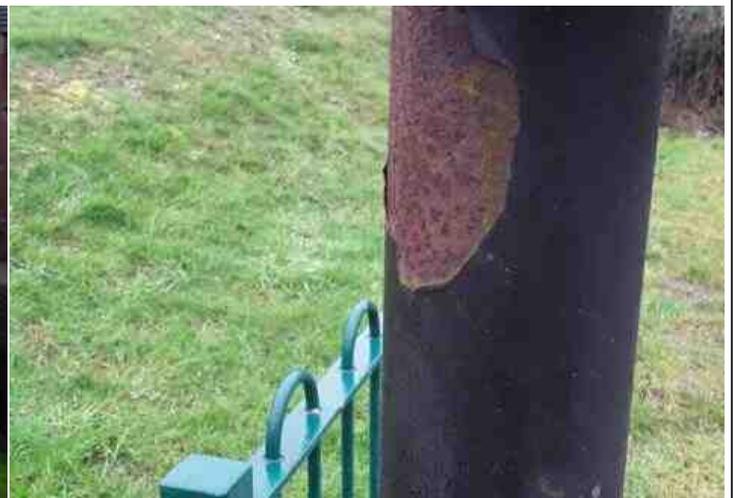
Finding: The paintwork on this item has been damaged or worn exposing the metal underneath which is rusting / corroding
Action: Treat affected areas and repaint

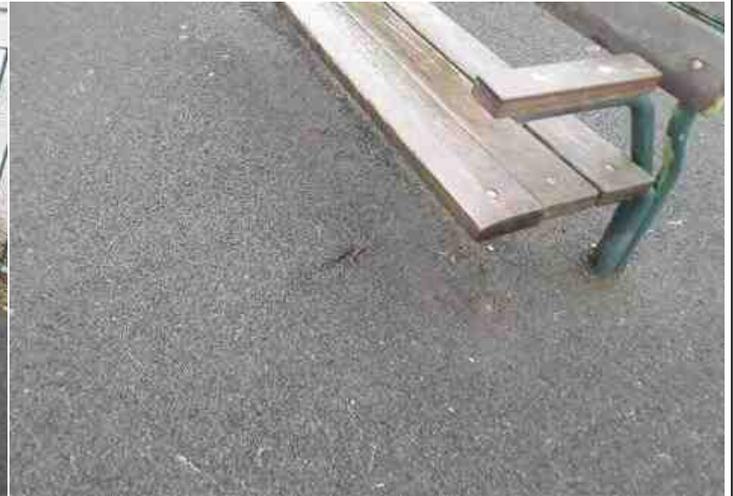
Finding: There is minor damage to the surface

Action: Monitor for any further deterioration and repair as required

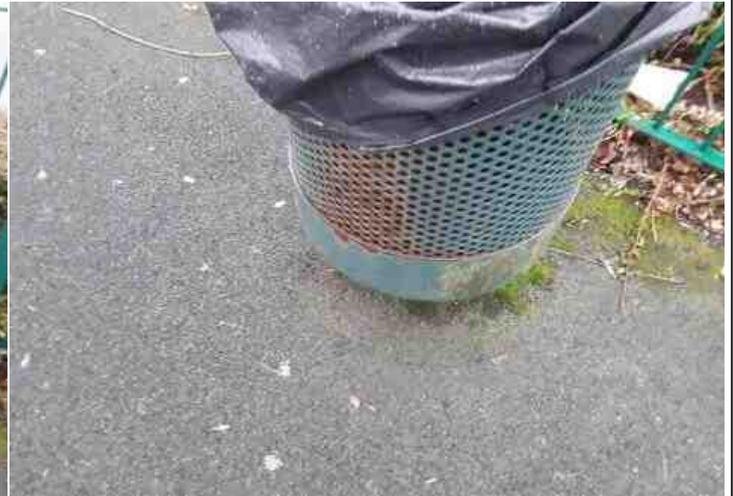
Finding: The paintwork on this item has been damaged or worn exposing the metal underneath which is rusting / corroding

Action: Treat affected areas and repaint

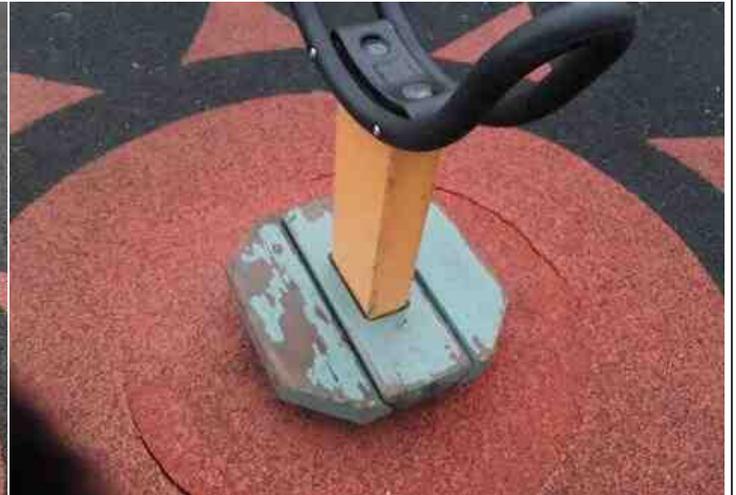
Finding: The bearing is showing signs of wear

Action: Monitor for any further deterioration and replace as required

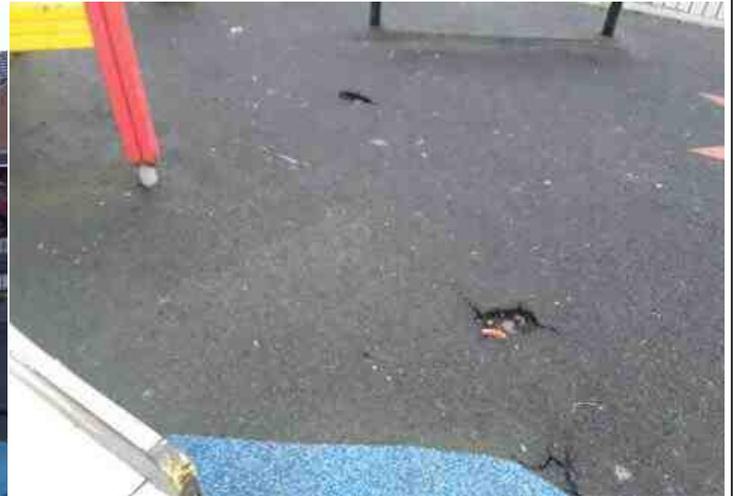
Finding: The surfacing is damaged creating trip hazards

Action: Repair damaged areas of surfacing

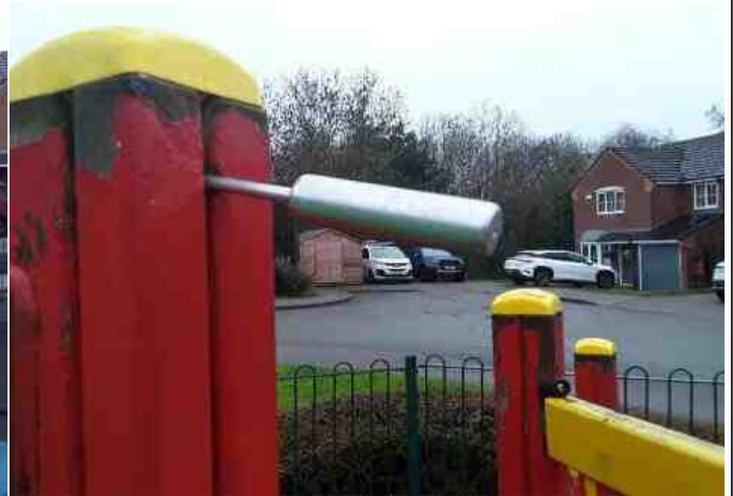
Finding: There is/are finger entrapment/s in the redundant bolt holes in the posts and the item fails to meet the requirements of BS EN 1176 Part 1 4.2.7.6 Entrapment of fingers

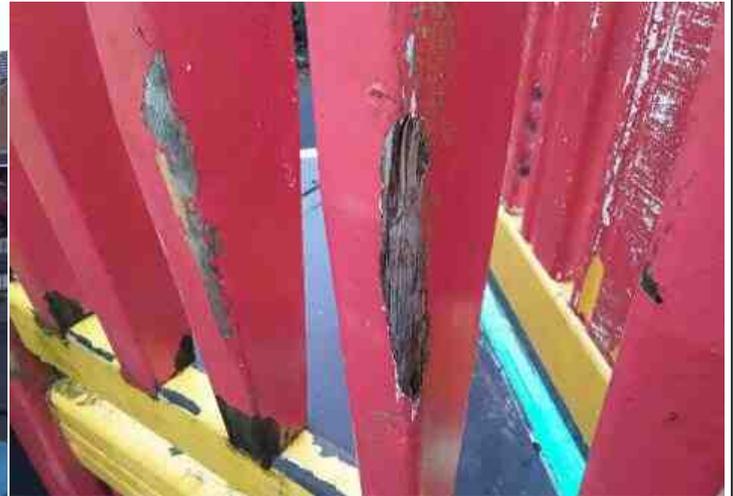
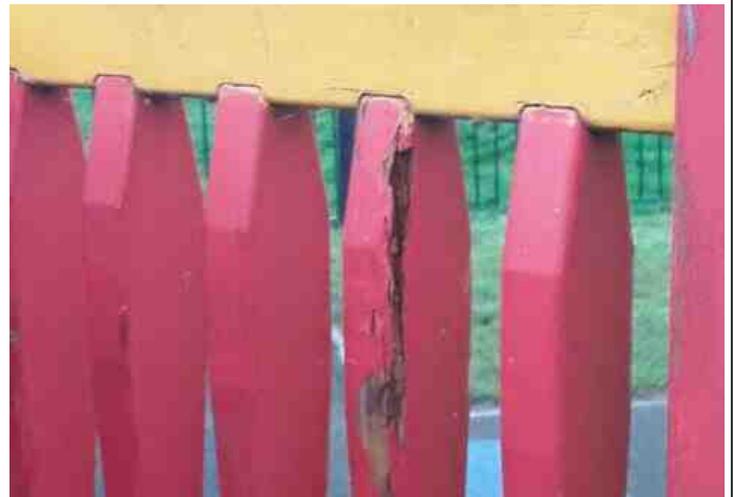
Finding: There are parts of the timber barriers that have rotted

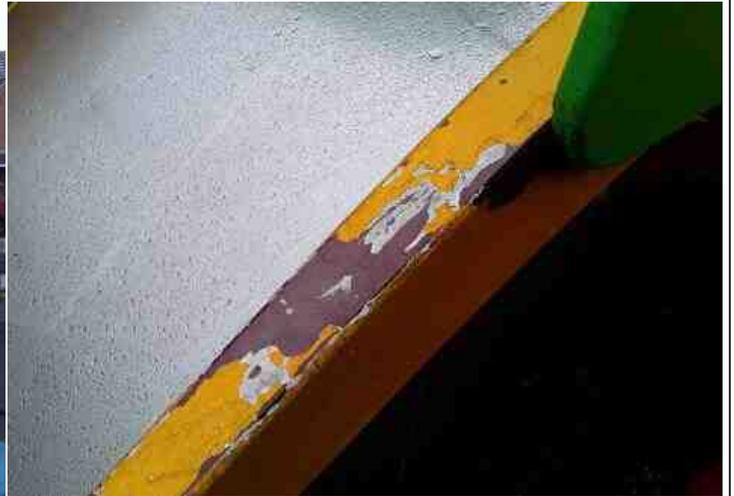
Finding: The side of the slide is damaged

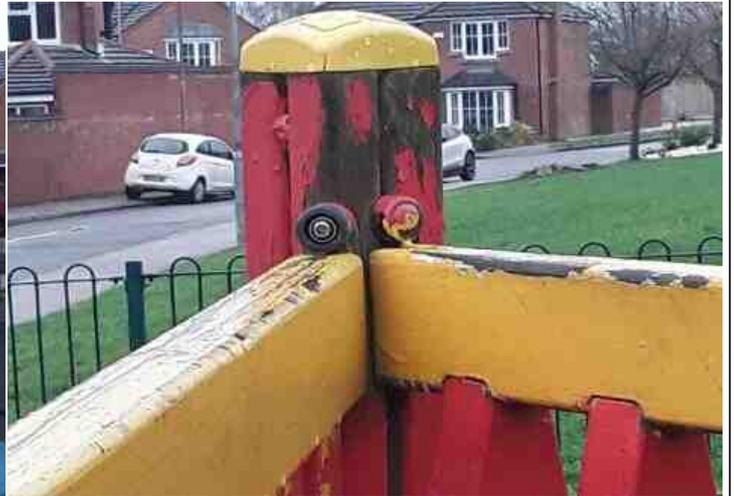
Finding: There is/are bolt cap covers missing or damaged on the item

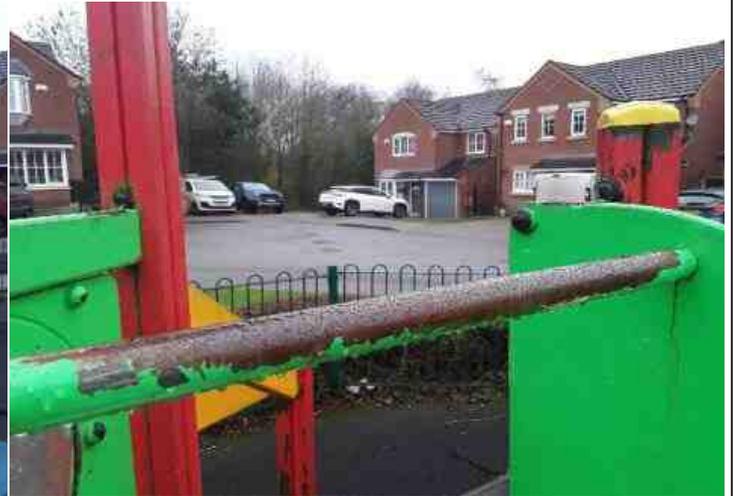
Finding: The paintwork on this item has been damaged or worn exposing the metal underneath which is rusting / corroding

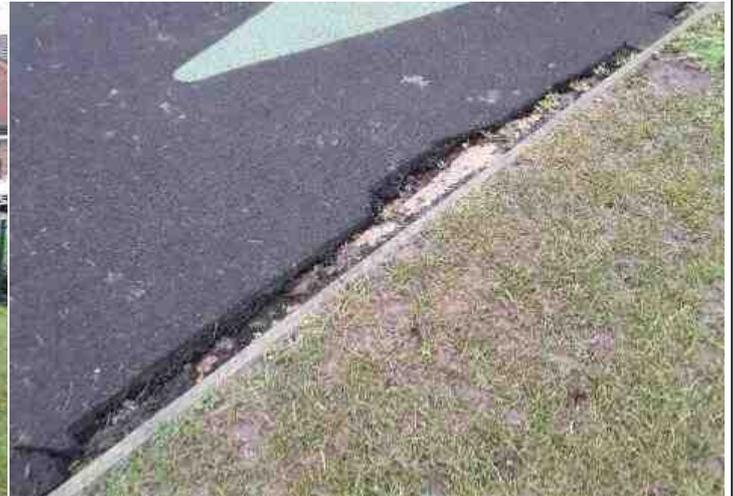
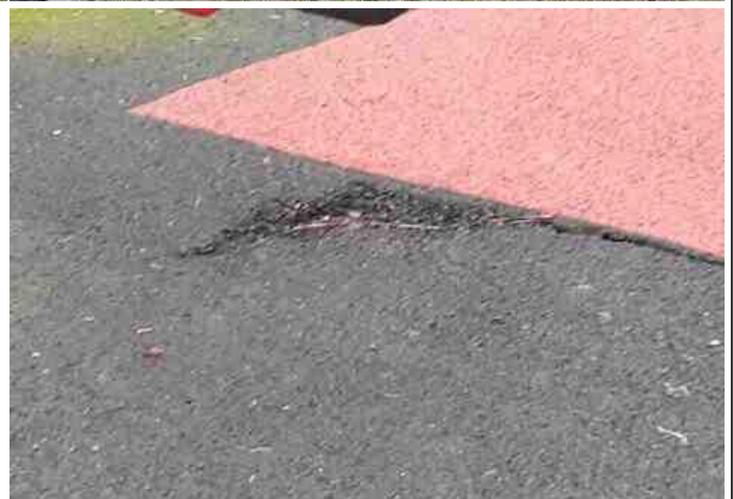
Finding: The surfacing is severely damaged

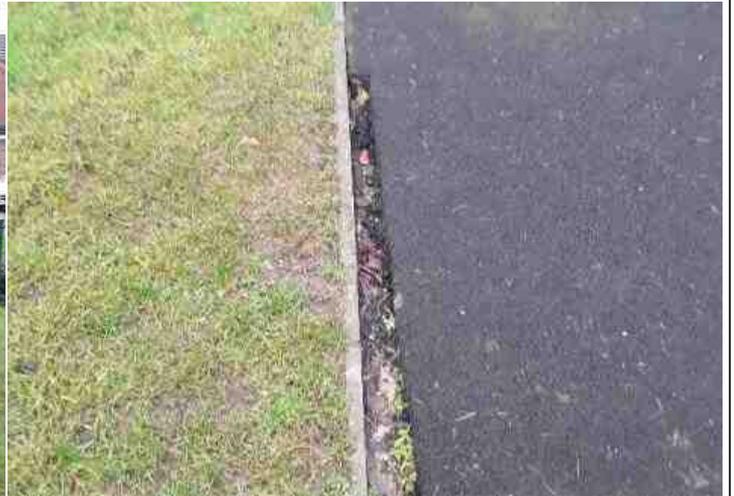
Finding: There are significant gaps (over 30mm) between the surface and the edging or between the joints in the surface; these are large enough for a small foot to enter

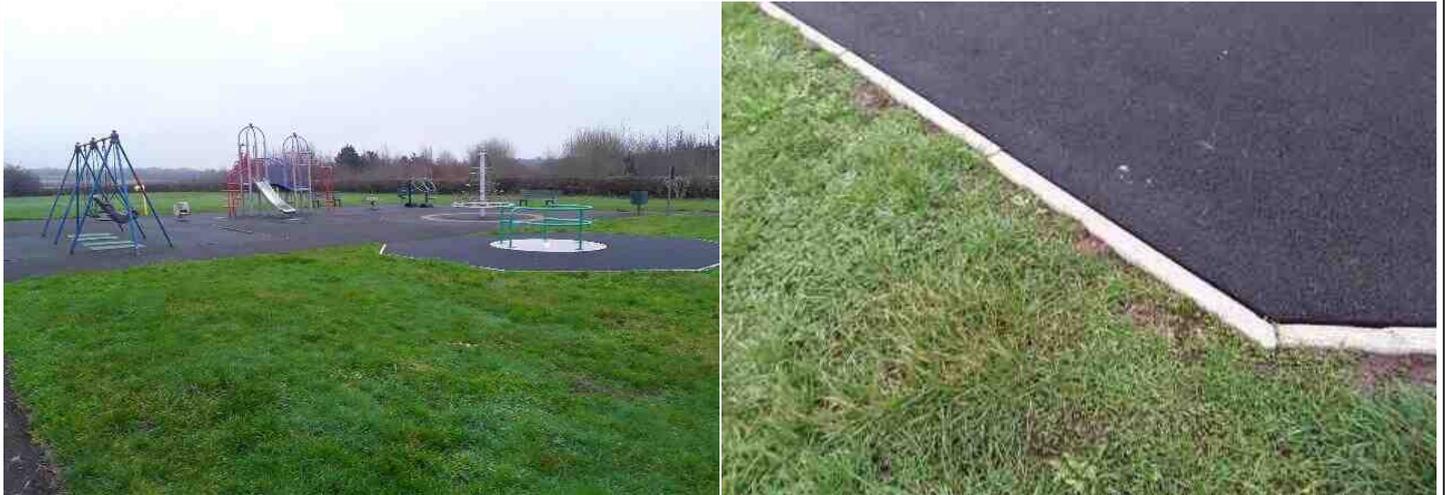
Finding: There are trip hazards at the edges of the surface **Action:** Remove trip hazard

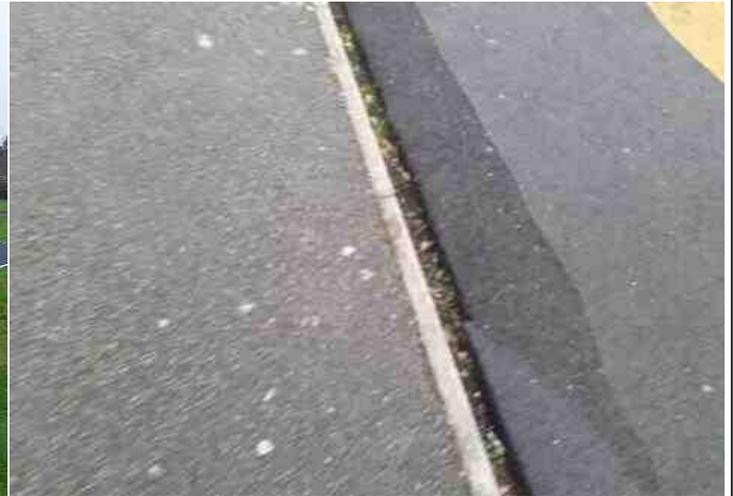
Finding: There are significant gaps (over 30mm) between the surface and the edging or between the joints in the surface; these are large enough for a small foot to enter

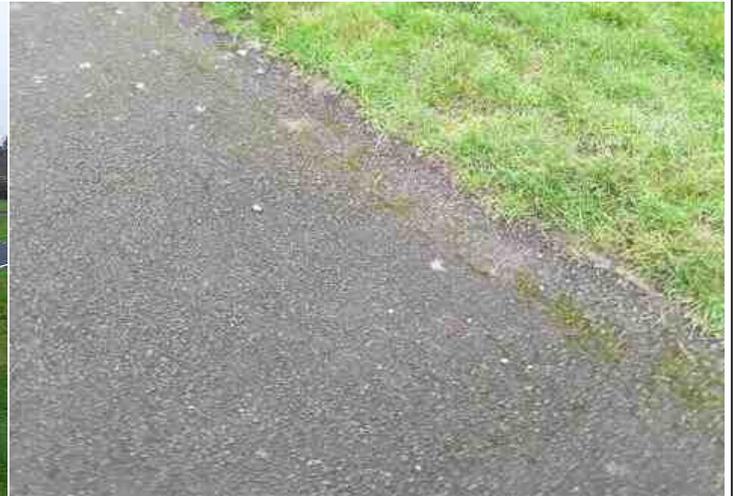
Finding: There is algae, silt or moss growth on the bitmac surface resulting in slippery conditions

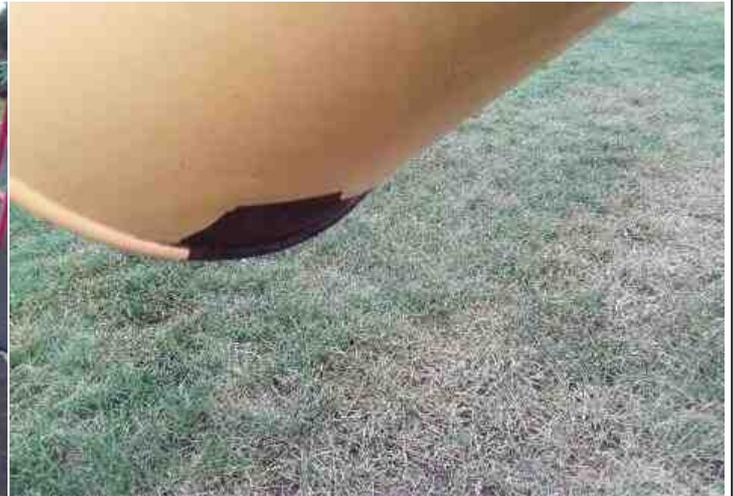
Finding: The paintwork on this item has been damaged or worn exposing the metal underneath which is rusting / corroding

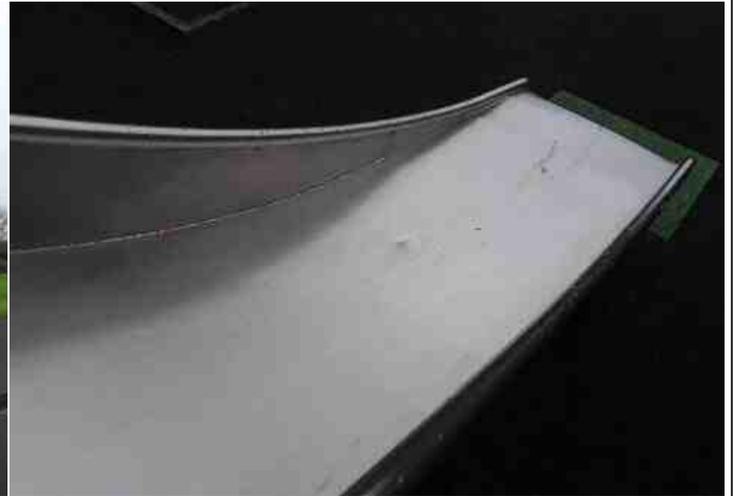
Finding: There are a number of dents in the slide surface

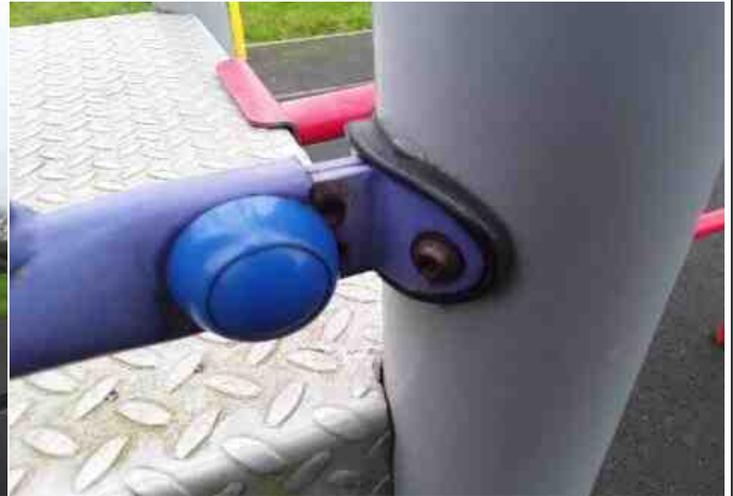
Finding: The fixings have corroded

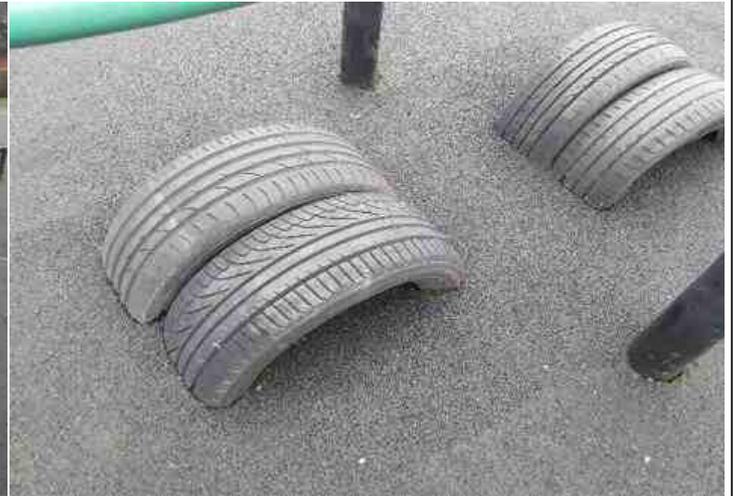
Finding: The tyre buffers are showing signs of wear

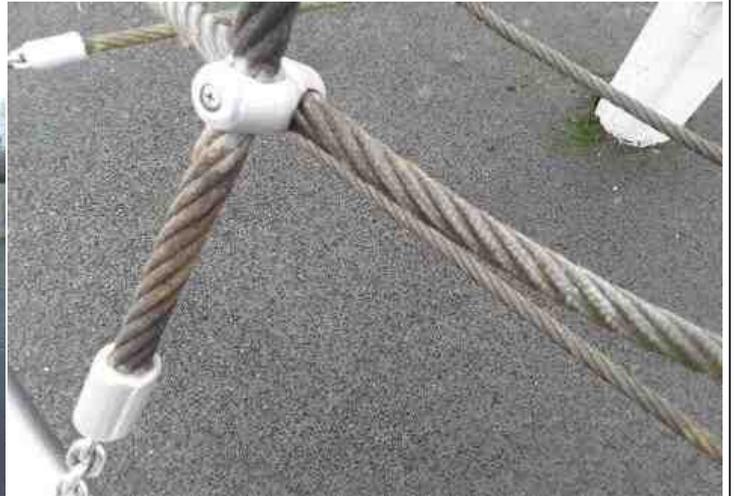
Finding: The ropes/nets are worn/damaged in places
