NOTICE OF PROPERTY MANAGEMENT AND GENERAL PURPOSES COMMITTEE MEETING

Thursday 5th March 2026 7pm

AGENDA

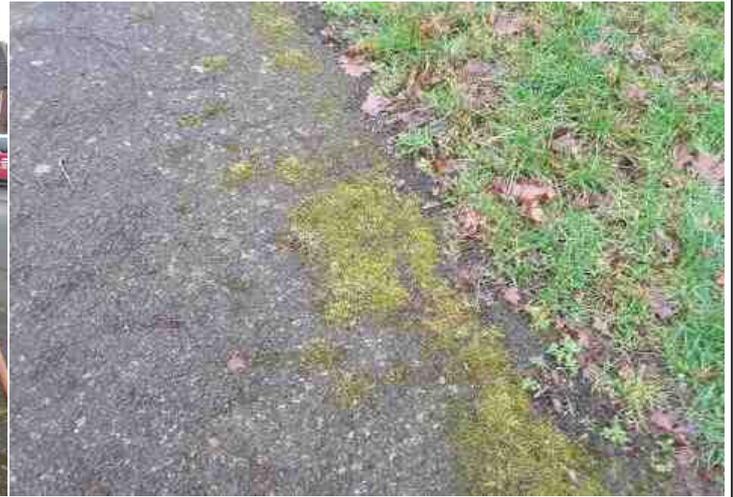
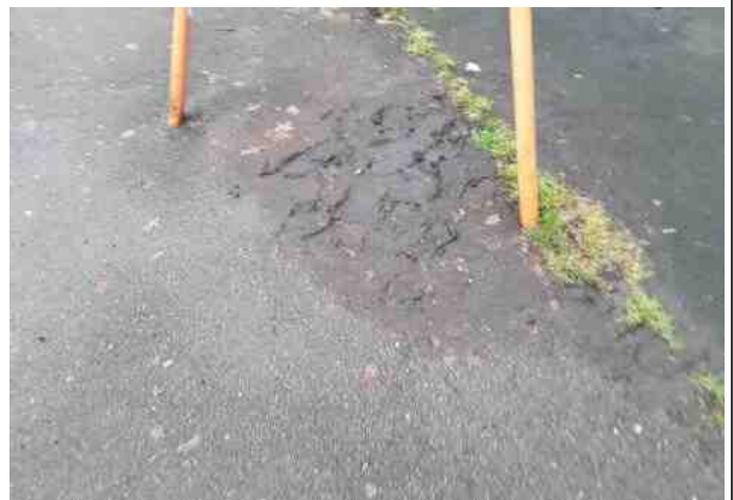
Finding: There is algae, silt or moss growth on the bitmac and safety surfaces resulting in slippery conditions

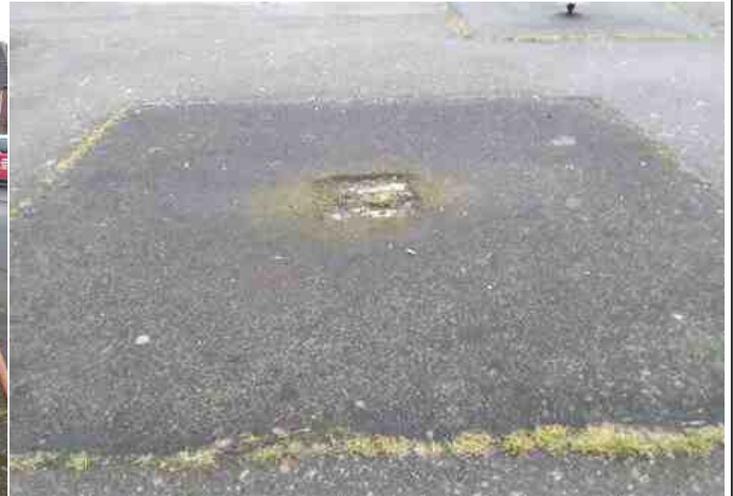
Finding: Equipment has been removed which has created trip hazards due to the redundant foundations

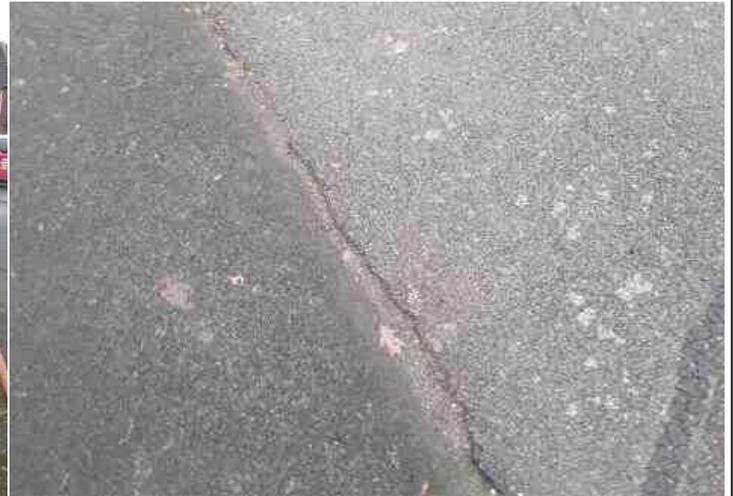
Finding: The bitmac surfacing is uneven creating trip hazards over the edges

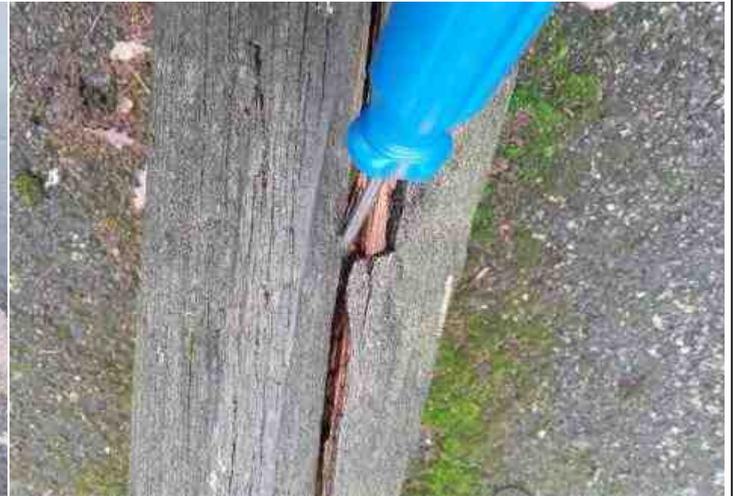
Finding: There are parts of the timber that have rotted

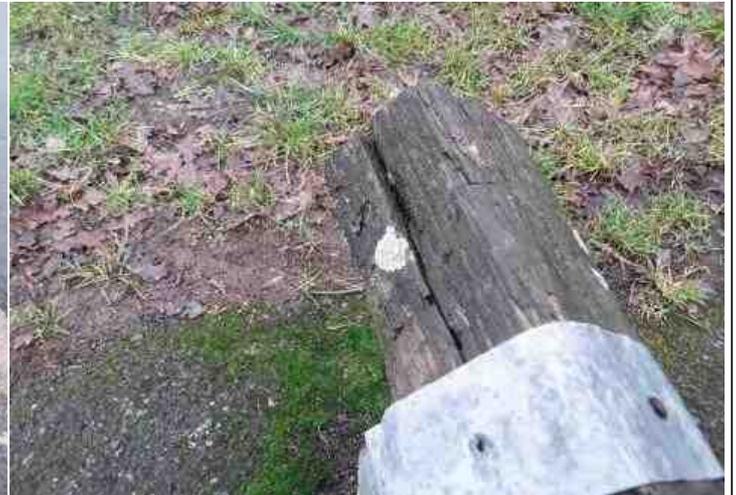
Finding: The timber has a number of splits/shakes or air cracks and this may affect the stability or allow water ingress which will accelerate the rotting process. Timber splits may also create rough / splintering edges.

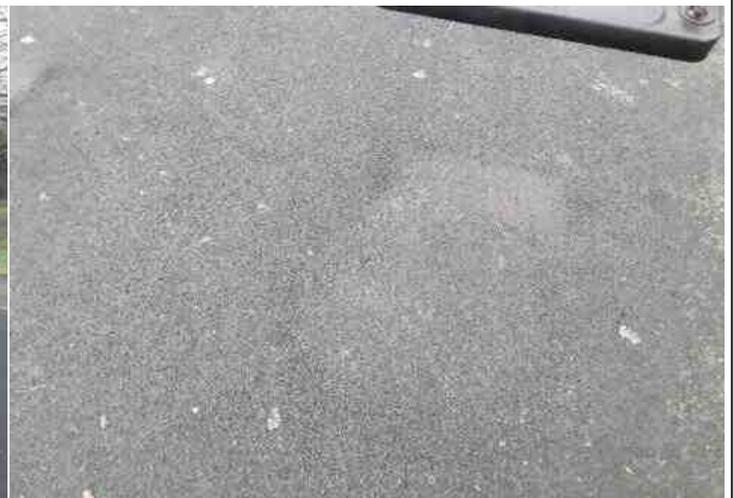
Finding: The safety surface is beginning to wear

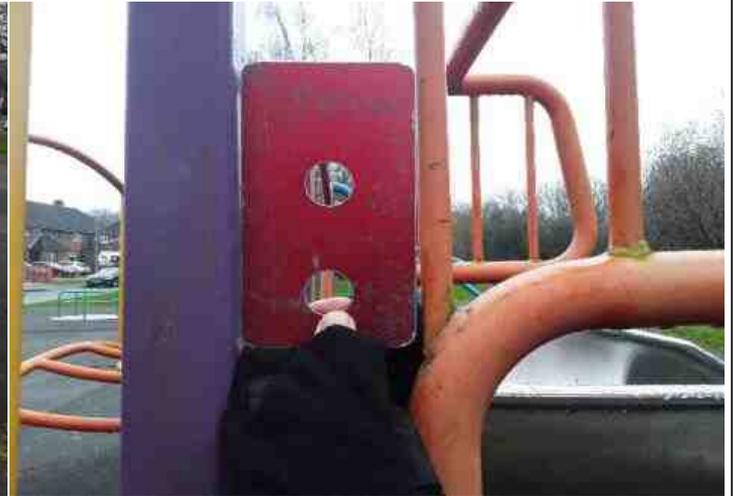
Finding: The item fails to meet the requirements of BS EN 1176 Part 1 4.2.7.2 head and neck entrapment in the barriers and/or steps
Action: Monitor - No action given the risk assessment

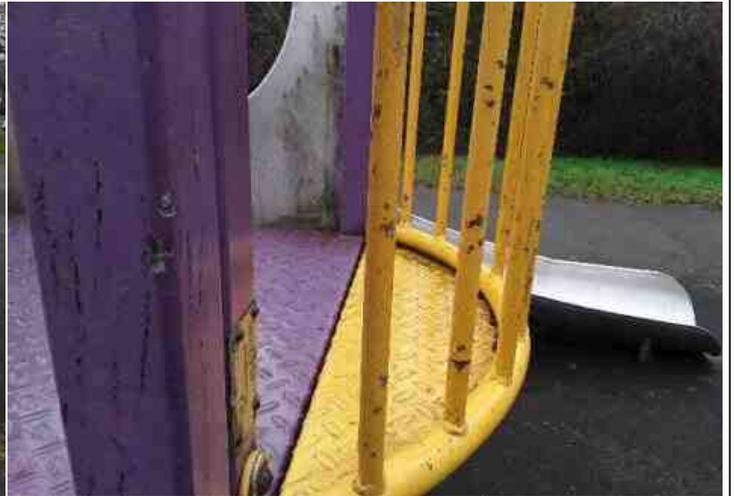
Finding: The paintwork on this item has been damaged or worn exposing the metal underneath which is rusting / corroding

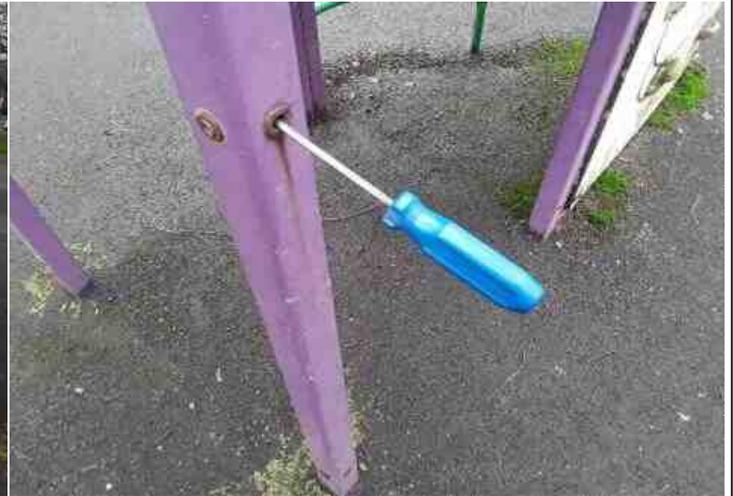
Finding: There is/are inserts missing

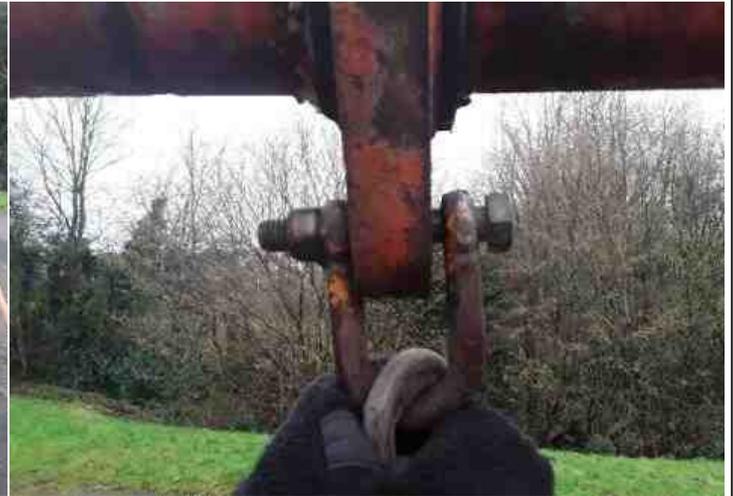
Finding: The bushes are showing signs of wear

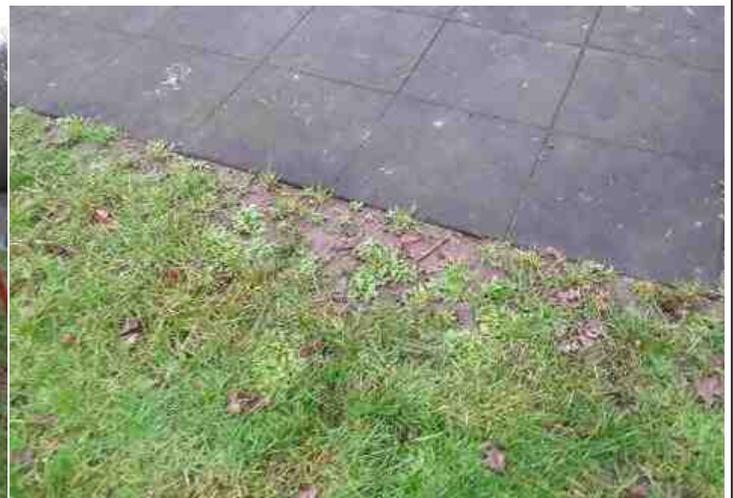
Finding: There are trip hazards at the edges of the tiled surface

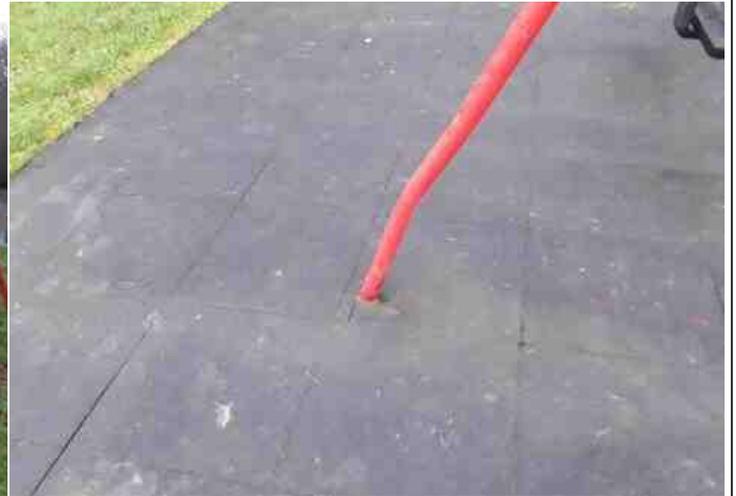
Finding: There is minor distortion damage to the frame

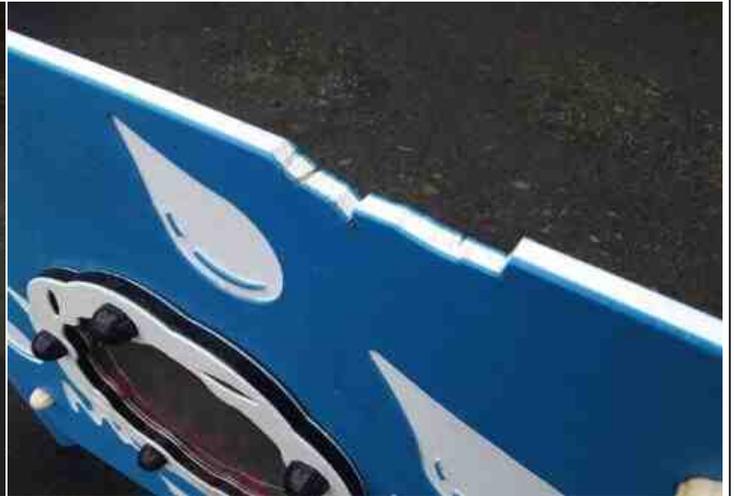
Finding: There is vandalism damage to the panel exposing sharp edges
