NOTICE OF PROPERTY MANAGEMENT AND GENERAL PURPOSES COMMITTEE MEETING

Thursday 5th March 2026 7pm

AGENDA

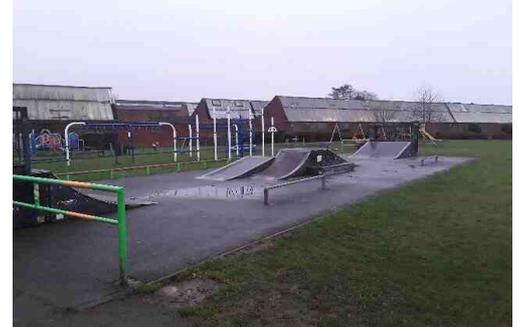
Item: Site General
Manufacturer: Owner/Operator
Surface Type: N/A
Item Quantity: 1
Equipment Compliance: N/A
Surface Area Compliance: N/A

The areas around the fitness equipment have eroded and may become slippery - Reinstate eroded areas

There are trip hazards present over the edgings - Remove trip hazard

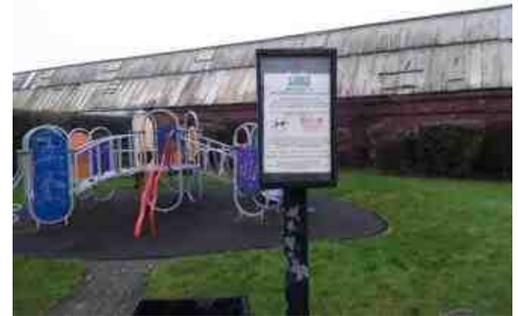
Item: Sign
Manufacturer: Owner/Operator
Surface Type: Grass
Item Quantity: 1
Equipment Compliance: N/A
Surface Area Compliance: N/A

This item is satisfactory - no work required -

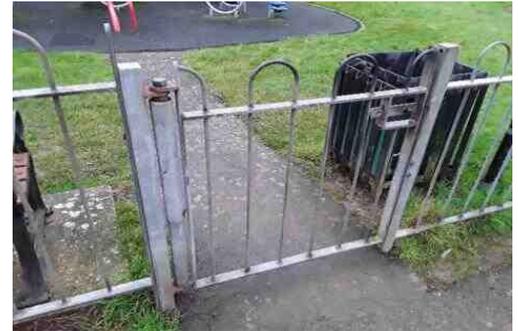
Item: Gate - Self Closing
Manufacturer: Not Identified
Surface Type: Bitmac
Item Quantity: 1
Equipment Compliance: N/A
Surface Area Compliance: N/A

There is minor damage to the infill sections - Monitor for any further deterioration and repair as required

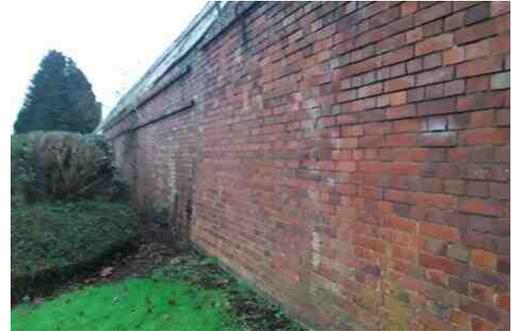
Item: Wall
Manufacturer: Not Applicable
Surface Type: Grass
Item Quantity: 1
Equipment Compliance: N/A
Surface Area Compliance: N/A

There is frost damage to the wall - Monitor and repair if required

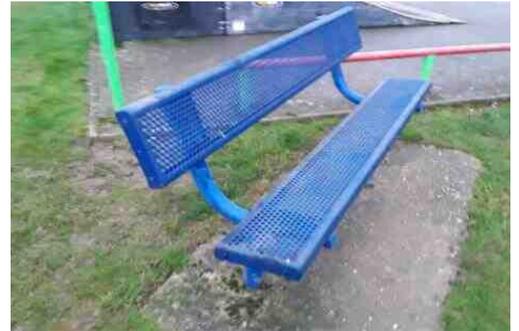
Item: Bench
Manufacturer: Not Identified
Surface Type: Concrete
Item Quantity: 1
Equipment Compliance: N/A
Surface Area Compliance: N/A

A number of fixing(s) have worked loose on the backrest - Secure all loose fixings

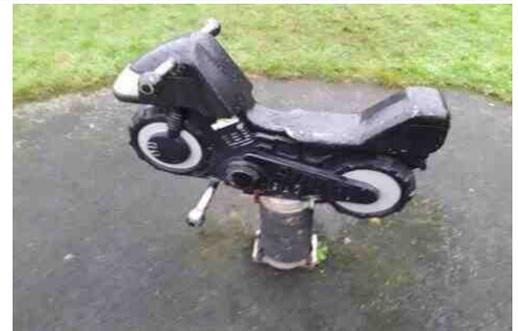
Item: Spring Bike
Manufacturer: Wicksteed Playgrounds
Surface Type: Wet Pour
Item Quantity: 1
Equipment Compliance: Yes
Surface Area Compliance: Yes
Life Expectancy: 5 -10 Years
Total Findings: 4

The fixings have corroded - Replace all corroded fixings

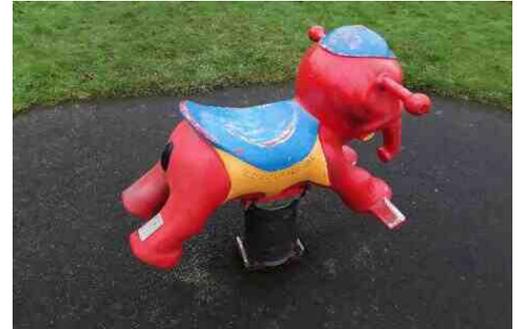
Item: Spring Elephant
Manufacturer: Wicksteed Playgrounds
Surface Type: Wet Pour
Item Quantity: 1
Equipment Compliance: Yes
Surface Area Compliance: Yes
Life Expectancy: 5 -10 Years
Total Findings: 3

The fixings have corroded - Replace all corroded fixings

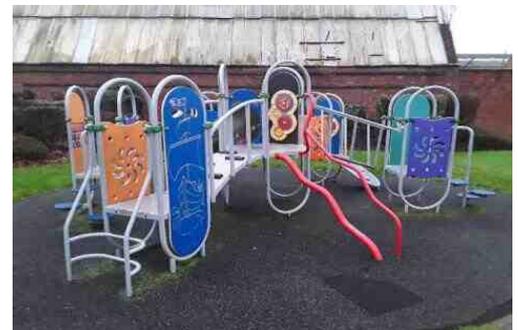
Item: Multi Play (Toddler)
Manufacturer: Wicksteed Playgrounds
Surface Type: Wet Pour
Item Quantity: 1
Equipment Compliance: No
Surface Area Compliance: Yes
Life Expectancy: >10 Years
Total Findings: 5

There is minor damage to the surface - Monitor for any further deterioration and repair as required

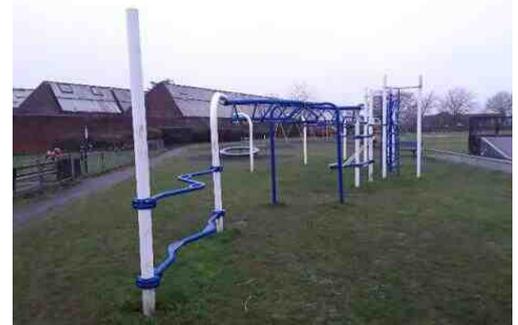
Item: Climbing Frame
Manufacturer: Parkdale Play & Leisure Ltd
Surface Type: Grass Matrix Tiles
Item Quantity: 1
Equipment Compliance: Yes
Surface Area Compliance: Yes
Life Expectancy: >10 Years
Total Findings: 5

Finding 1
 There is surface corrosion / rust present on the item - Consider treating the item

Finding 2
 The grass has eroded within the impact area of the equipment and may not provide the necessary impact attenuating properties for the equipment fall height; the surface may also be slippery in wet weather - Reinststate the grass or provide an all weather surface

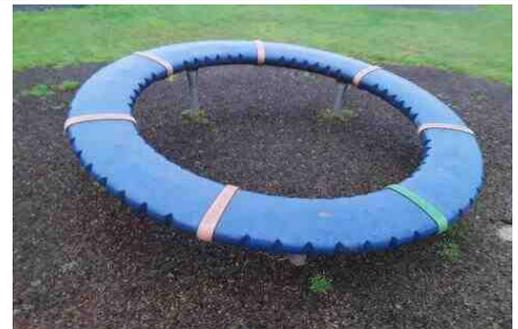
Item: Supernova
Manufacturer: Kompan Ltd
Surface Type: Bonded Rubber Mulch
Item Quantity: 1
Equipment Compliance: Yes
Surface Area Compliance: Yes
Life Expectancy: 5 -10 Years
Total Findings: 3

Finding 1
 The surfacing is severely damaged exposing the sub base - Repair damaged areas of surfacing

Finding 2
 The surface has subsided in some areas - Monitor for any further deterioration and repair as required

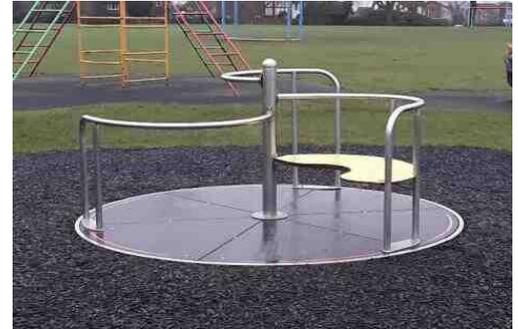
Item: Inclusive Roundabout
Manufacturer: Playdale Playgrounds Ltd
Surface Type: Bonded Rubber Mulch
Item Quantity: 1
Equipment Compliance: No
Surface Area Compliance: Yes
Life Expectancy: >10 Years
Total Findings: 4

A number of fixing(s) have worked loose - Secure all loose fixings

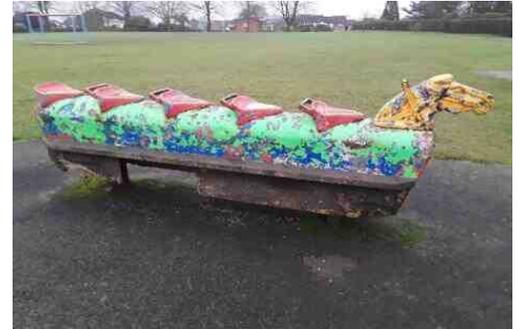
Item: Rocking Horse
Manufacturer: Wicksteed Playgrounds
Surface Type: Wet Pour
Item Quantity: 1
Equipment Compliance: No
Surface Area Compliance: Yes
Life Expectancy: 3 - 5 Years
Total Findings: 5

The timber guarding has rotted - Replace the guarding

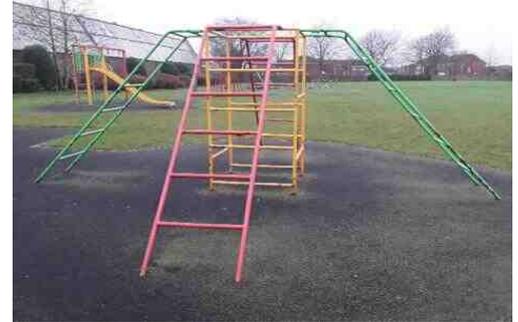
Item: Climbing Frame
Manufacturer: Wicksteed Playgrounds
Surface Type: Wet Pour
Item Quantity: 1
Equipment Compliance: No
Surface Area Compliance: Yes
Life Expectancy: >10 Years
Total Findings: 3

The paintwork on this item has been damaged or worn exposing the metal underneath which is rusting / corroding - Treat affected areas and repaint

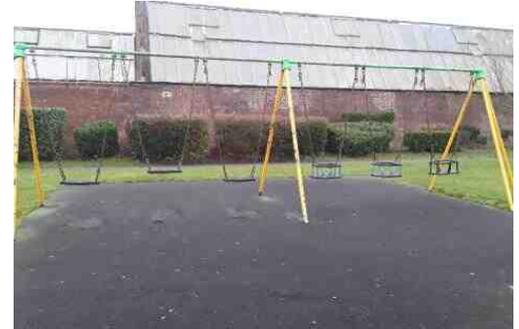
Item: 2 Bay Swing
Manufacturer: Wicksteed Playgrounds
Surface Type: Wet Pour
Item Quantity: 1
Equipment Compliance: No
Surface Area Compliance: No
Life Expectancy: >10 Years
Total Findings: 11

The surfacing is damaged - Repair damaged areas of surfacing

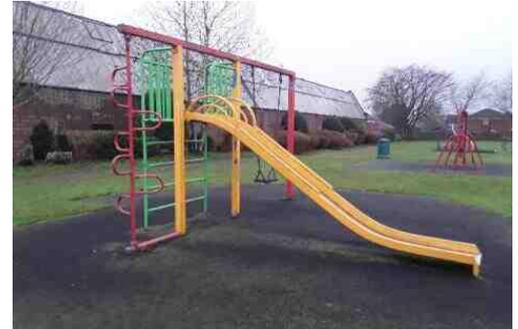
Item: Multi Play (Junior)
Manufacturer: Wicksteed Playgrounds
Surface Type: Wet Pour
Item Quantity: 1
Equipment Compliance: No
Surface Area Compliance: Yes
Life Expectancy: 3 - 5 Years
Total Findings: 10

There are falls in excess of 600mm between adjacent components on the structure, in contravention of the recommendations set out in BS EN 1176 Part 1; 4.2.8.4 - Monitor - No action given the risk assessment

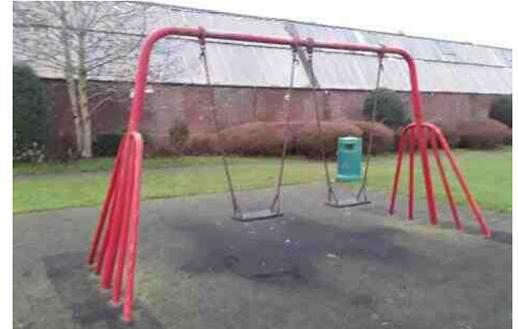
Item: 1 Bay 2 Seat (Flat)
Manufacturer: Wicksteed Playgrounds
Surface Type: Wet Pour
Item Quantity: 1
Equipment Compliance: No
Surface Area Compliance: Yes
Life Expectancy: >10 Years
Total Findings: 7

The surfacing is damaged - Repair damaged areas of surfacing

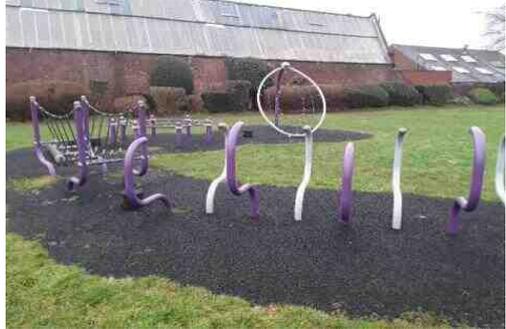
Item:	Activity Trail
Manufacturer:	Wicksteed Playgrounds
Surface Type:	Bonded Rubber Mulch
Item Quantity:	1
Equipment Compliance:	No
Surface Area Compliance:	Yes
Life Expectancy:	>10 Years
Total Findings:	6

Finding 1	Finding 2
The surface has subsided in some areas - Monitor for any further deterioration and repair as required	There are falls in excess of 600mm between adjacent components on the structure, in contravention of the recommendations set out in BS EN 1176 Part 1; 4.2.8.4 - Monitor - No action given the risk assessment
Finding 3	Finding 4
There is minor damage to the stepping posts - Monitor and replace if required	There is/are inserts missing - Replace missing inserts
Finding 5	Finding 6
The surfacing is damaged - Repair damaged areas of surfacing	There is leeching through the bonded rubber mulch - Consider providing additional drainage

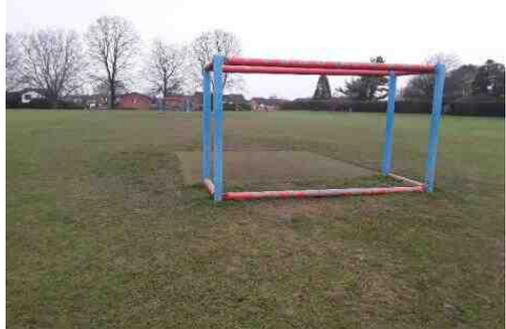
Item:	Goal End
Manufacturer:	Parkdale Play & Leisure Ltd
Surface Type:	Artificial Grass
Item Quantity:	2
Equipment Compliance:	N/A
Surface Area Compliance:	N/A
Life Expectancy:	5 -10 Years
Total Findings:	3

Finding 1	Finding 2
The paint is flaking off the metalwork - Rub down and re-paint	The area around the item has eroded and may become slippery - Reinstate eroded area
Finding 3	
There are holes in the playing surface that may cause users to trip or roll ankles - Infill to provide a sound reasonably level surface.

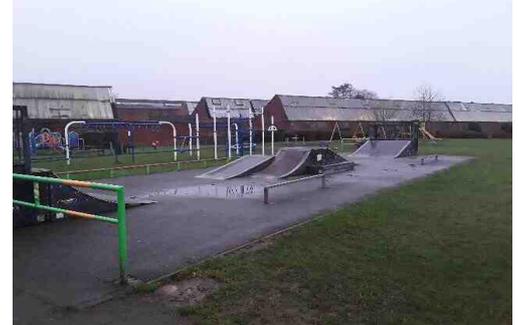
Item: Sign
Manufacturer: Not Identified
Surface Type: N/A
Item Quantity: 1
Equipment Compliance: N/A
Surface Area Compliance: N/A

Signage of the wheeled sports area should be provided as recommended in BS EN 14974; this will include, but not exclusively, the use of the area, a recommendation to wear protective equipment, emergency contact details etc - Provide signage as recommended by BS EN 14974 for wheeled sports areas

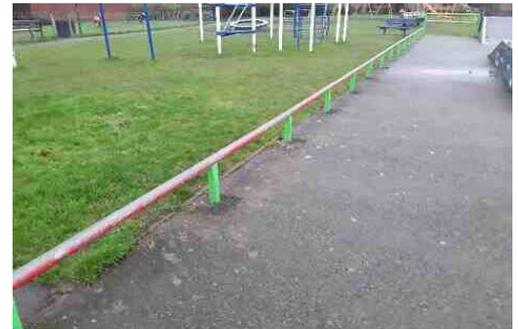
Item: Fencing - Post & Rail
Manufacturer: Not Identified
Surface Type: Bitmac
Item Quantity: 1
Equipment Compliance: N/A
Surface Area Compliance: N/A

The paint is flaking off the metalwork - Rub down and re-paint

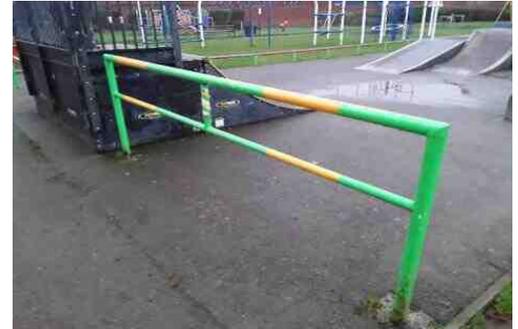
Item: Barrier
Manufacturer: Not Identified
Surface Type: Bitmac
Item Quantity: 1
Equipment Compliance: N/A
Surface Area Compliance: N/A

The weld(s) on this item have failed - Repair item

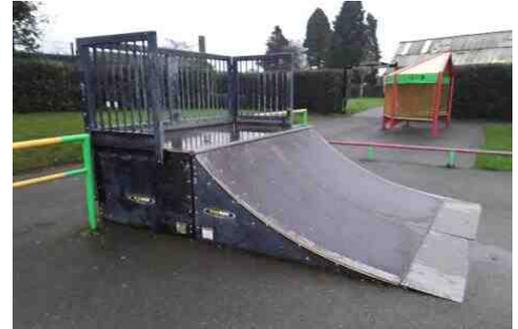
Item: Quarter Pipe
Manufacturer: Woodward
Surface Type: Bitmac
Item Quantity: 1
Equipment Compliance: No
Surface Area Compliance: Yes
Life Expectancy: >10 Years
Total Findings: 6

There is or are fixings missing on the item - Replace all missing fixings

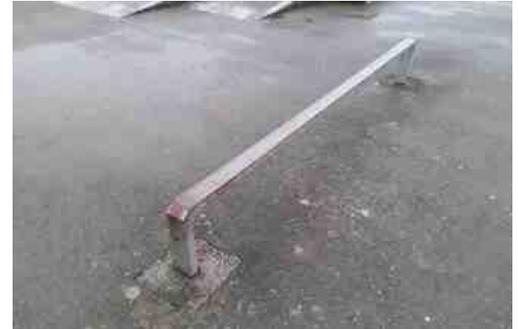
Item: Grind Rail
Manufacturer: Not Identified
Surface Type: Bitmac
Item Quantity: 1
Equipment Compliance: Yes
Surface Area Compliance: Yes
Life Expectancy: 5 -10 Years
Total Findings: 1

This item is satisfactory - no work required -

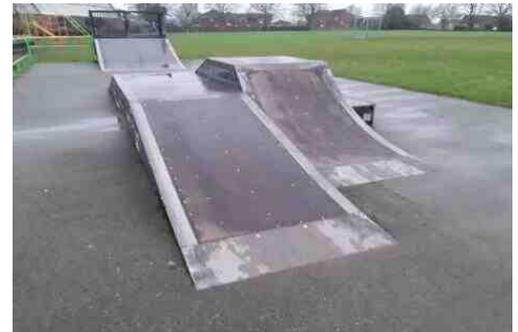
Item: Combination Ramp
Manufacturer: Woodward
Surface Type: Bitmac
Item Quantity: 1
Equipment Compliance: No
Surface Area Compliance: Yes
Life Expectancy: 5 -10 Years
Total Findings: 3

The kicker plate protrudes more than 5mm above the surrounding surface level, BS EN 14974 - 6.1.4 recommends a maximum of 5mm - Adjust height to ensure a maximum of 5mm change in level

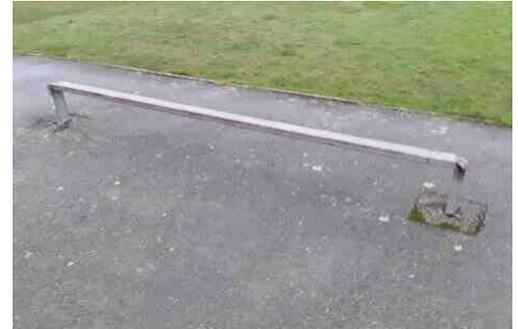
Item: Grind Rail
Manufacturer: Not Identified
Surface Type: Bitmac
Item Quantity: 1
Equipment Compliance: Yes
Surface Area Compliance: Yes
Life Expectancy: 5 -10 Years
Total Findings: 1

The weld(s) on this item have failed - Repair item

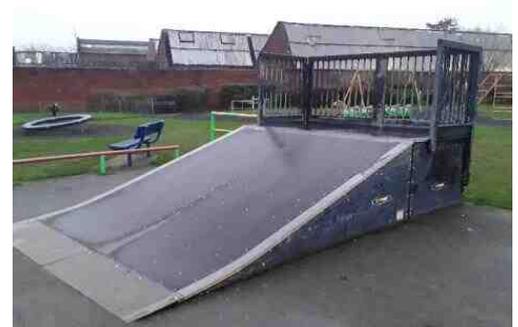
Item: Flat Bank
Manufacturer: Woodward
Surface Type: Bitmac
Item Quantity: 1
Equipment Compliance: No
Surface Area Compliance: Yes
Life Expectancy: 5 -10 Years
Total Findings: 6

The ends of the barrier do not have a radius of at least 50mm or are not chamfered by at least 50mm x 50mm in contravention of the requirements of BS EN 14974 - 6.2.6 - Monitor - no reasonably practicable action given the risk assessment

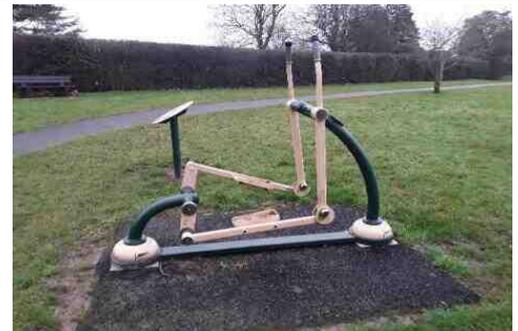
There is/are inserts missing - Replace missing inserts

There is/are bolt cap covers missing or damaged on the item - Replace missing or damaged bolt cap covers

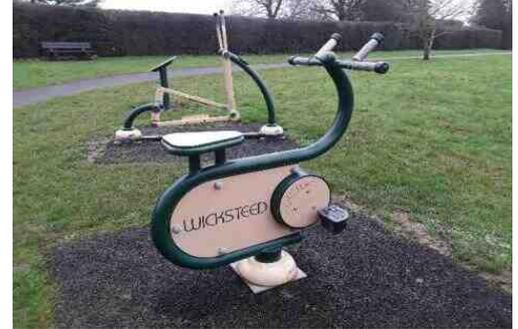
The seat has been damaged - Monitor for any further deterioration and replace as required

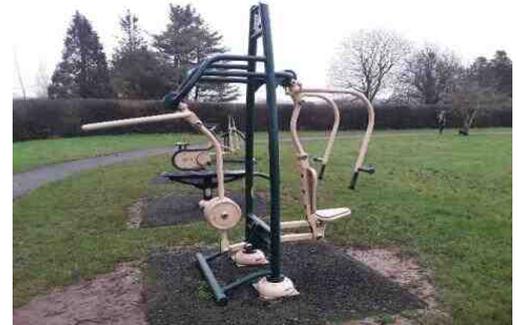
There is/are bolt cap covers missing or damaged on the item - Replace missing or damaged bolt cap covers

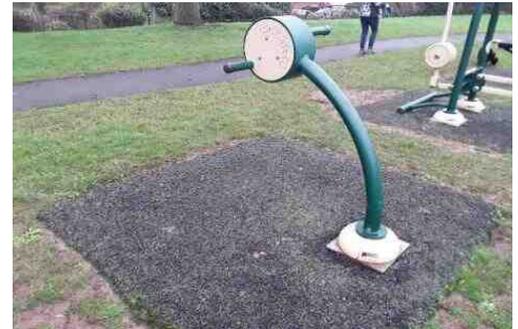
There are obstacles located within the movement space of the item in contravention of the requirements of BS EN 16630 - Monitor - No action given the risk assessment

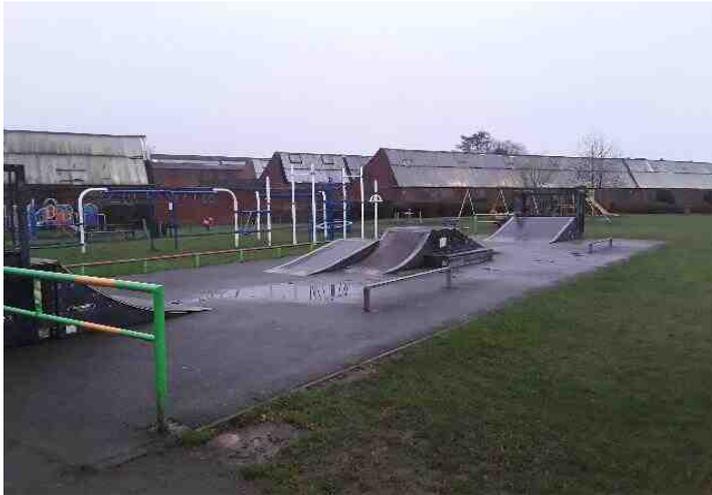
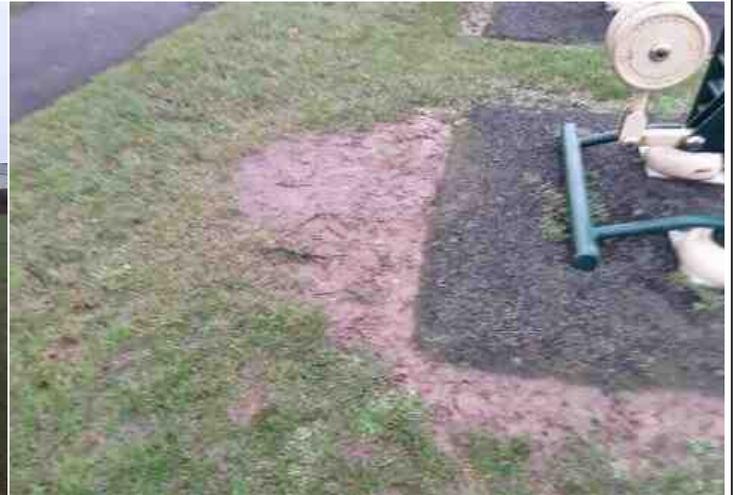
Finding: The areas around the fitness equipment have eroded and may become slippery

Action: Reinstate eroded areas

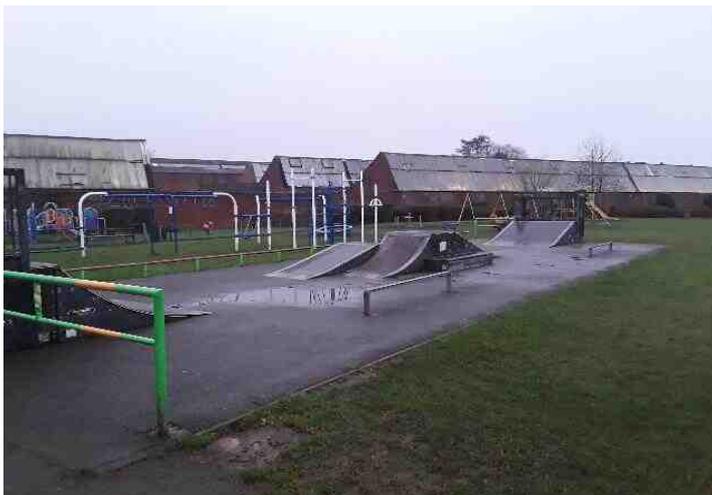
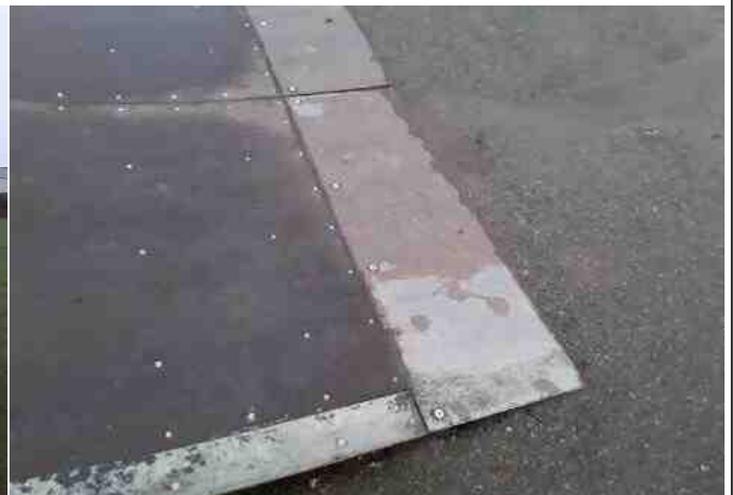
Finding: There is surface corrosion / rust present on the skate equipment

Action: Consider treating the items

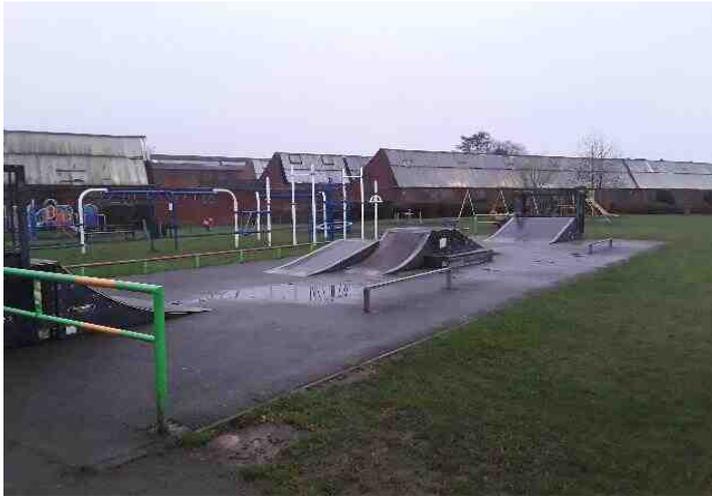
Finding: There are trip hazards present over the edgings

Action: Remove trip hazard

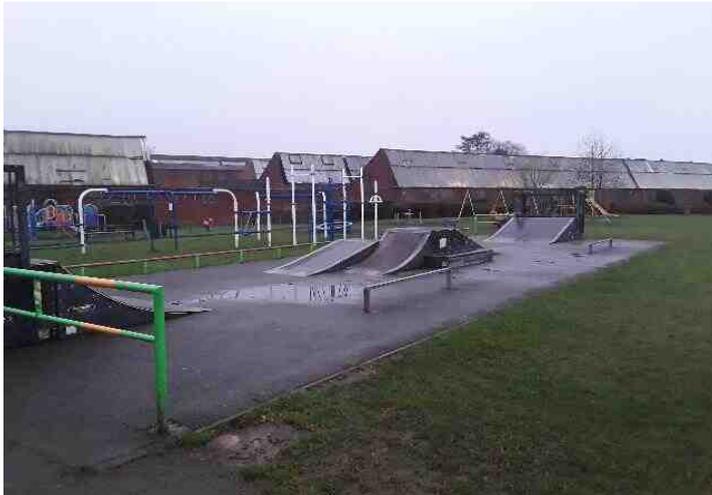
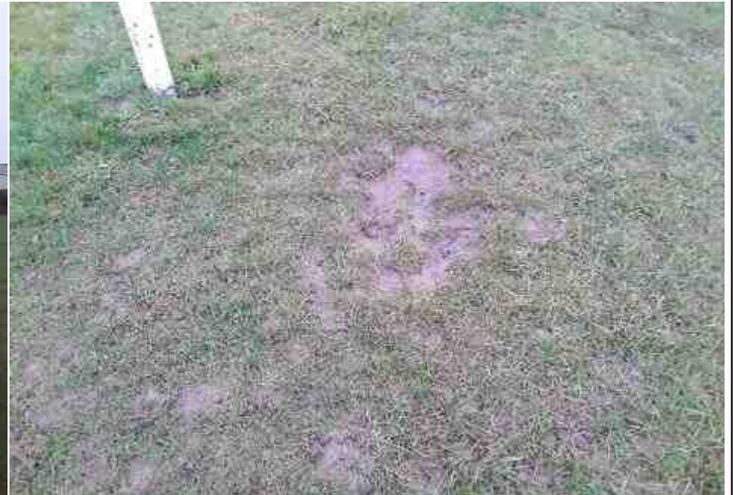
Finding: The grass mats are silted up and the soil is compacted; this may have an effect on the impact absorbing properties of the surface. Consideration should be given to HIC testing the surface to verify impact attenuating properties (<https://playinspections.co.uk/inspection-services/safety-surface-testing/>)

Action: Contact our office for a quotation for this service

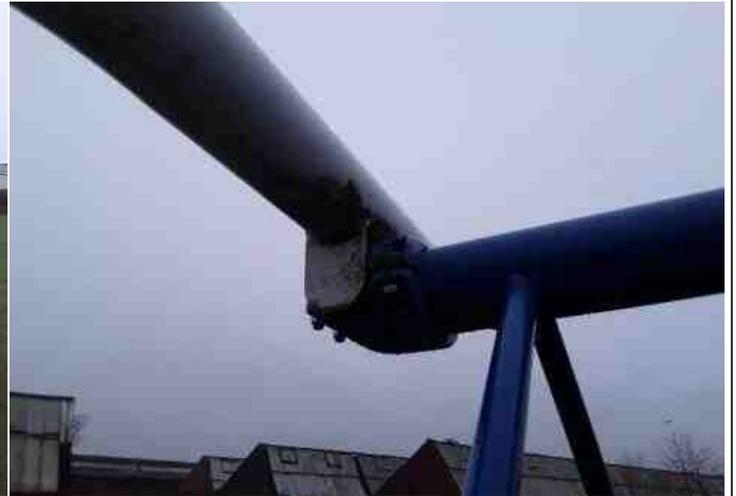
Finding: There is algae or moss on the equipment

Action: Clean and treat appropriately

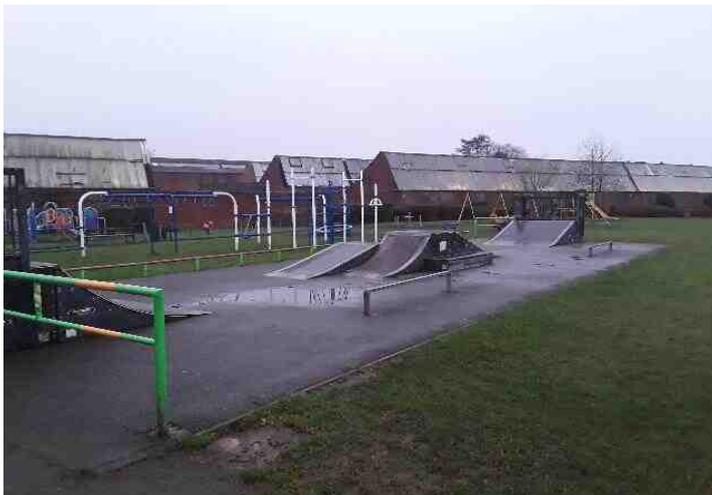
Finding: There is wear damage to the access footpath creating trip hazards and unforeseen changes in levels

Action: Repair the damaged areas of bitmac to provide a uniform surface

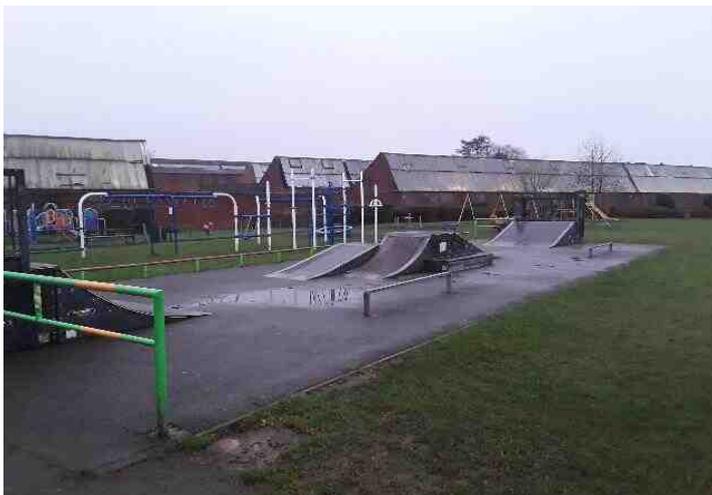
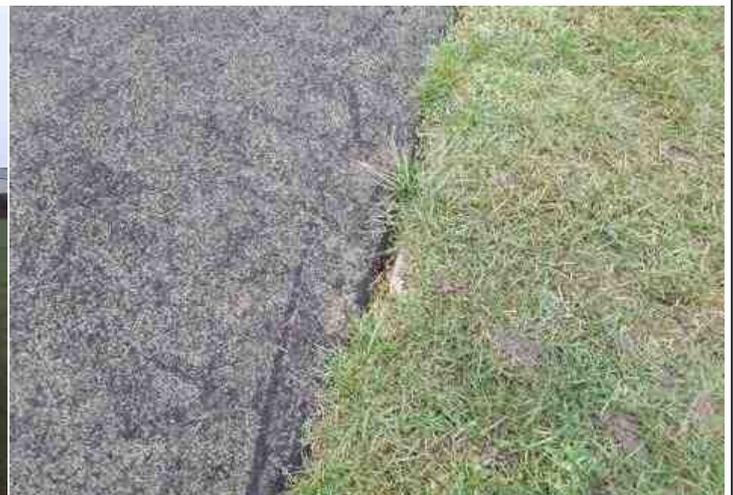
Finding: There are gaps opening between the surfacing and the edging surround or between the joints in the surfacing

Action: Monitor for any further deterioration and repair as required

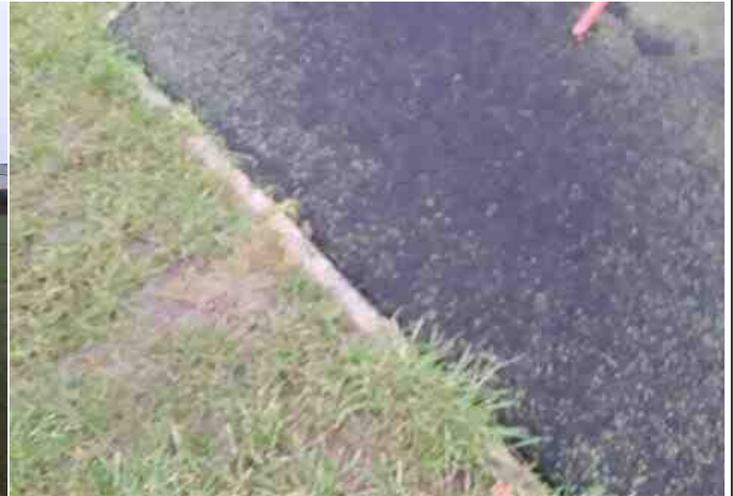
Finding: There is weed / vegetation growth on and around the surfaces
Action: Remove weed / vegetation growth

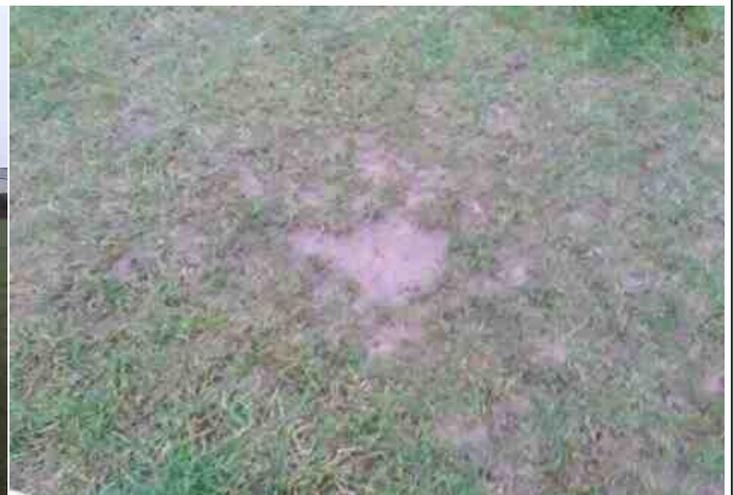
Finding: The grass surface has eroded in some areas and may be slippery in wet conditions
Action: Reinstate the surface

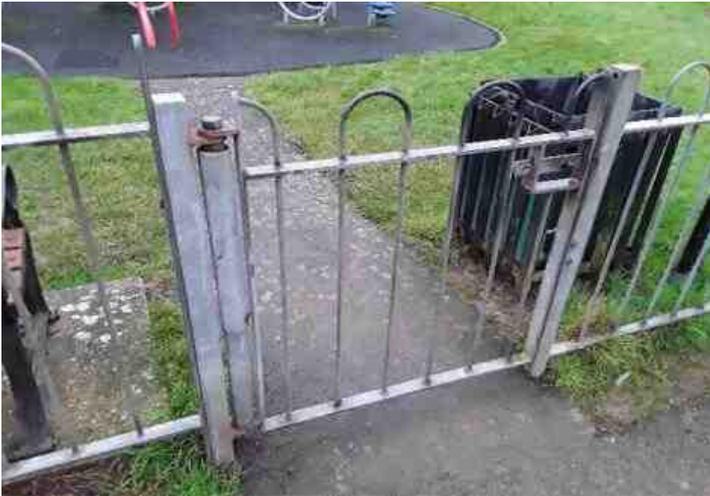
Finding: There is minor damage to the infill sections

Action: Monitor for any further deterioration and repair as required

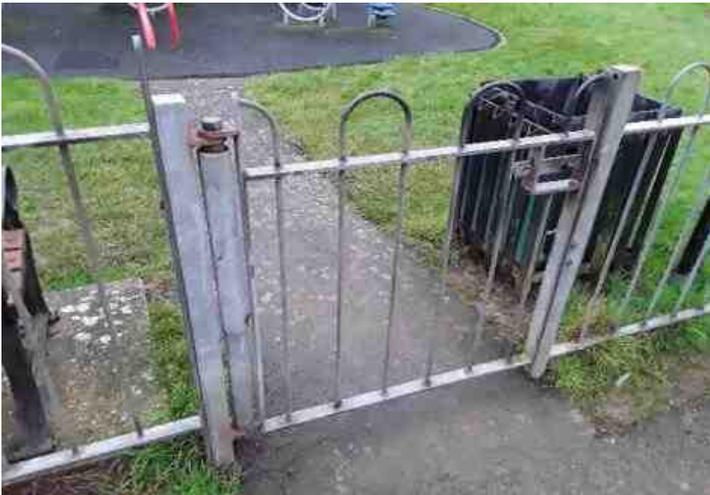
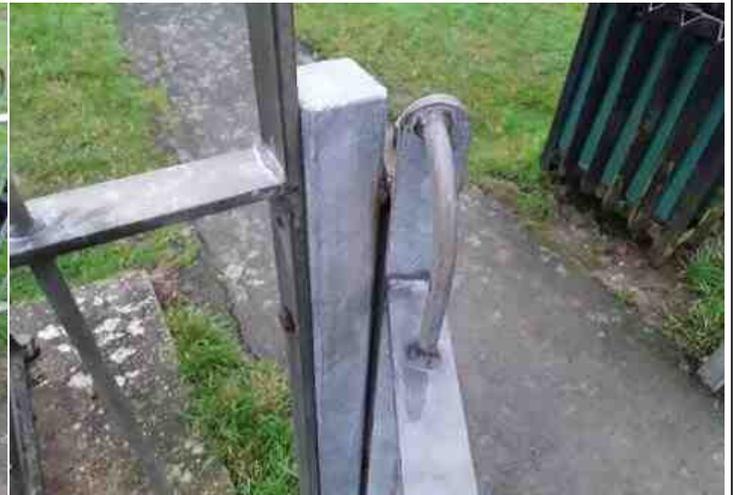
Finding: There are openings that are less than 12mm that could trap or crush fingers

Action: Provide a 12mm gap throughout full range of motion at both sides of gate

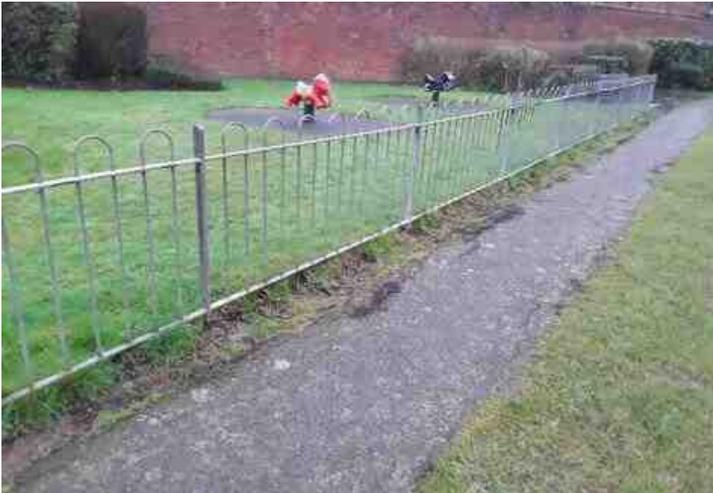
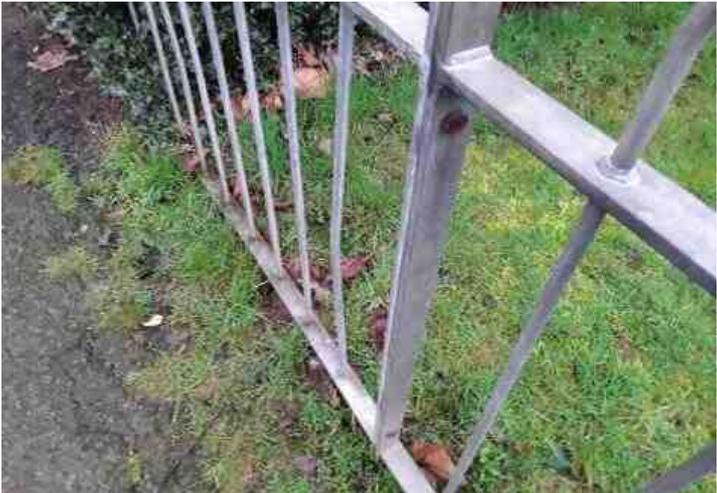
Finding: There is minor damage to the fence sections

Action: Monitor for any further deterioration and repair as required

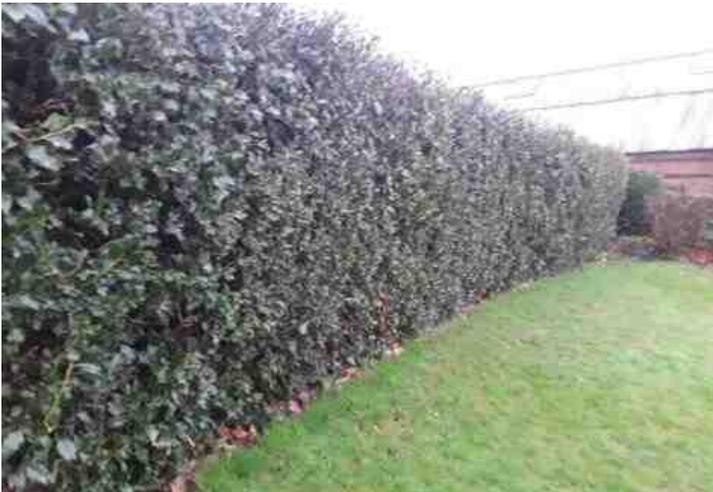
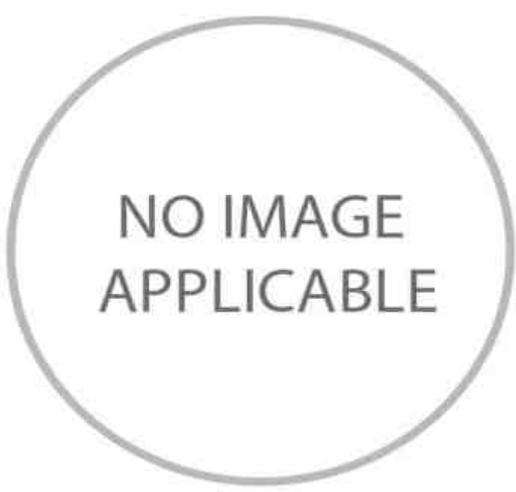
Finding: The hedge consists primarily of Holly, the leaves have sharp protrusions and may cause slight puncture wounds

Action: Monitor and provide guarding if required

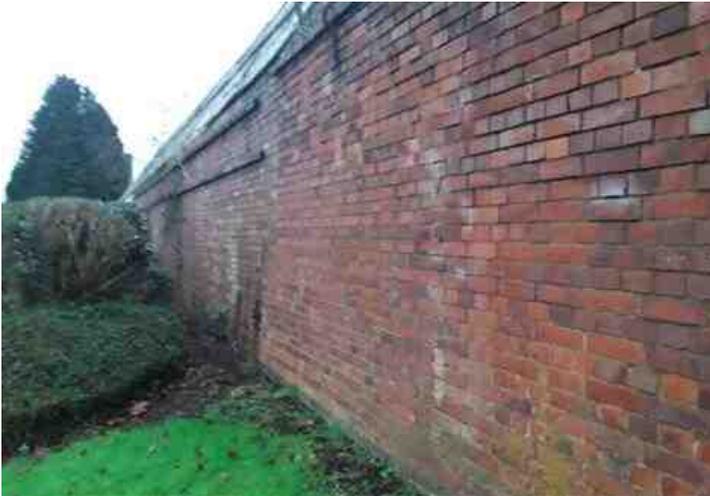
Finding: There is frost damage to the wall

Action: Monitor and repair if required

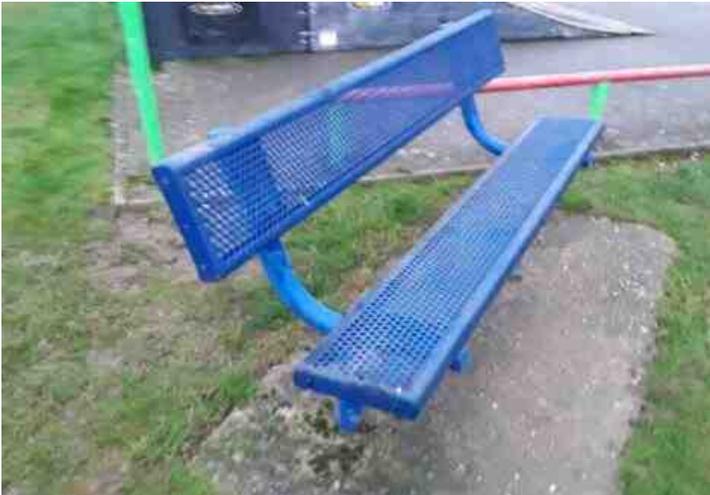
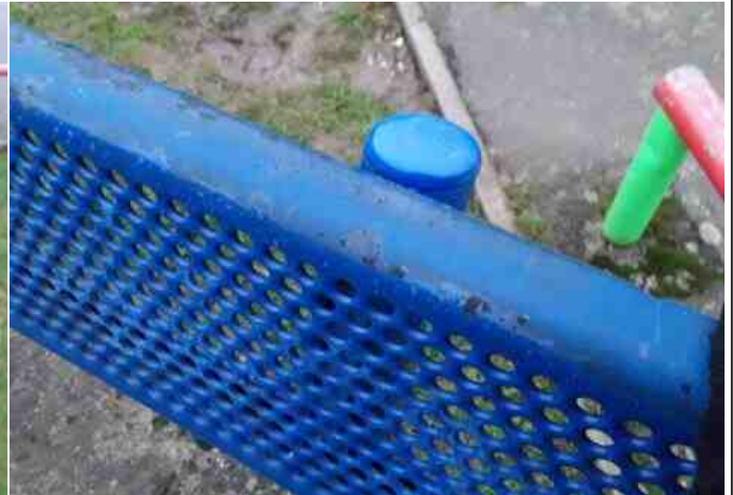
Finding: A number of fixing(s) have worked loose on the backrest

Action: Secure all loose fixings

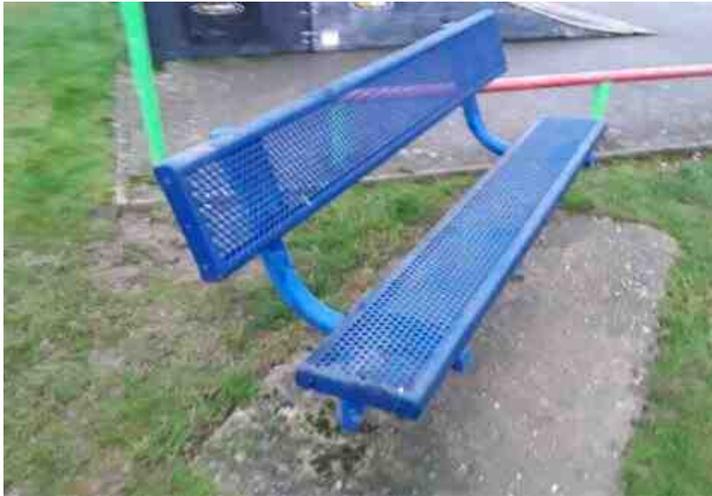
Finding: There is minor damage to the protective coating

Action: Monitor and repair if required

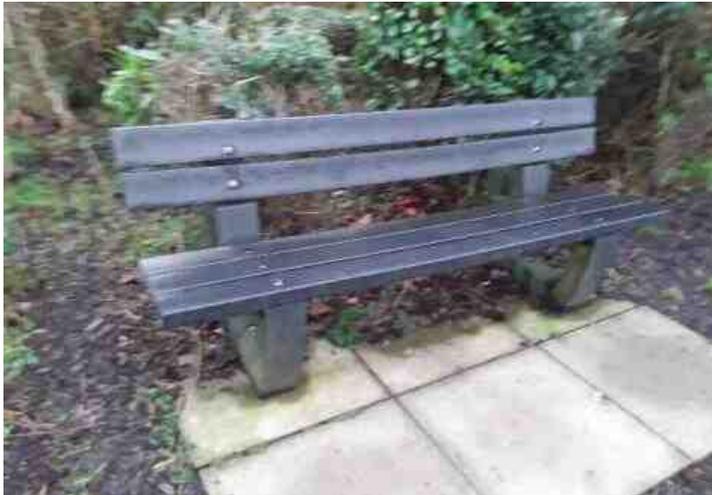
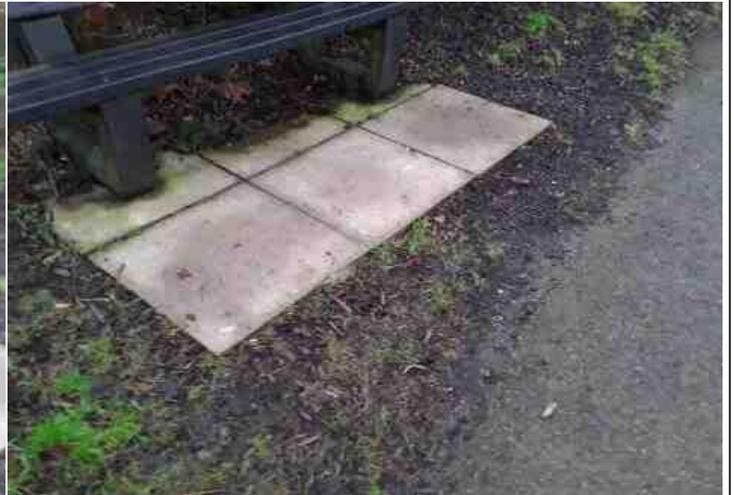
Finding: There are trip hazards present over the pavings under the bench

Action: Remove trip hazard

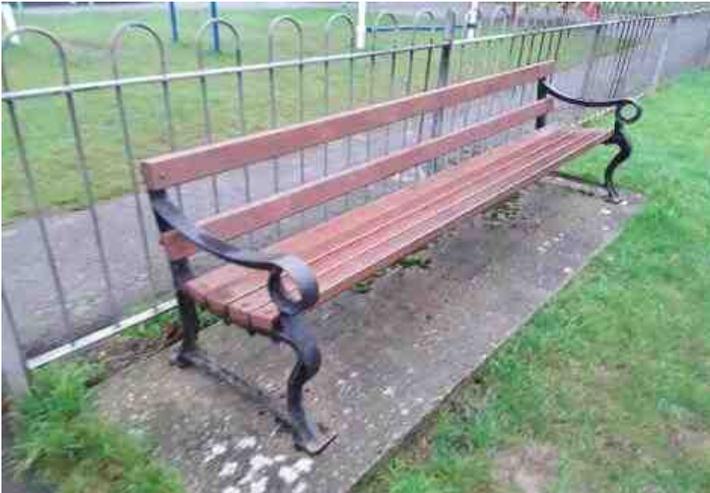
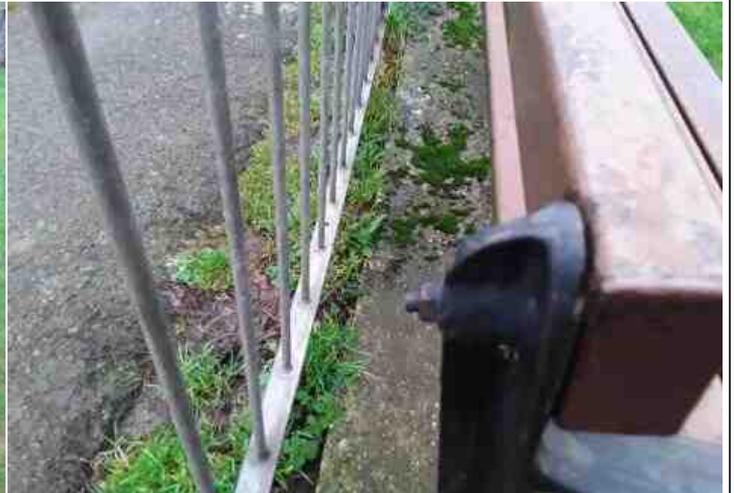
Finding: There are projecting bolt thread(s) present

Action: Remove excess thread length and deburr or provide cap

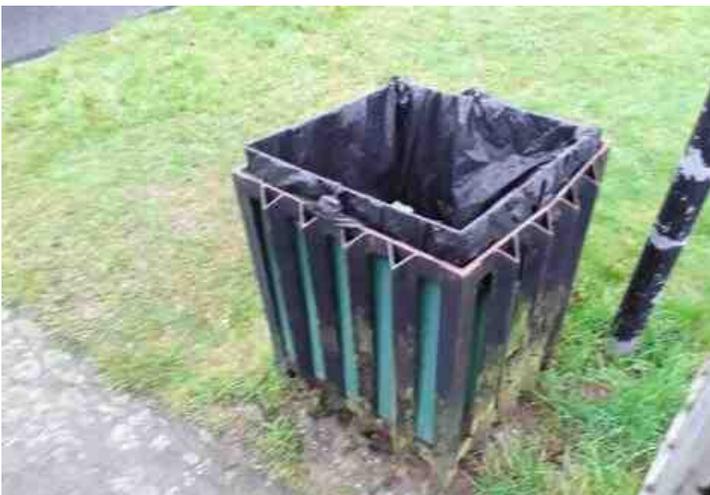
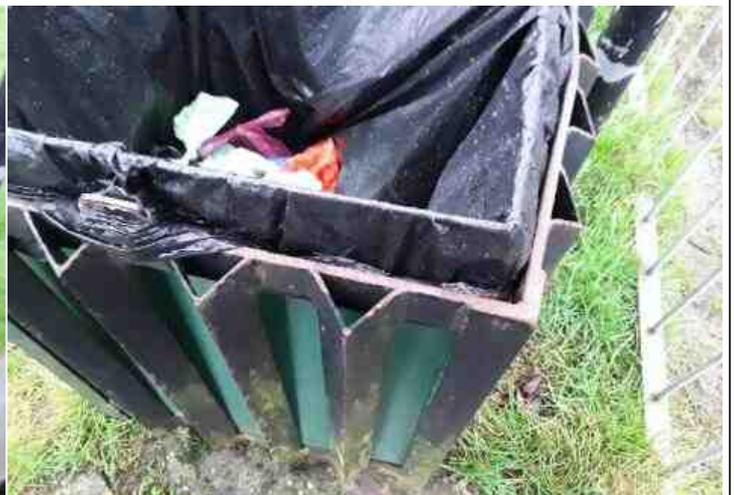
Finding: The paintwork on this item has been damaged or worn exposing the metal underneath which is rusting / corroding

Action: Treat affected areas and repaint

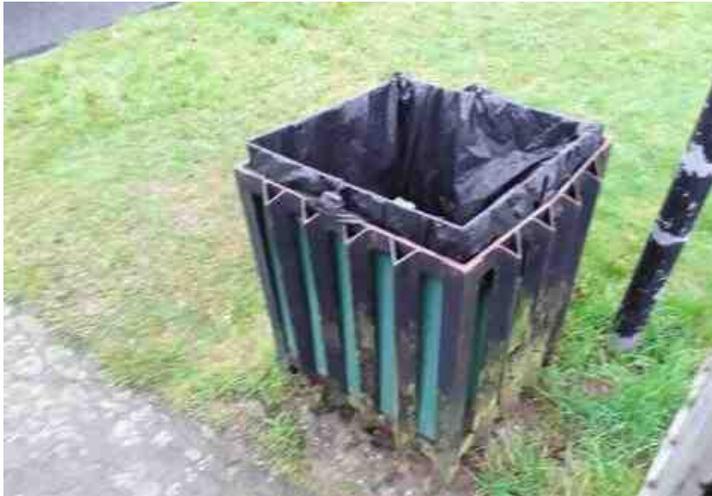
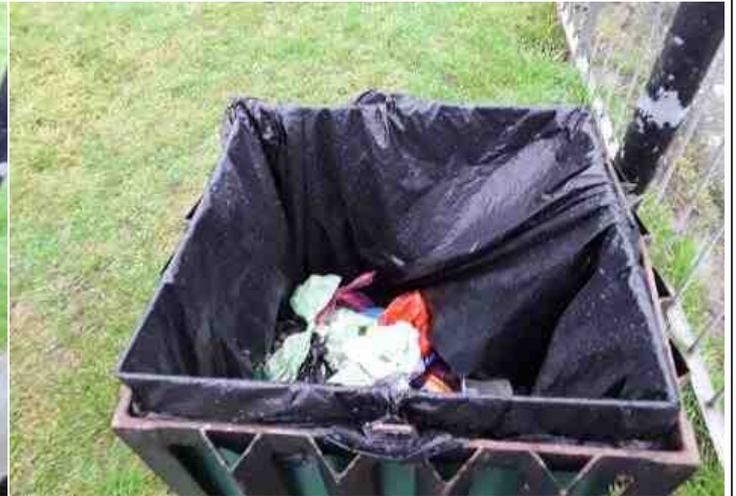
Finding: The liner of the litter bin is not secured and can be easily removed
Action: Ensure the liner is secured

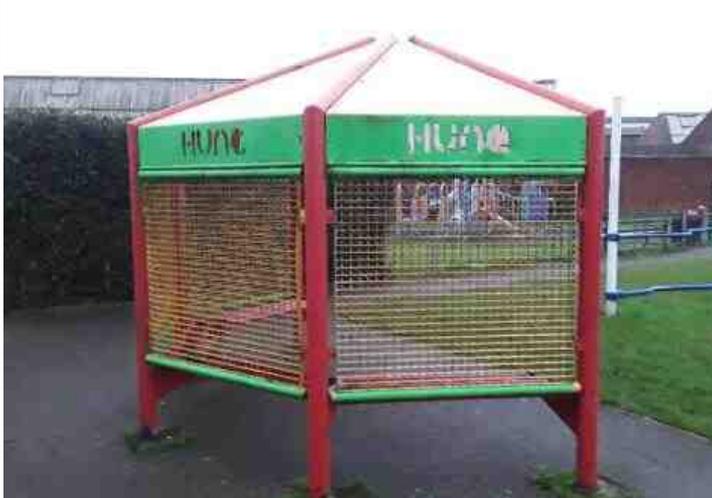
Finding: The paintwork on this item has been damaged or worn exposing the metal underneath which is rusting / corroding
Action: Treat affected areas and repaint

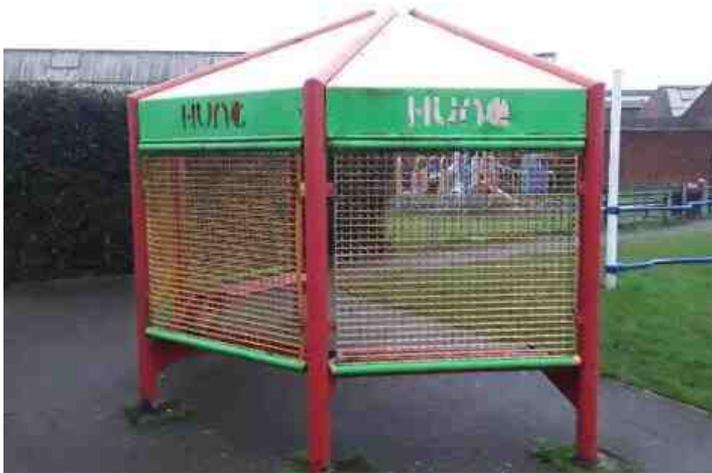
Finding: There is / are post or end caps missing / damaged on the item
Action: Replace missing / damaged post or end caps

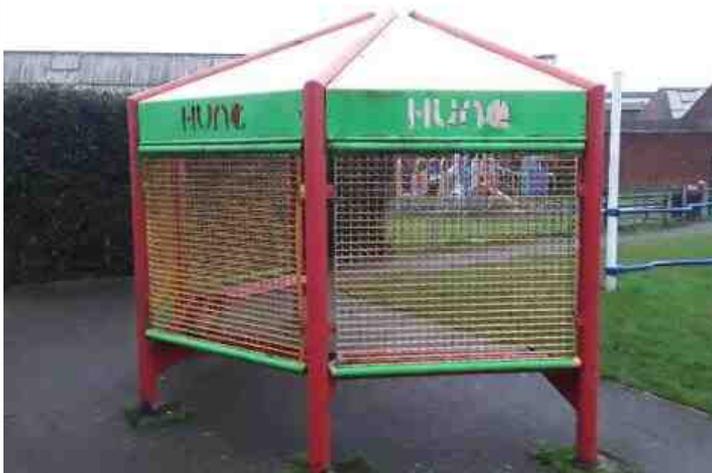
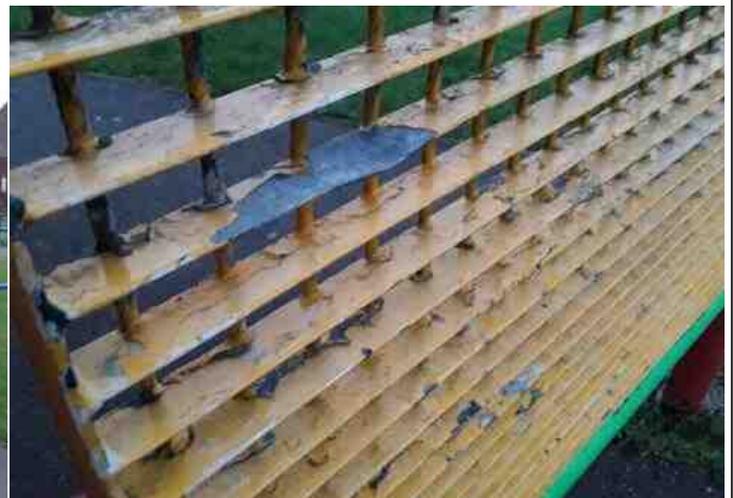
Item: Ancillary Items - Teenage Shelter
Manufacturer: Not Identified

Finding: The paint is flaking off the metalwork
Action: Rub down and re-paint

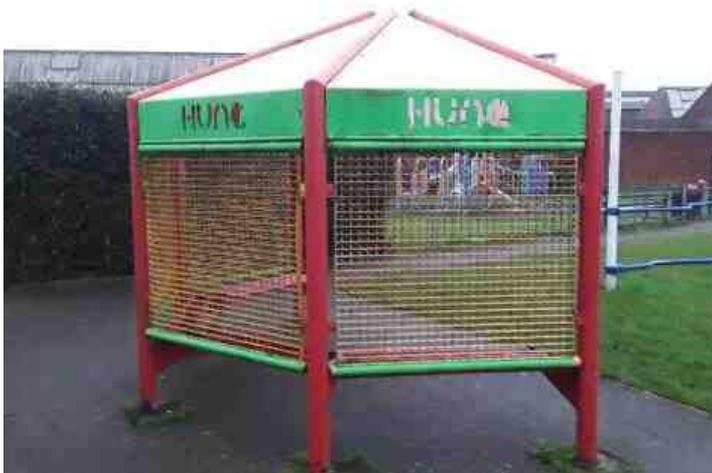
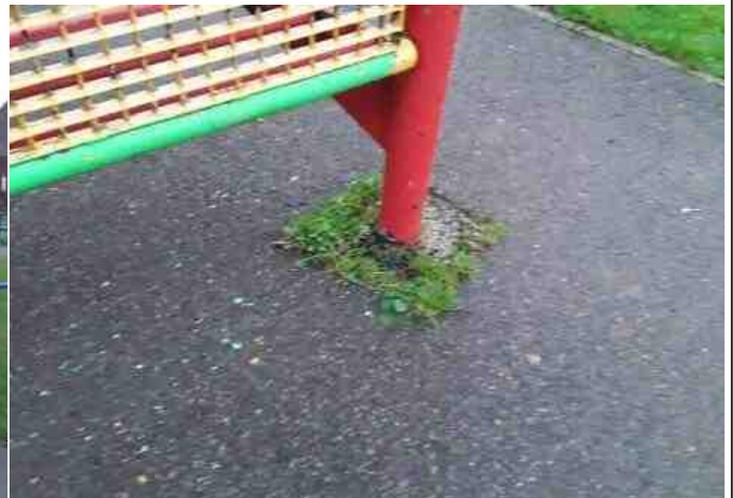
Item: Ancillary Items - Teenage Shelter
Manufacturer: Not Identified

Finding: There is weed / vegetation growth on and around the reinstatement surface

Action: Remove weed / vegetation growth

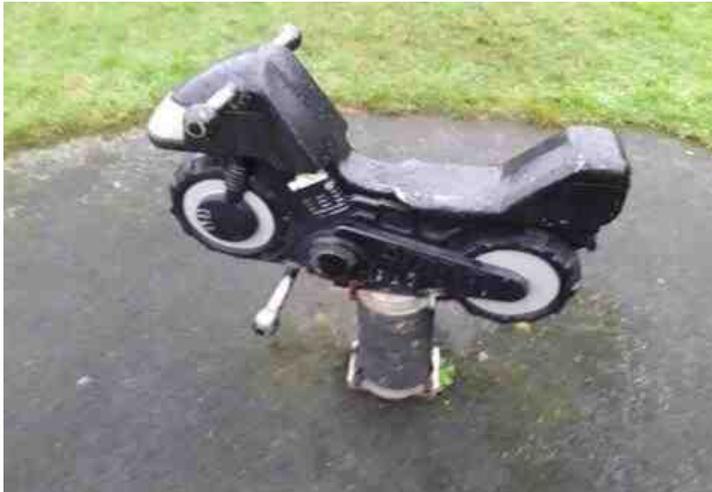
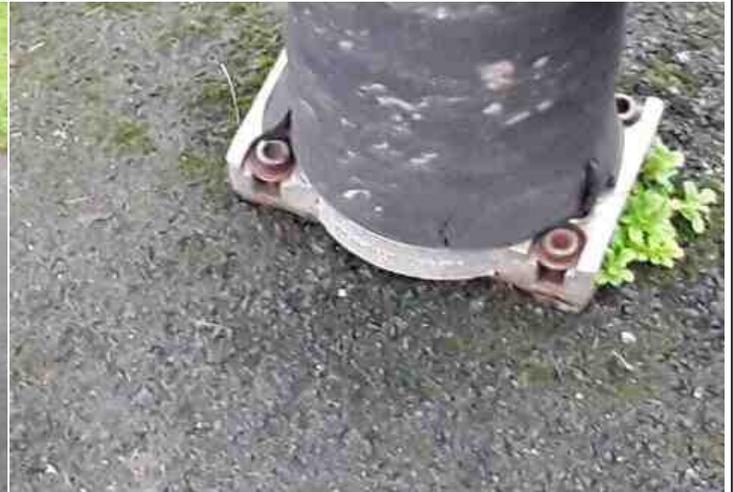
Item: Rocking Equipment - Spring Bike
Manufacturer: Wicksteed Playgrounds

Finding: The fixings have corroded

Action: Replace all corroded fixings
