NOTICE OF PROPERTY MANAGEMENT AND GENERAL PURPOSES COMMITTEE MEETING

Thursday 5th March 2026 7pm

AGENDA

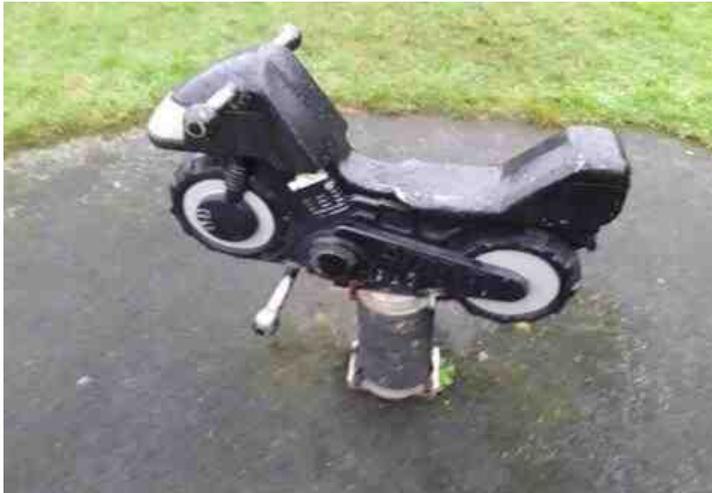
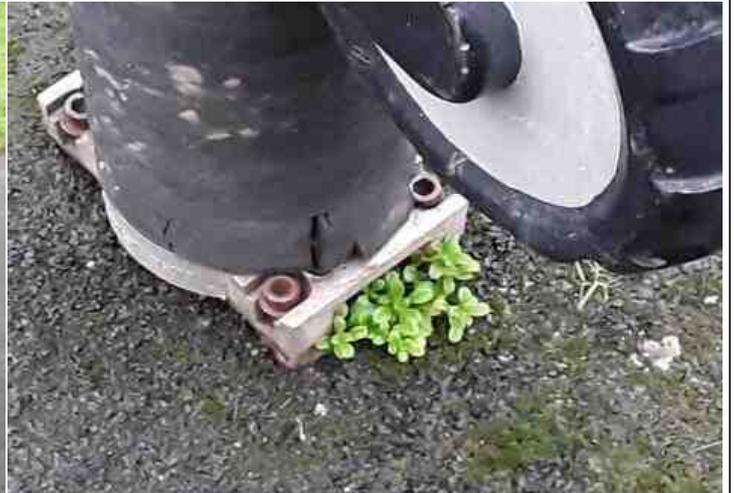
Item: Rocking Equipment - Spring Bike
Manufacturer: Wicksteed Playgrounds

Finding: The spring cover is damaged, split or missing

Action: Replace the cover

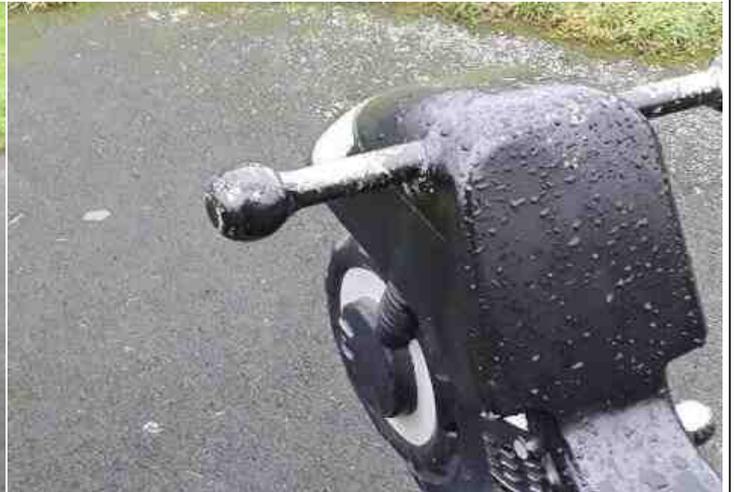
Item: Rocking Equipment - Spring Bike
Manufacturer: Wicksteed Playgrounds

Finding: The paint is flaking off the metalwork

Action: Rub down and re-paint

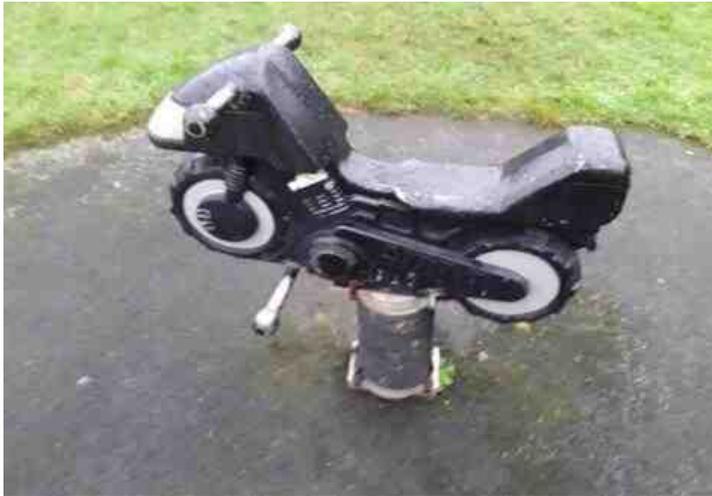
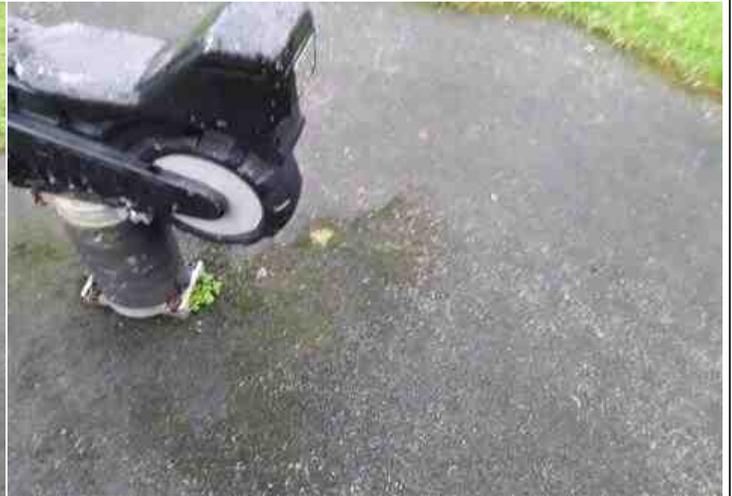
Item: Rocking Equipment - Spring Bike
Manufacturer: Wicksteed Playgrounds

Finding: There is minor damage to the surface

Action: Monitor for any further deterioration and repair as required

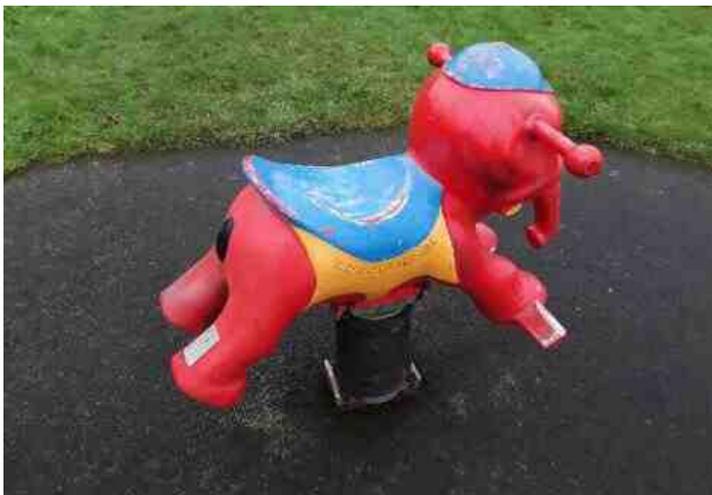
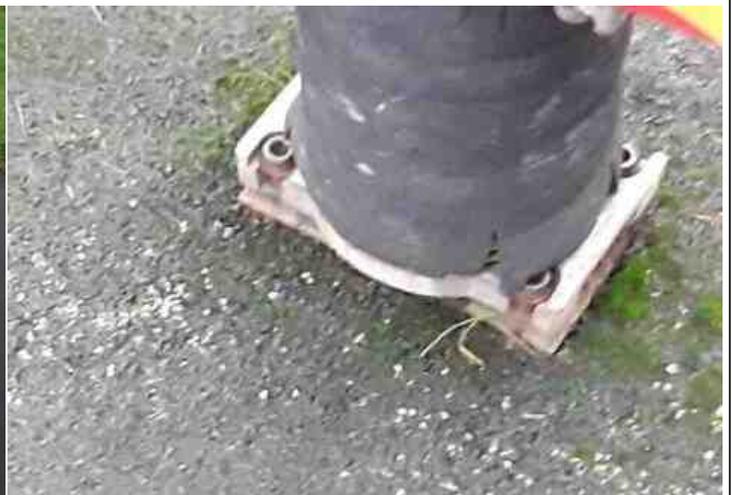
Item: Rocking Equipment - Spring Elephant
Manufacturer: Wicksteed Playgrounds

Finding: The fixings have corroded

Action: Replace all corroded fixings

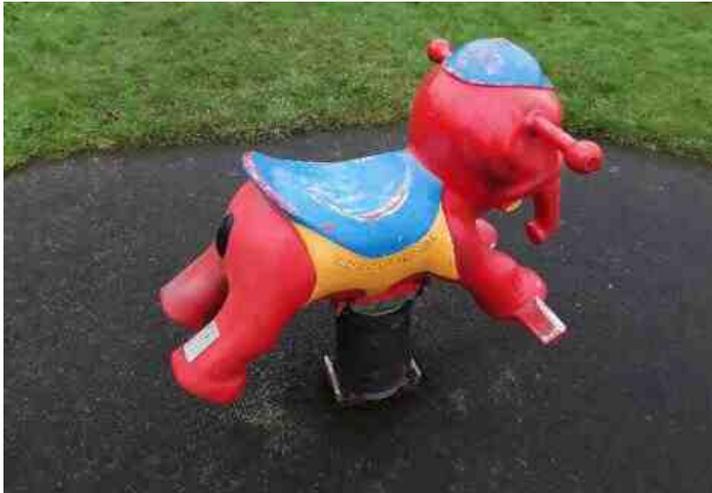
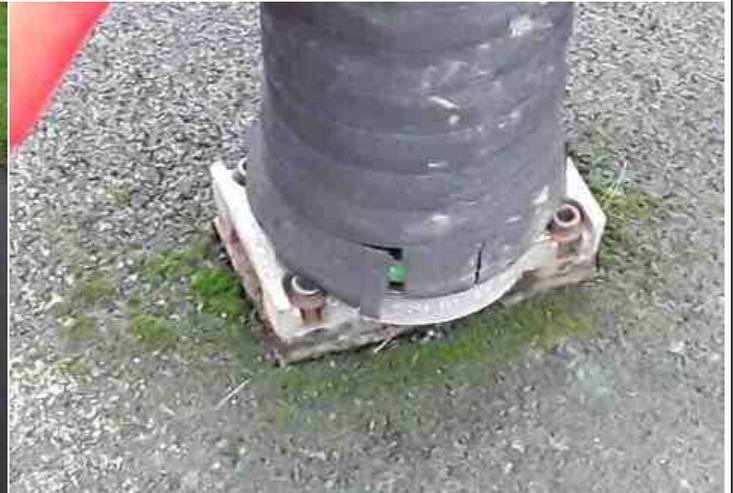
Item: Rocking Equipment - Spring Elephant
Manufacturer: Wicksteed Playgrounds

Finding: The spring cover is damaged, split or missing

Action: Replace the cover

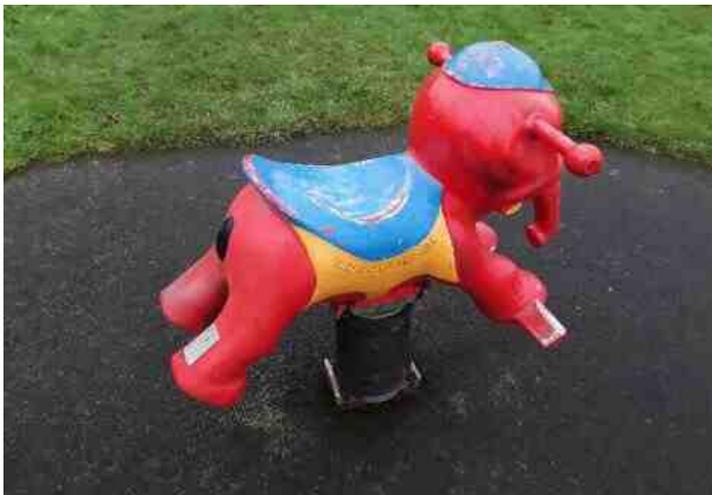
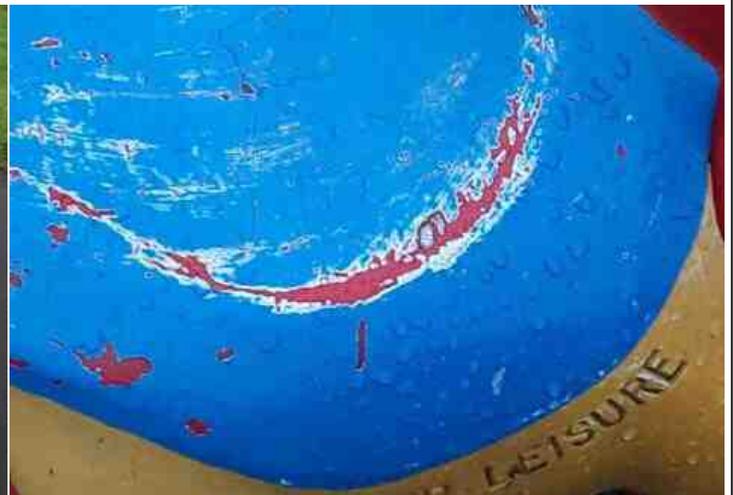
Item: Rocking Equipment - Spring Elephant
Manufacturer: Wicksteed Playgrounds

Finding: The paint is flaking off the metalwork

Action: Rub down and re-paint

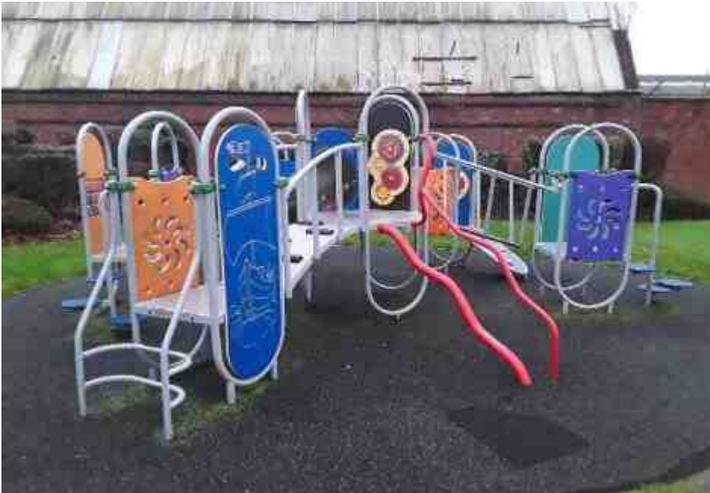
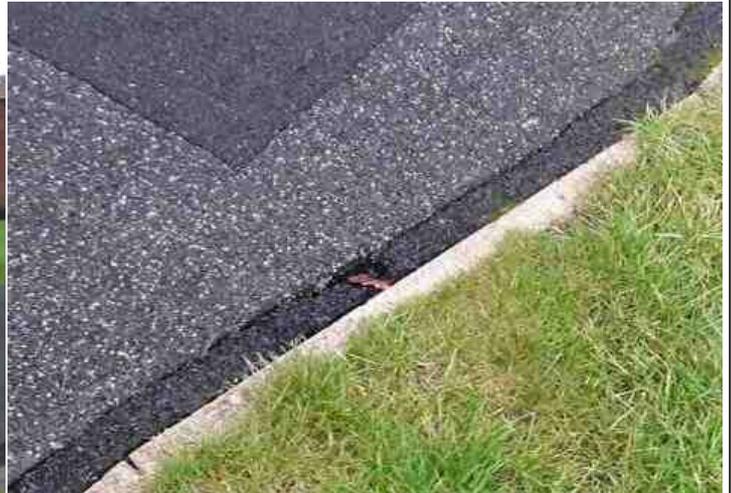
Item: Activity Equipment - Multi Play (Toddler)
Manufacturer: Wicksteed Playgrounds

Finding: There is minor damage to the surface

Action: Monitor for any further deterioration and repair as required

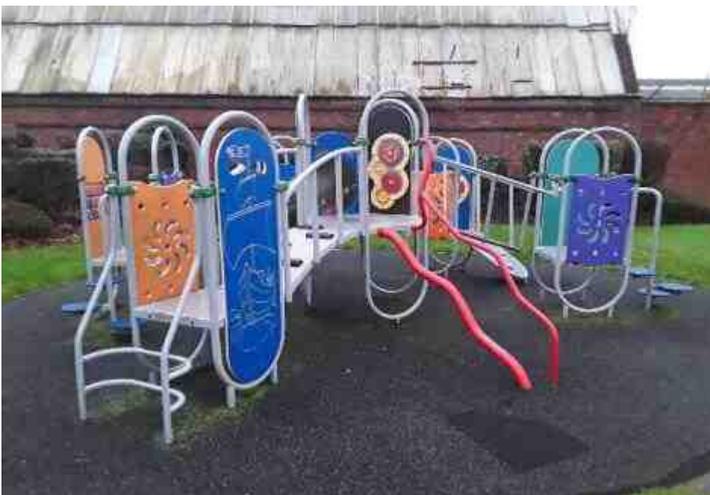
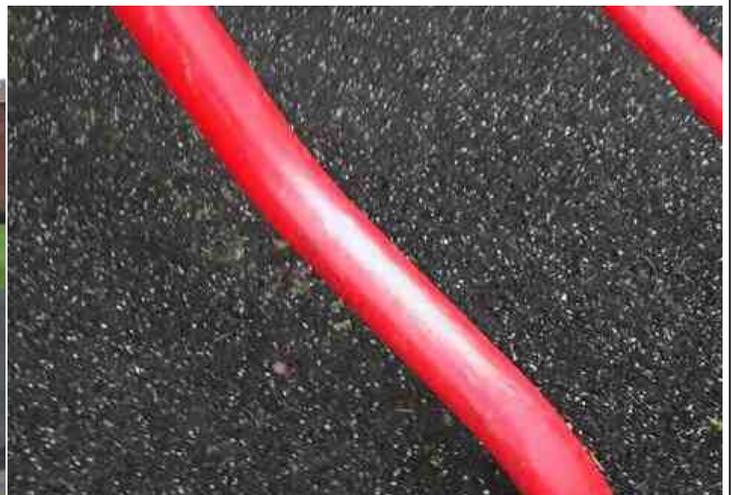
Item: Activity Equipment - Multi Play (Toddler)
Manufacturer: Wicksteed Playgrounds

Finding: There is surface corrosion / rust present on the item

Action: Consider treating the item

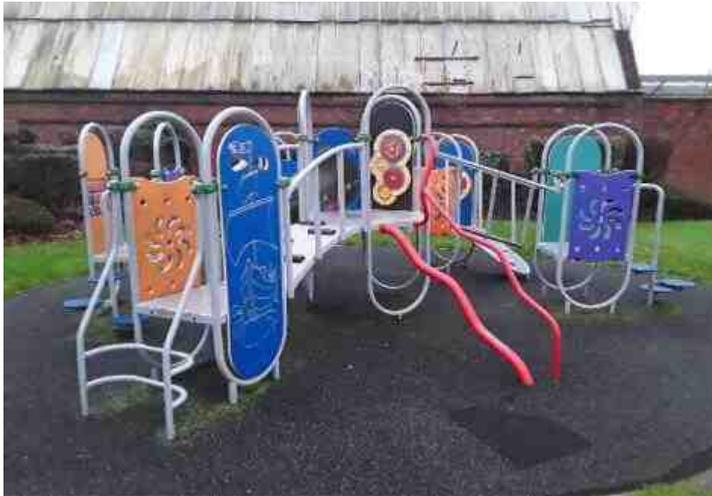
Item: Activity Equipment - Multi Play (Toddler)
Manufacturer: Wicksteed Playgrounds

Finding: There is some evidence of fire damage to the side panel

Action: Monitor for any further deterioration and repair as required

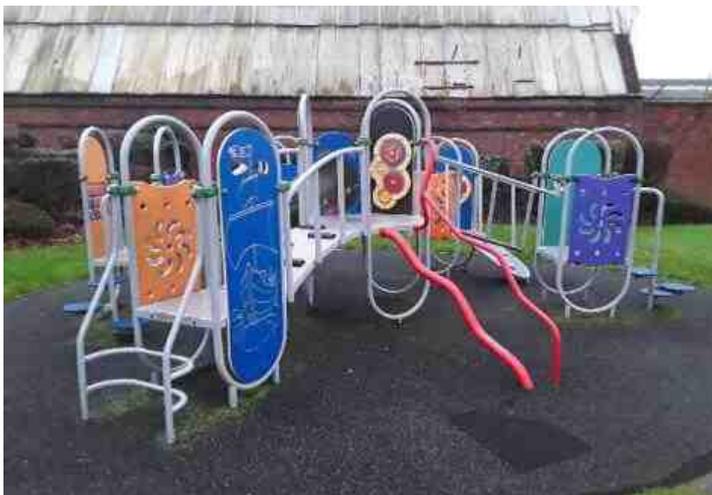
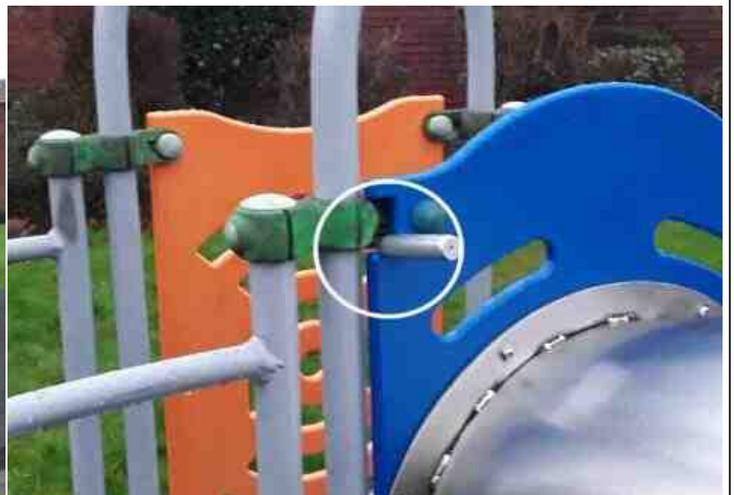
Item: Activity Equipment - Multi Play (Toddler)
Manufacturer: Wicksteed Playgrounds

Finding: There is/are finger entrapment/s in the structure and the item fails to meet the requirements of BS EN 1176 Part 1 4.2.7.6 Entrapment of fingers

Action: Monitor - No action given the risk assessment

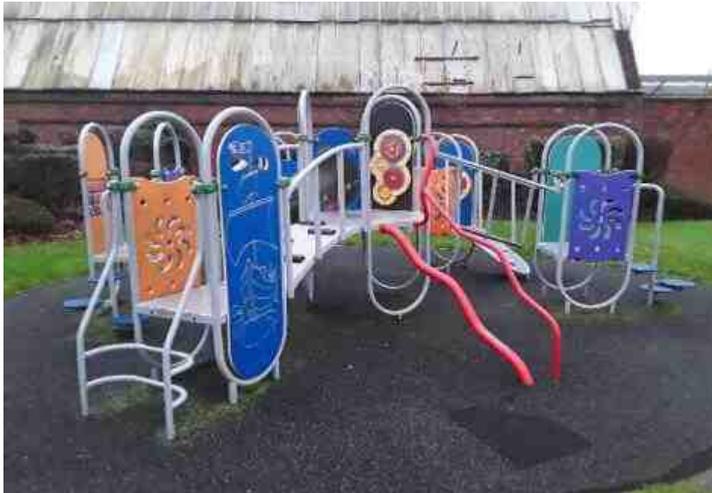
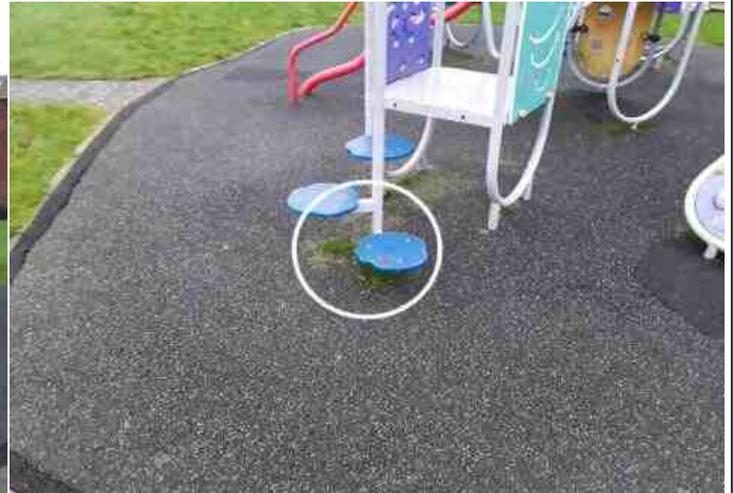
Item: Activity Equipment - Multi Play (Toddler)
Manufacturer: Wicksteed Playgrounds

Finding: The stepping post is loose in the foundations

Action: Reset the post

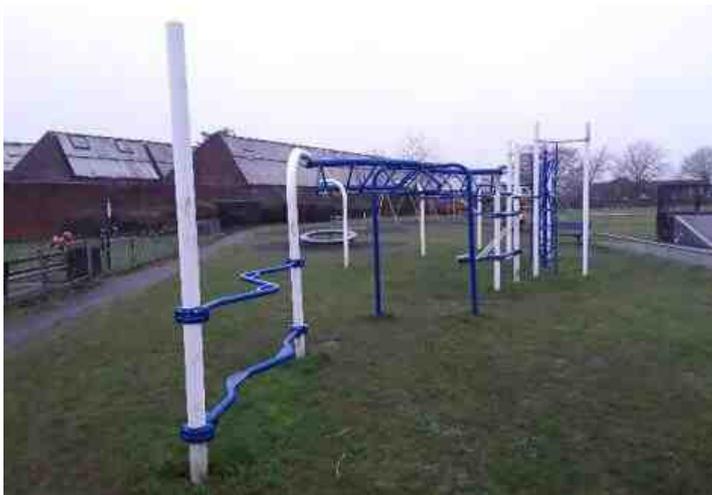
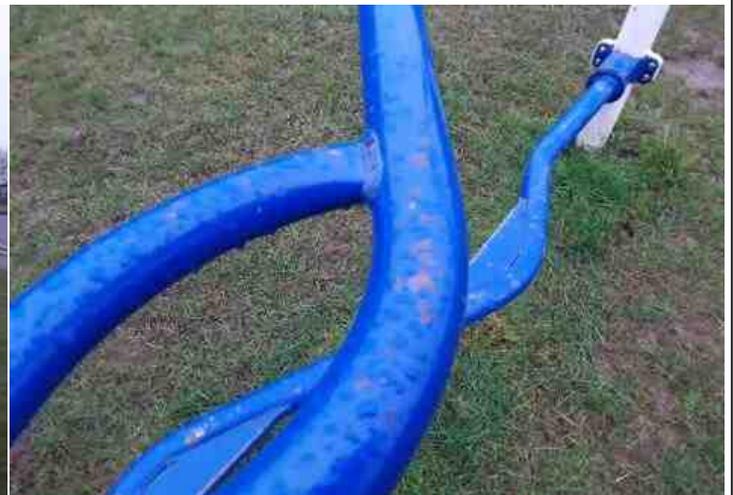
Item: Activity Equipment - Climbing Frame
Manufacturer: Parkdale Play & Leisure Ltd

Finding: There is surface corrosion / rust present on the item

Action: Consider treating the item

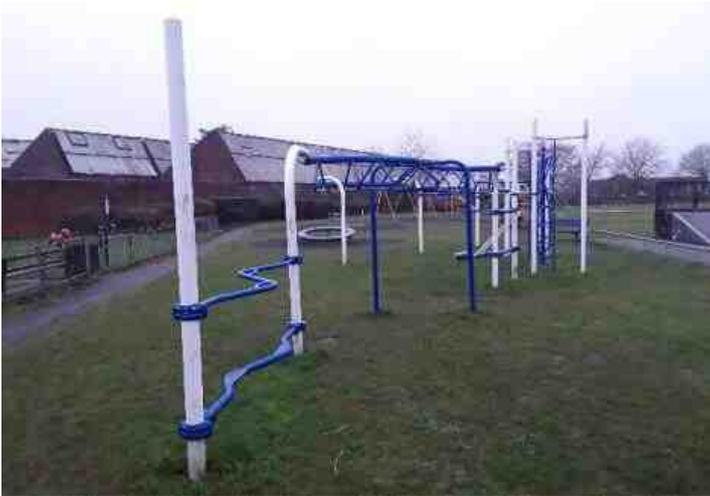
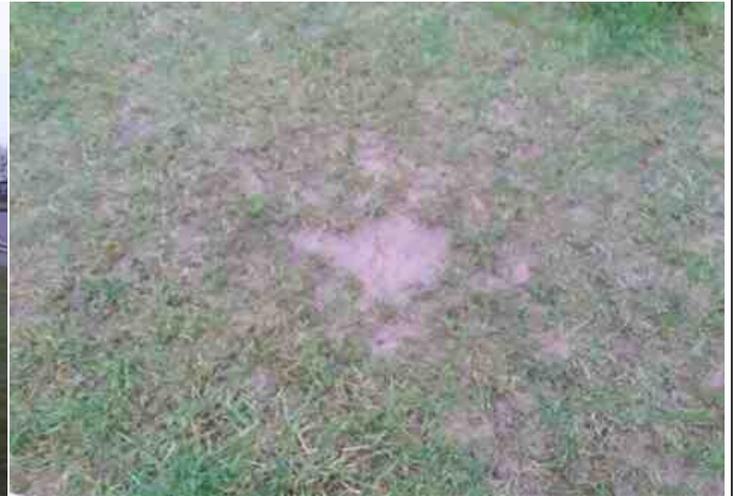
Item: Activity Equipment - Climbing Frame
Manufacturer: Parkdale Play & Leisure Ltd

Finding: The grass has eroded within the impact area of the equipment and may not provide the necessary impact attenuating properties for the equipment fall height; the surface may also be slippery in wet weather
Action: Reinststate the grass or provide an all weather surface

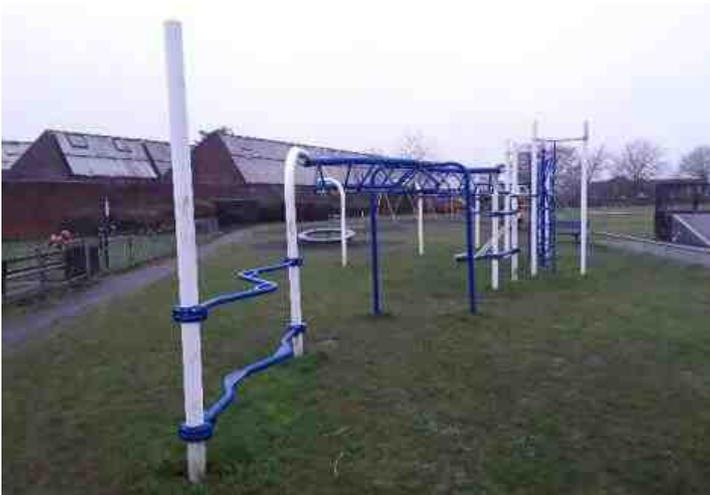
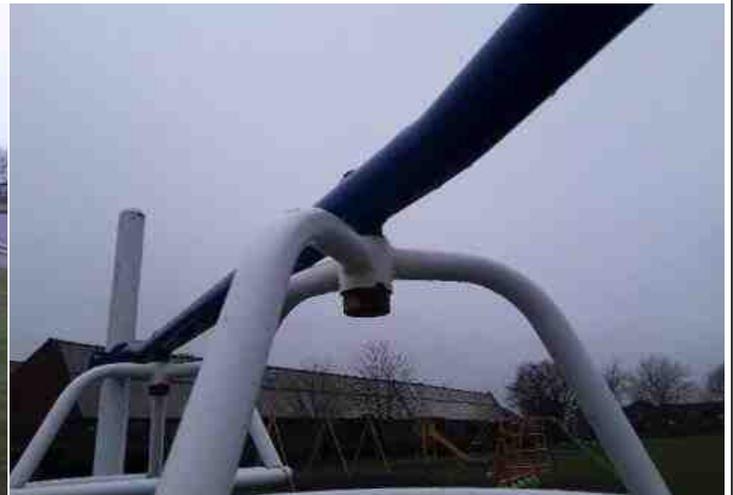
Item: Activity Equipment - Climbing Frame
Manufacturer: Parkdale Play & Leisure Ltd

Finding: The bearing is worn / damaged and the item is not operating correctly
Action: Repair / replace the bearing

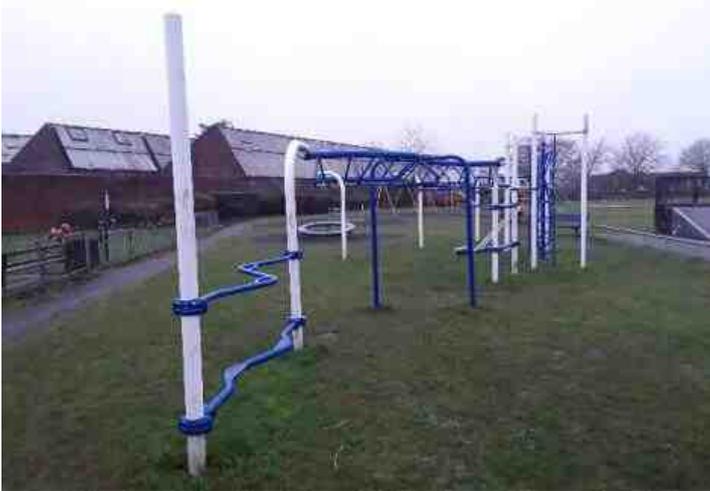
Item: Activity Equipment - Climbing Frame
Manufacturer: Parkdale Play & Leisure Ltd

Finding: The dampening mechanisms are worn

Action: Replace the dampening mechanisms

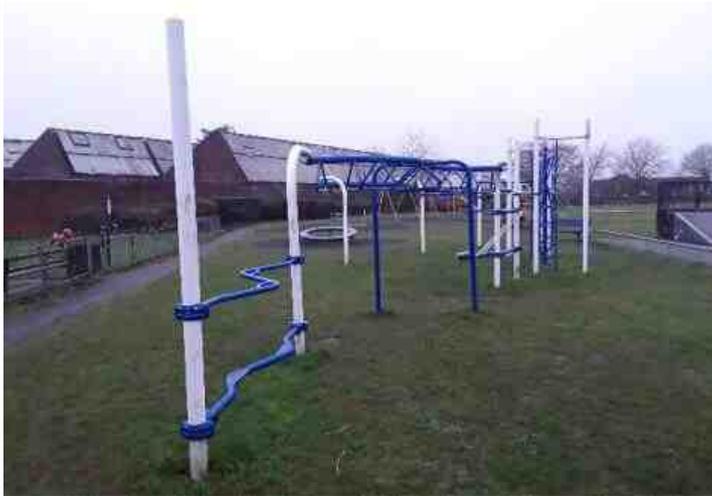
Item: Activity Equipment - Climbing Frame
Manufacturer: Parkdale Play & Leisure Ltd

Finding: The surface has subsided in some areas

Action: Monitor for any further deterioration and repair as required

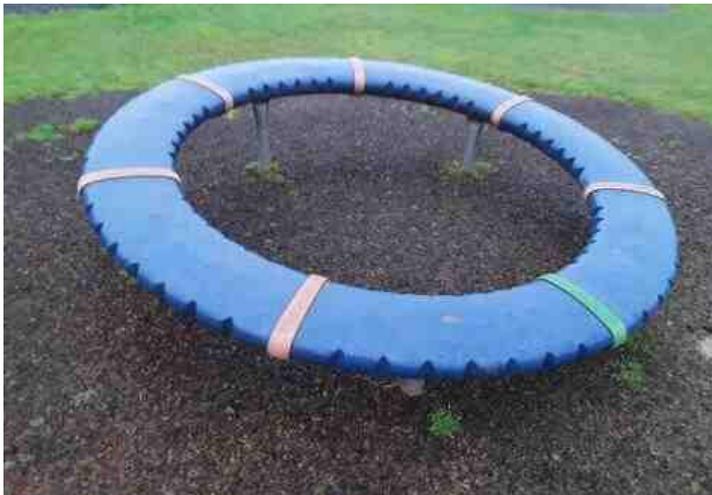
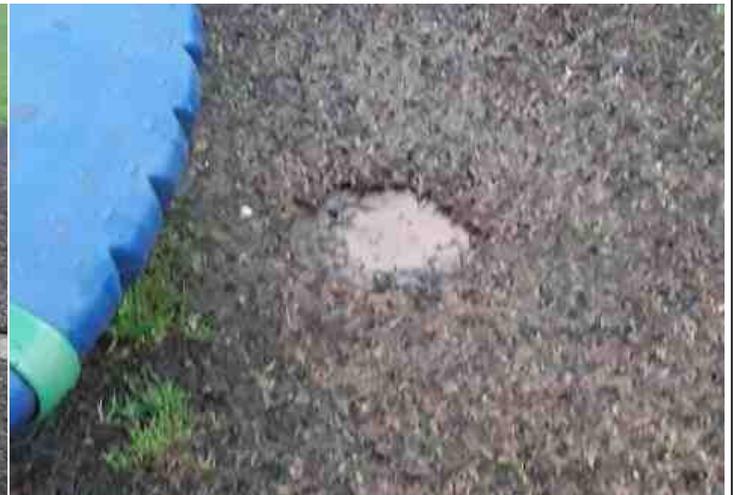
Item: Rotor Play - Supernova
Manufacturer: Kompan Ltd

Finding: The surfacing is severely damaged exposing the sub base

Action: Repair damaged areas of surfacing

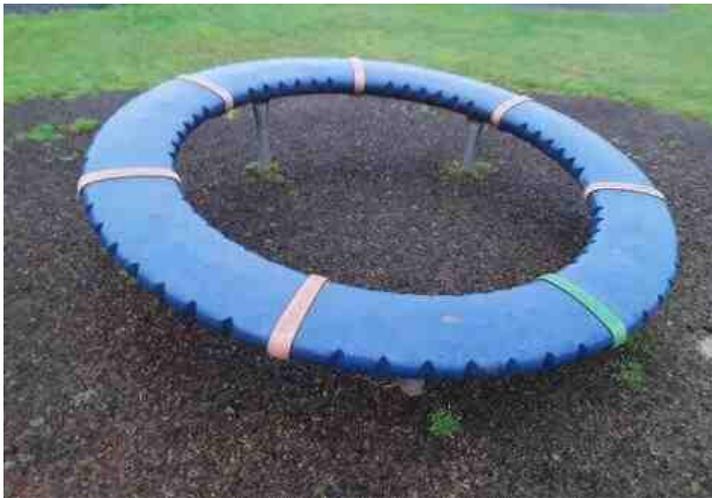
Item: Rotor Play - Supernova
Manufacturer: Kompan Ltd
Risk Level: L - Low Risk
Surface: Bonded Rubber Mulch

Finding: The surface has subsided in some areas
Action: Monitor for any further deterioration and repair as required

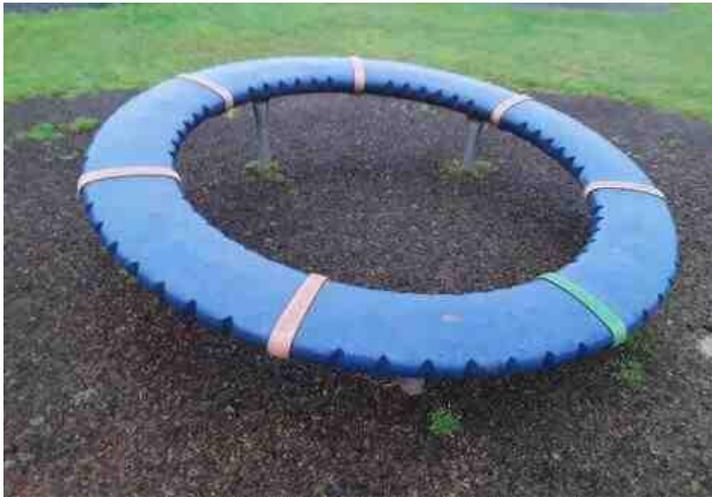
Item: Rotor Play - Supernova
Manufacturer: Kompan Ltd
Risk Level: L - Low Risk
Surface: Bonded Rubber Mulch

Finding: There is minor damage to the casing
Action: Remove the sharp protrusions

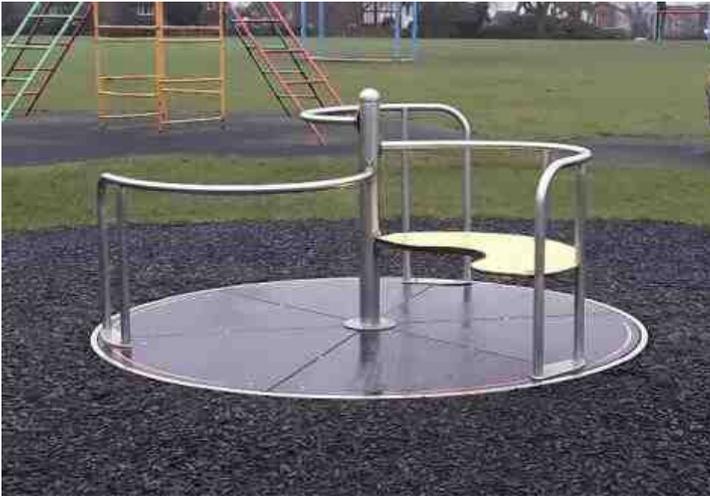
Item: Rotor Play - Inclusive Roundabout
Manufacturer: Playdale Playgrounds Ltd

Finding: A number of fixing(s) have worked loose

Action: Secure all loose fixings

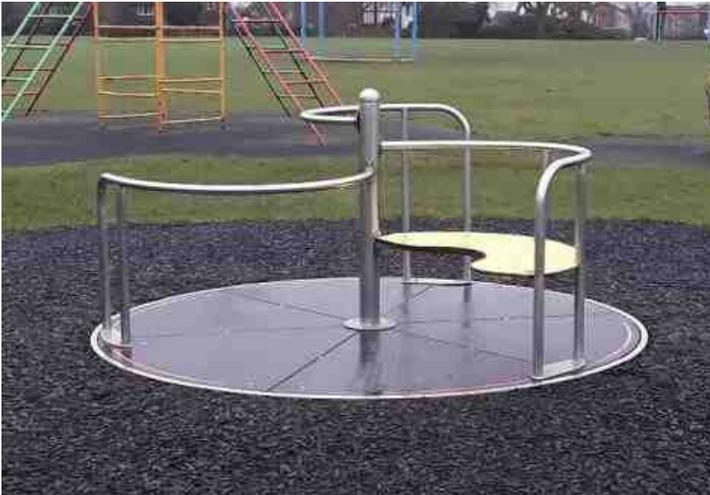
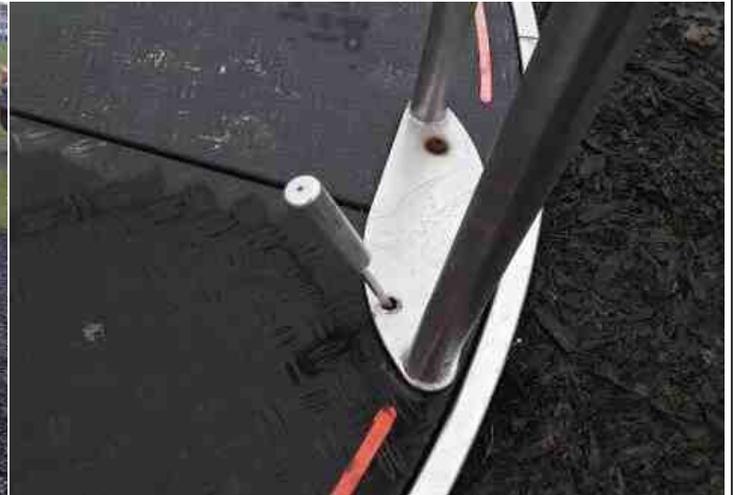
Item: Rotor Play - Inclusive Roundabout
Manufacturer: Playdale Playgrounds Ltd

Finding: There is/are fixings missing creating finger entrapment/s in the redundant bolt holes and the item fails to meet the requirements of BS EN 1176 Part 1 4.2.7.6 Entrapment of fingers

Action: Replace the missing fixings

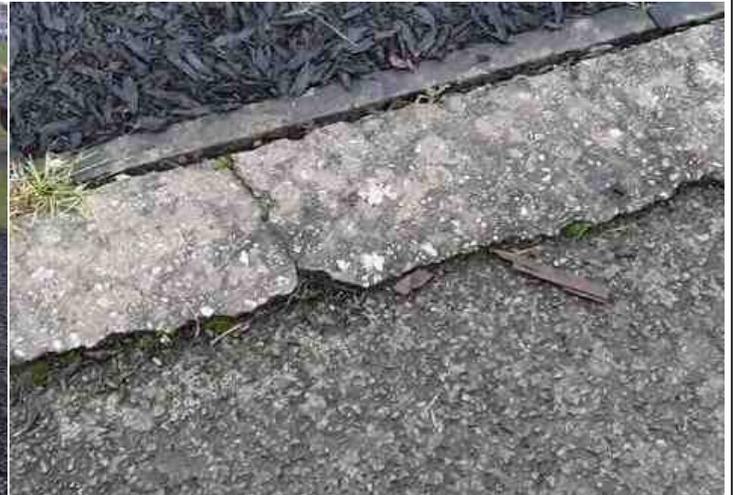
Item: Rotor Play - Inclusive Roundabout
Manufacturer: Playdale Playgrounds Ltd

Finding: The concrete surround is lifting creating trip hazards

Action: Remove the trip hazards

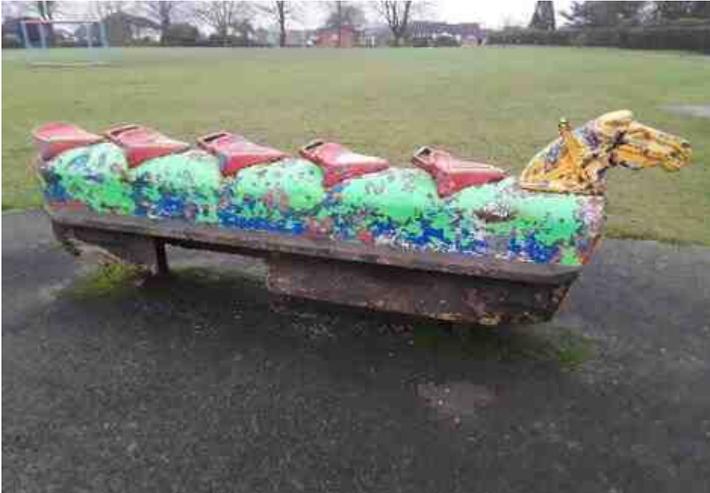
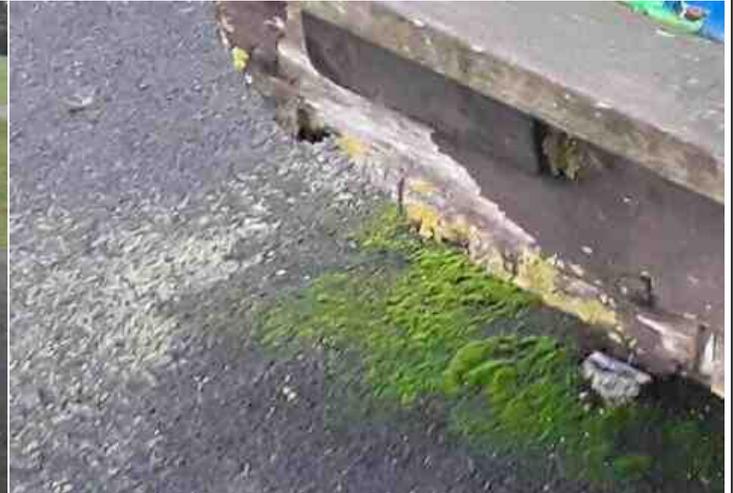
Item: Rocking Equipment - Rocking Horse
Manufacturer: Wicksteed Playgrounds

Finding: The timber guarding has rotted

Action: Replace the guarding

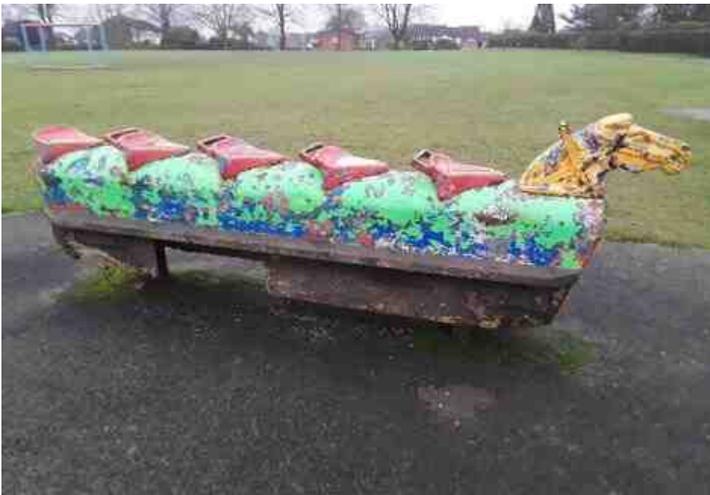
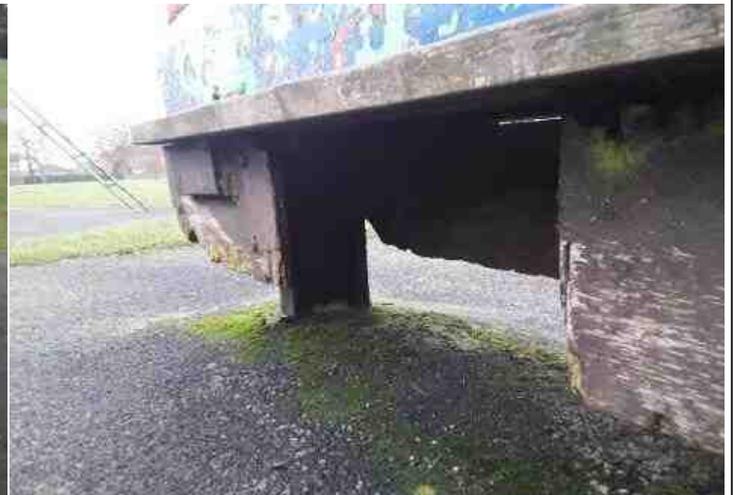
Item: Rocking Equipment - Rocking Horse
Manufacturer: Wicksteed Playgrounds

Finding: There is no gaiter protection for accessible moving parts (possible shear trap) as recommended in BS EN 1176 Part 1; 4.2.6 Moving Parts

Action: Monitor - No action given the risk assessment

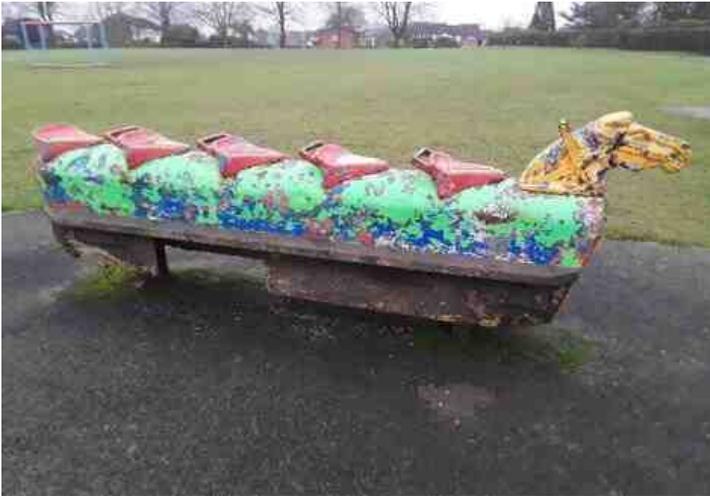
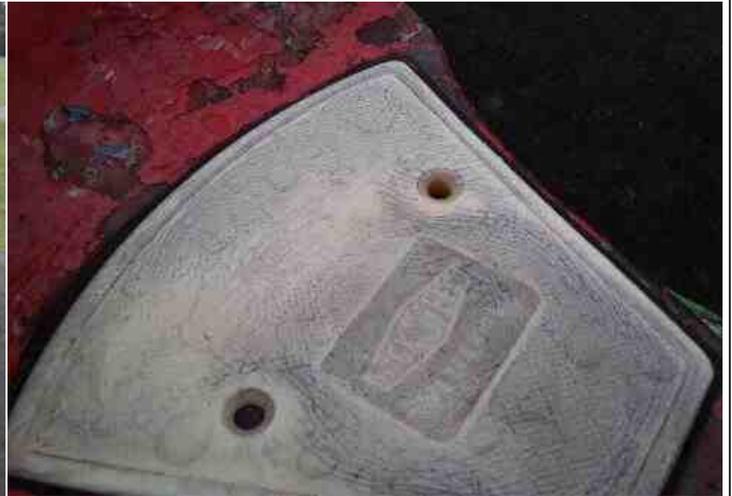
Item: Rocking Equipment - Rocking Horse
Manufacturer: Wicksteed Playgrounds

Finding: There is or are fixings missing on the item

Action: Replace all missing fixings

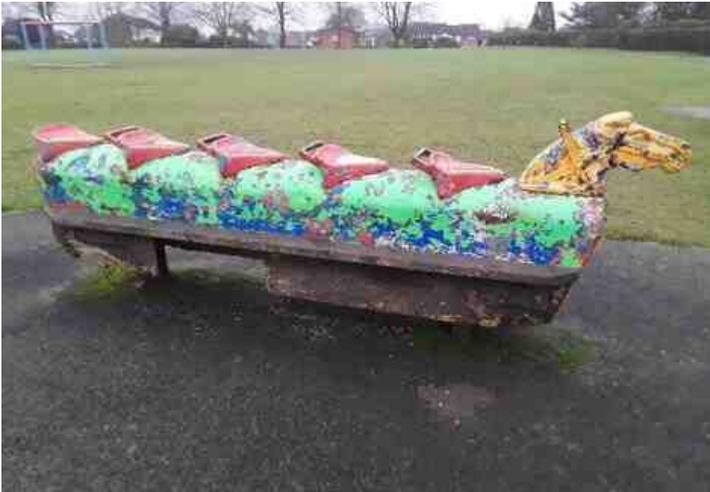
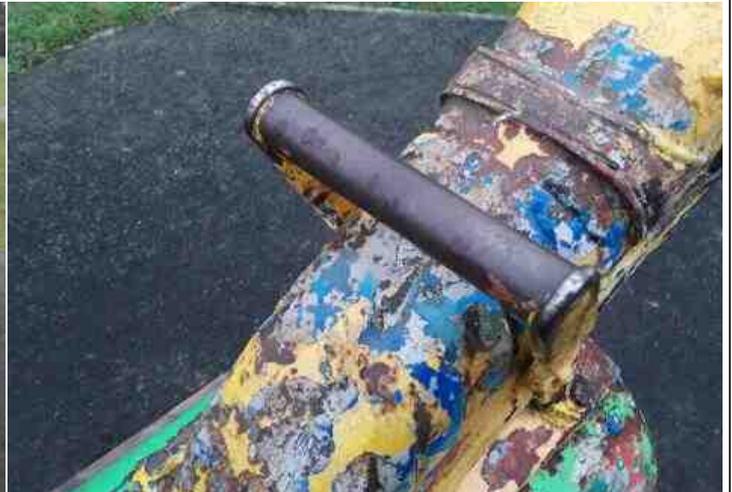
Item: Rocking Equipment - Rocking Horse
Manufacturer: Wicksteed Playgrounds

Finding: The paintwork on this item has been damaged or worn exposing the metal underneath which is rusting / corroding

Action: Treat affected areas and repaint

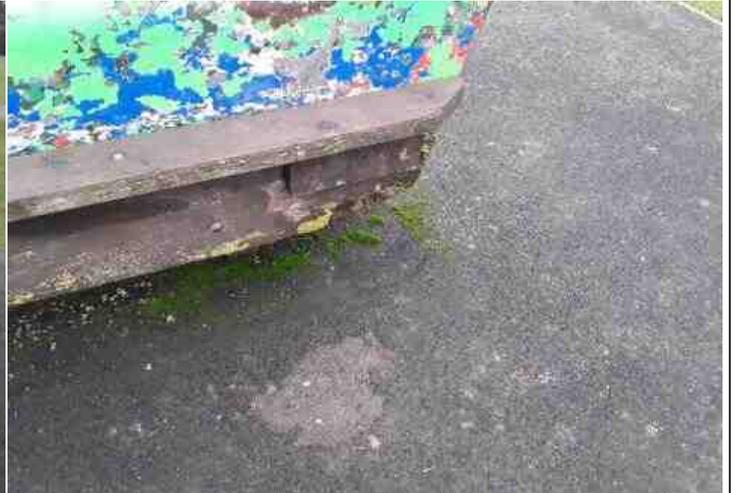
Item: Rocking Equipment - Rocking Horse
Manufacturer: Wicksteed Playgrounds

Finding: The surfacing is severely damaged exposing the sub base

Action: Repair damaged areas of surfacing

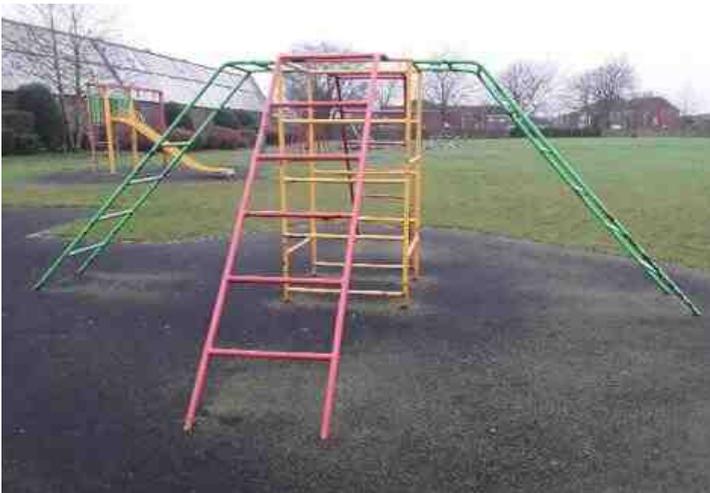
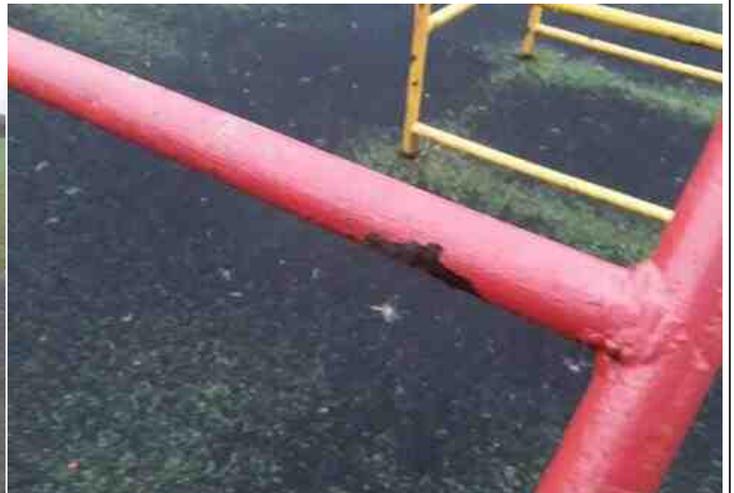
Item: Activity Equipment - Climbing Frame
Manufacturer: Wicksteed Playgrounds

Finding: The paintwork on this item has been damaged or worn exposing the metal underneath which is rusting / corroding

Action: Treat affected areas and repaint

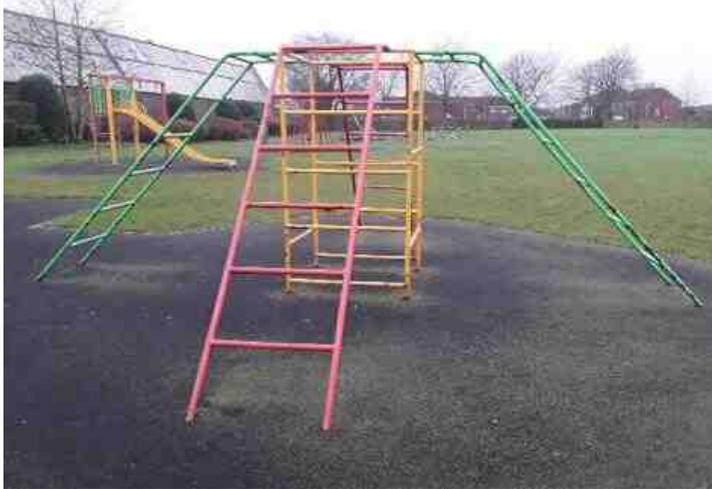
Item: Activity Equipment - Climbing Frame
Manufacturer: Wicksteed Playgrounds

Finding: There is minor distortion damage to the item

Action: Monitor and repair if required

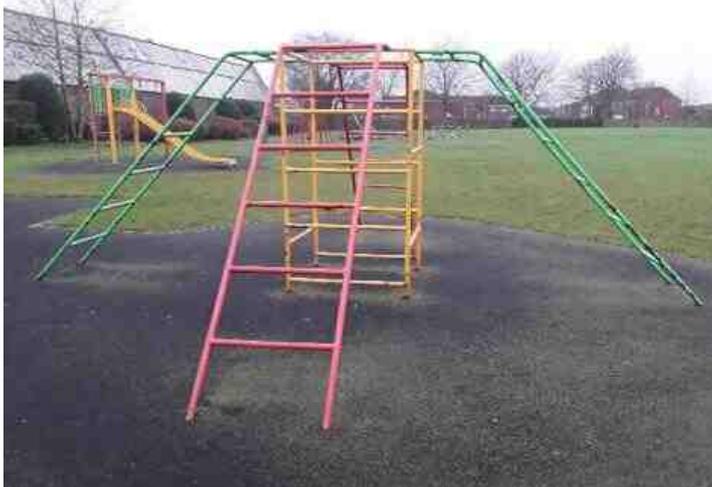
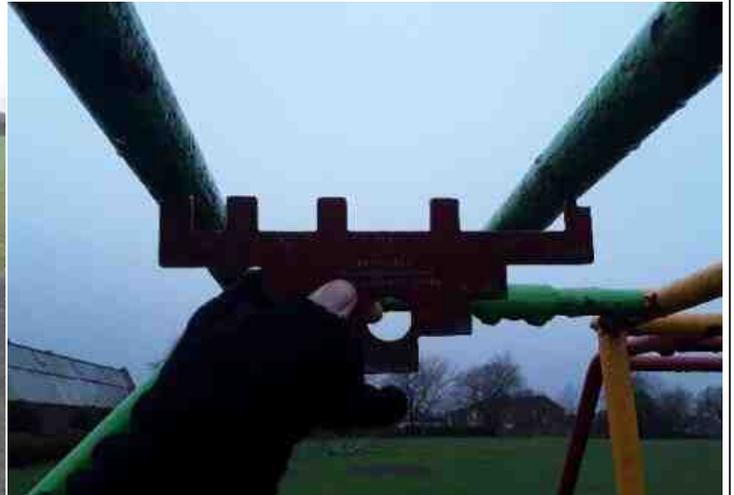
Item: Activity Equipment - Climbing Frame
Manufacturer: Wicksteed Playgrounds

Finding: The item fails to meet the requirements of BS EN 1176 Part 1 4.2.7.2 for head and neck entrapment in the framework

Action: Monitor - No action given the risk assessment

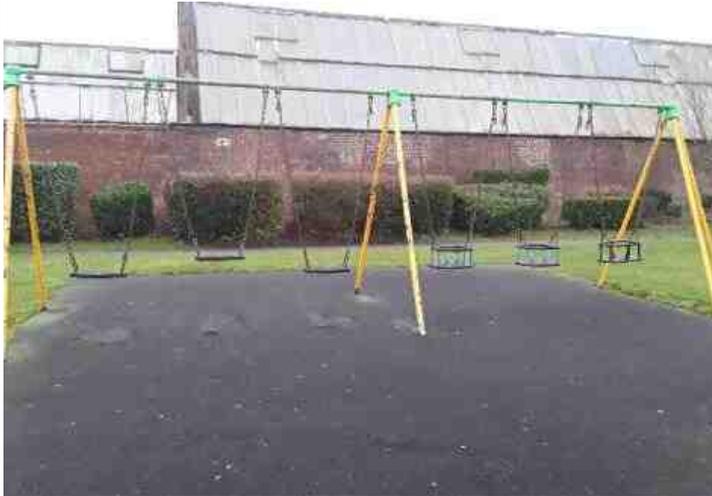
Item: Swings - 2 Bay Swing
Manufacturer: Wicksteed Playgrounds

Finding: The surfacing is damaged

Action: Repair damaged areas of surfacing

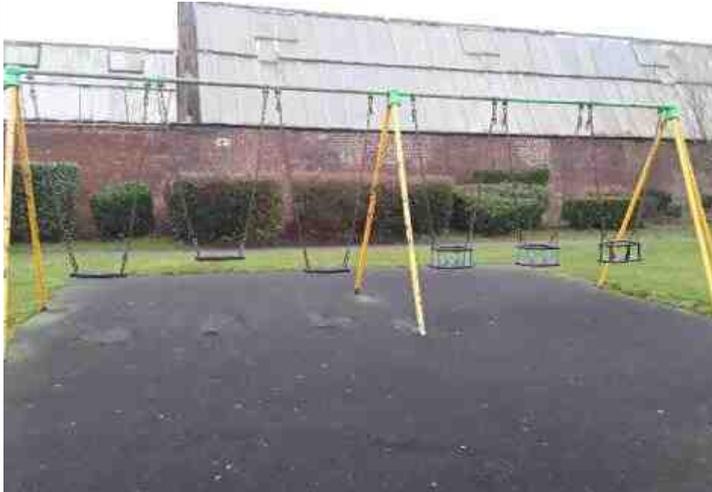
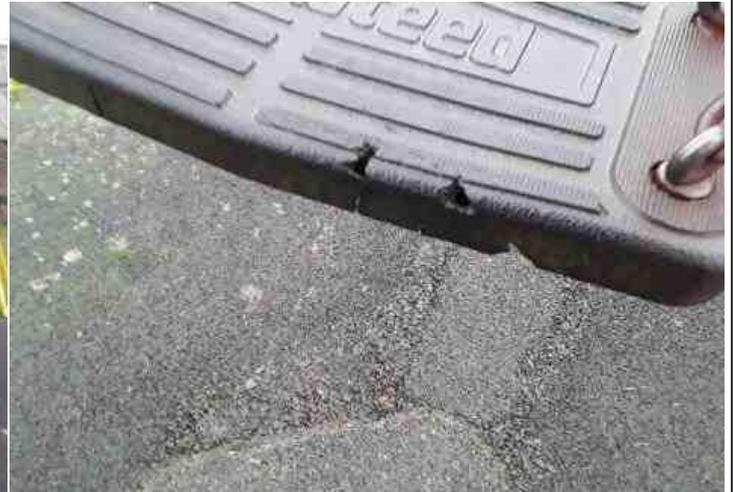
Item: Swings - 2 Bay Swing
Manufacturer: Wicksteed Playgrounds

Finding: The seat has minor damage or wear

Action: Monitor for any further deterioration and replace as required

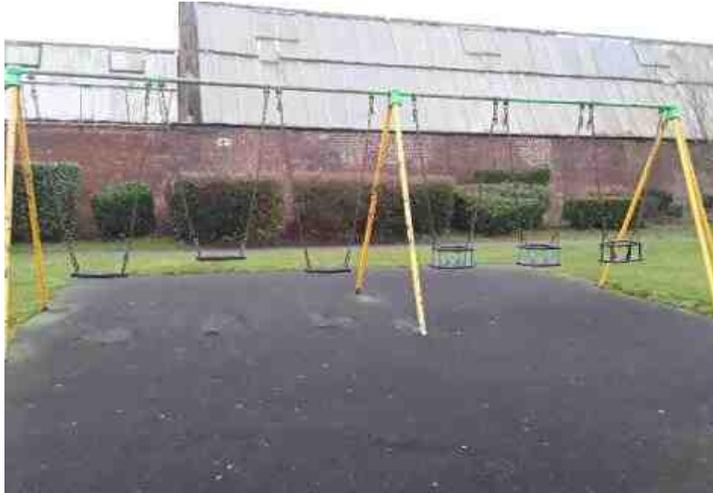
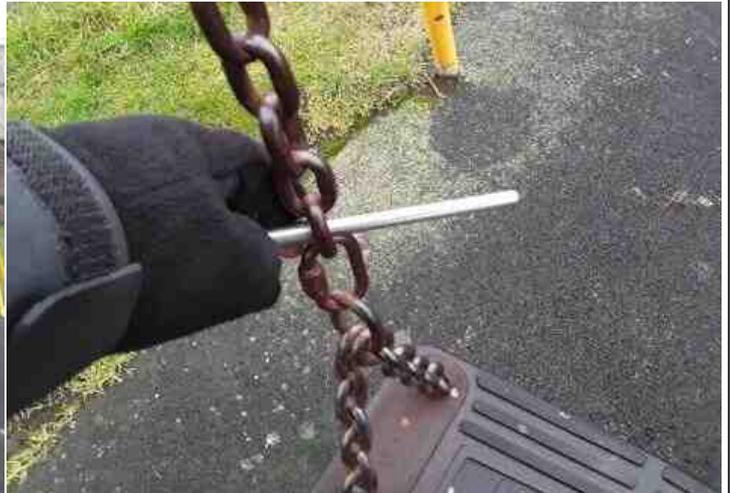
Item: Swings - 2 Bay Swing
Manufacturer: Wicksteed Playgrounds

Finding: The chain openings are in excess of the 8.6mm as recommended by BS EN 1176
Action: Monitor - No action given the risk assessment

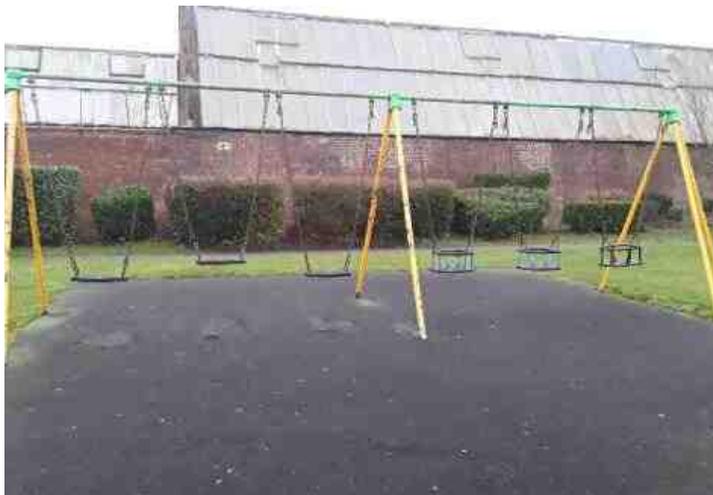
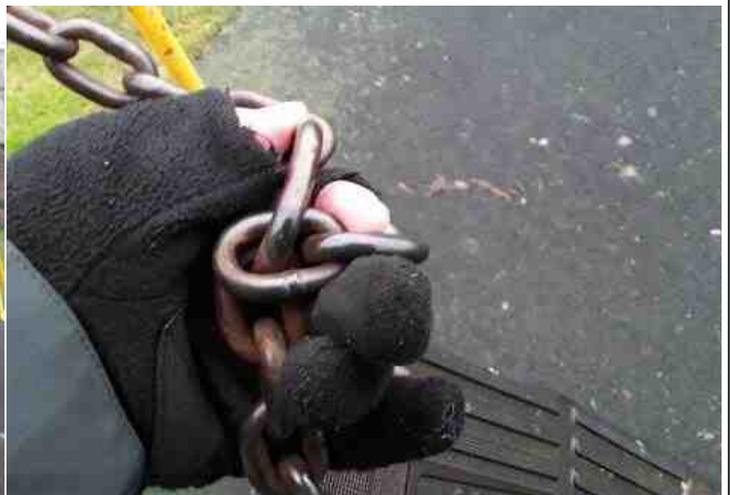
8 - Low Risk (Finding 4)

Item: Swings - 2 Bay Swing
Manufacturer: Wicksteed Playgrounds

Finding: The chain links are worn and require renewing
Action: Replace worn chains

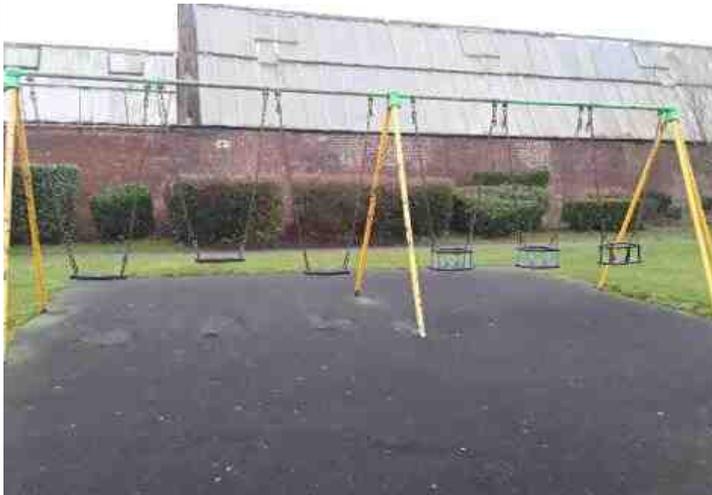
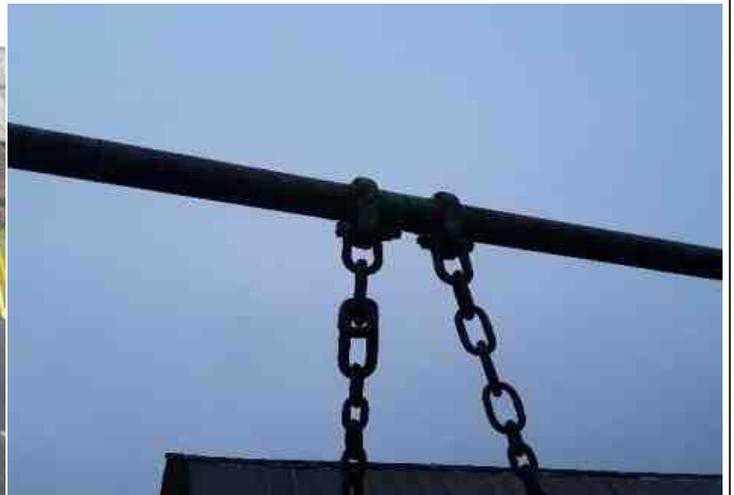
8 - Low Risk (Finding 5)

Item: Swings - 2 Bay Swing
Manufacturer: Wicksteed Playgrounds

Finding: The bush / bushes is / are worn or missing

Action: Replace worn or missing bushes
