NOTICE OF PROPERTY MANAGEMENT AND GENERAL PURPOSES COMMITTEE MEETING

Thursday 5th March 2026 7pm

AGENDA

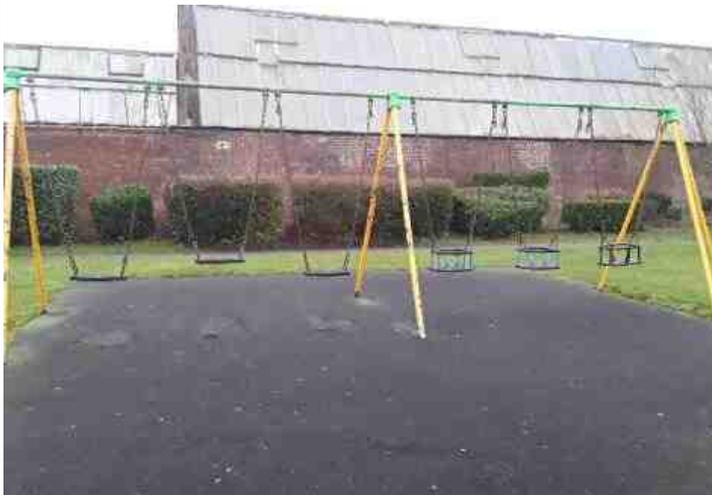
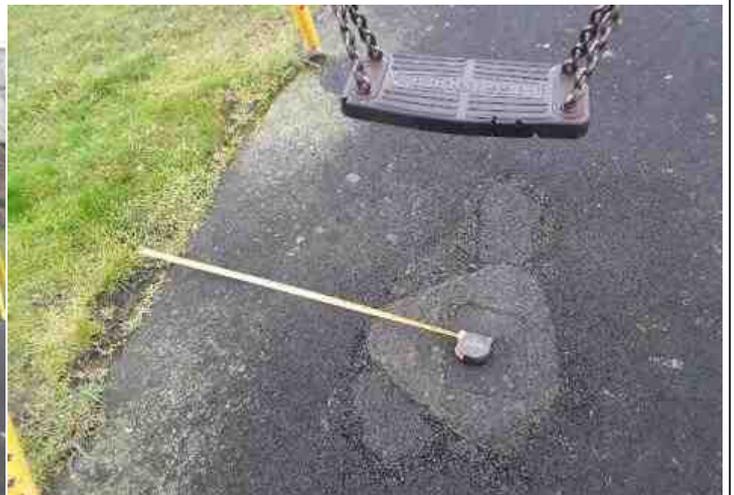
Item: Swings - 2 Bay Swing
Manufacturer: Wicksteed Playgrounds

Finding: The surfacing width under the seat/s is / are less than 875mm when measured from the centre of the seat outwards, and fail the requirements of BS EN 1176 Part 2

Action: Monitor - No action given the risk assessment

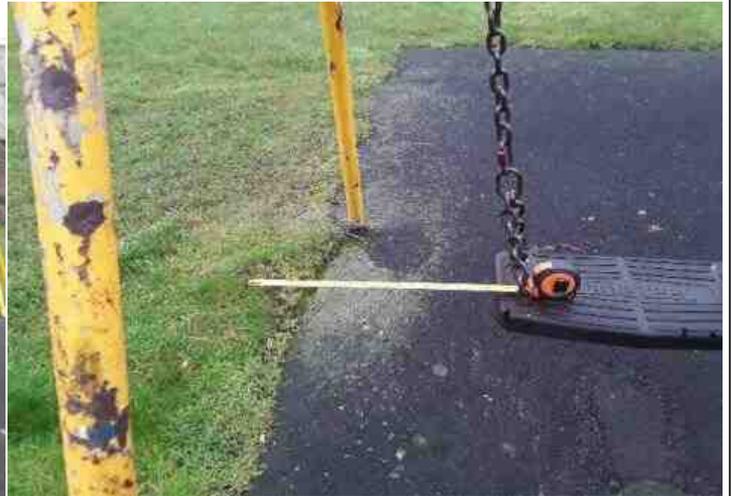
Item: Swings - 2 Bay Swing
Manufacturer: Wicksteed Playgrounds

Finding: The seat/s is / are too close to the frame as defined in BS EN 1176 Part 2

Action: Monitor - No action given the risk assessment

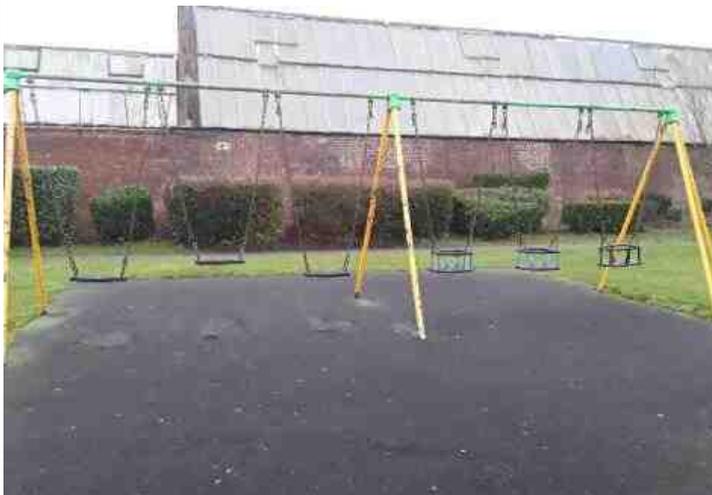
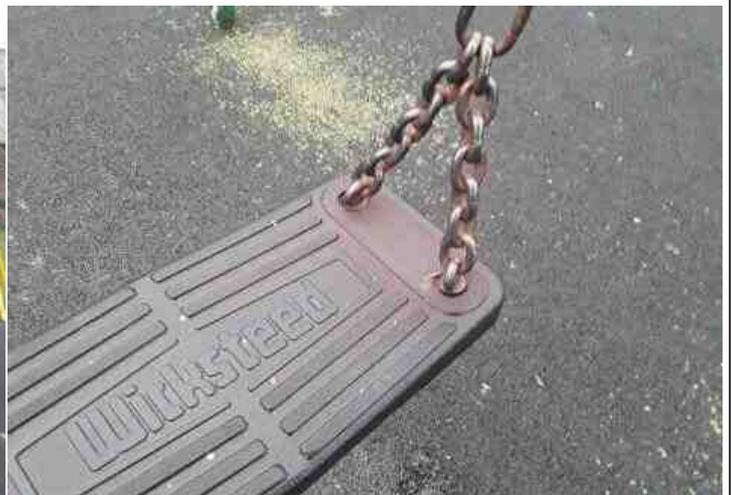
Item: Swings - 2 Bay Swing
Manufacturer: Wicksteed Playgrounds

Finding: The swing seat connectors are loose

Action: Tighten to secure

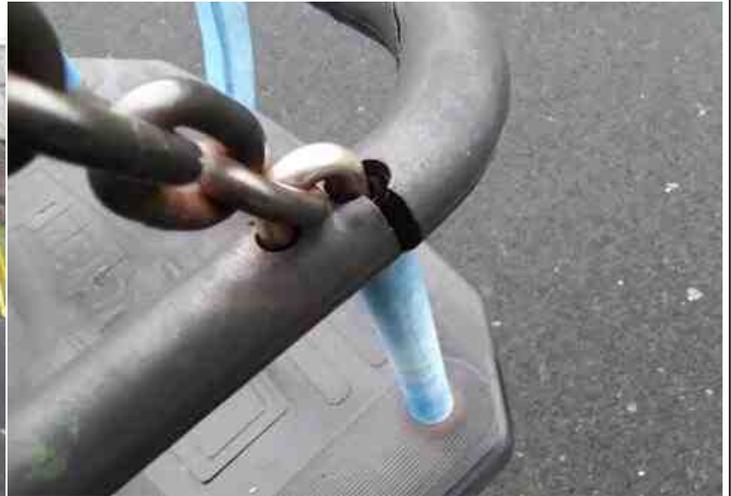
Item: Swings - 2 Bay Swing
Manufacturer: Wicksteed Playgrounds

Finding: The swing seat frames are corroding

Action: Monitor for any further deterioration and replace as required

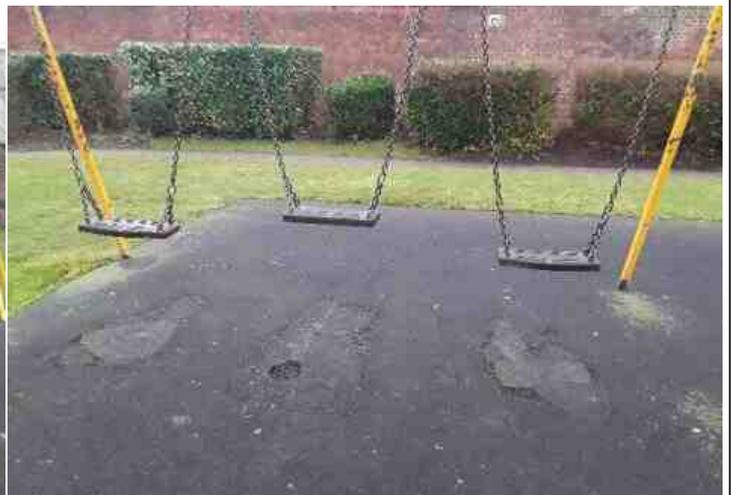
Item: Swings - 2 Bay Swing
Manufacturer: Wicksteed Playgrounds

Finding: There are more than two swings per bay in contravention of BS EN 1176 Part 2

Action: Remove the middle seats

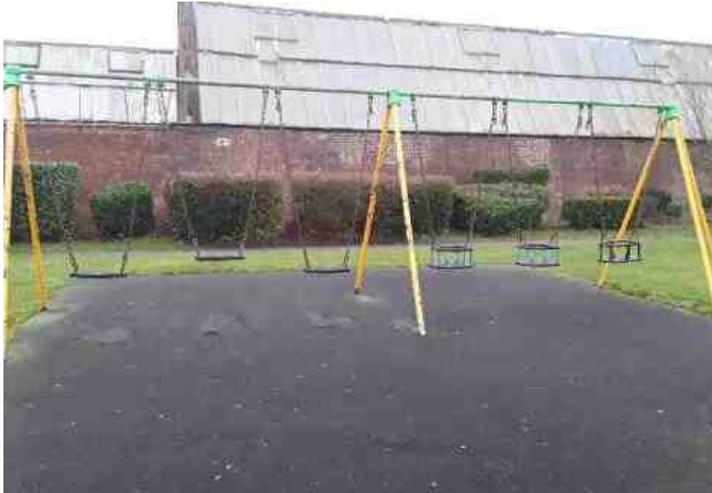
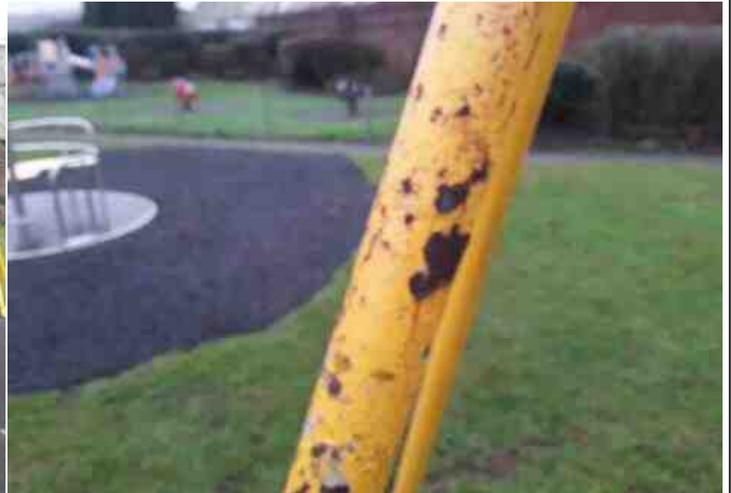
Item: Swings - 2 Bay Swing
Manufacturer: Wicksteed Playgrounds

Finding: The paintwork on this item has been damaged or worn exposing the metal underneath which is rusting / corroding

Action: Treat affected areas and repaint

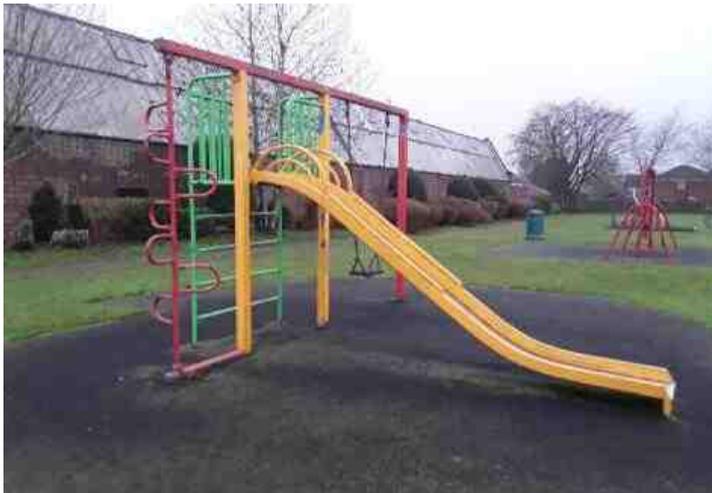
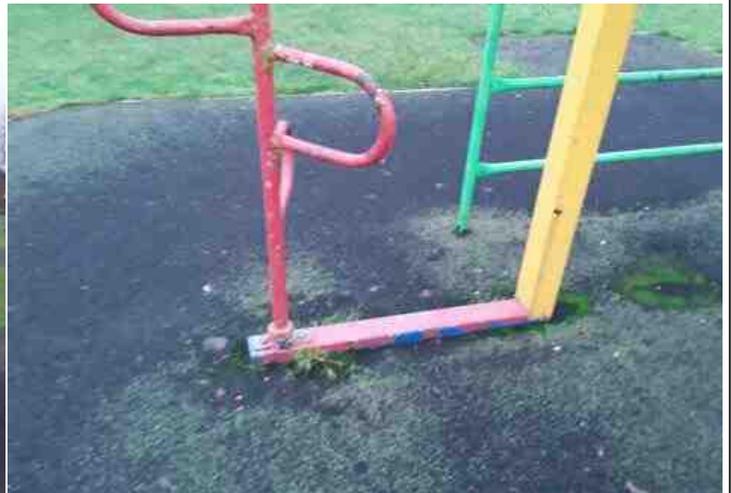
Item: Activity Equipment - Multi Play (Junior)
Manufacturer: Wicksteed Playgrounds

Finding: There are falls in excess of 600mm between adjacent components on the structure, in contravention of the recommendations set out in BS EN 1176 Part 1; 4.2.8.4

Action: Monitor - No action given the risk assessment

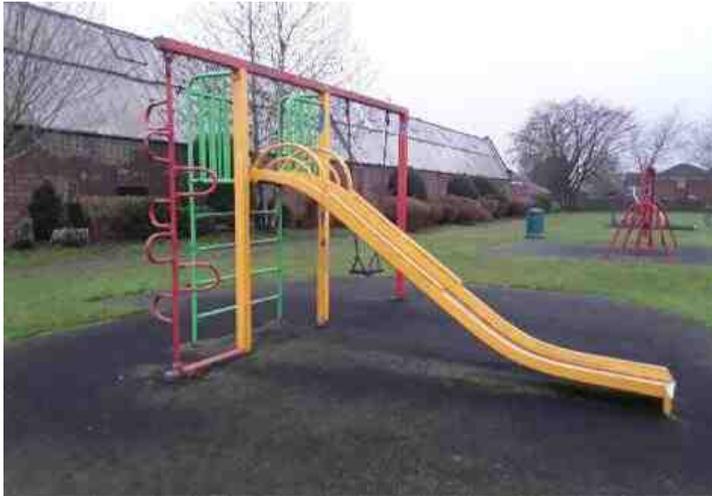
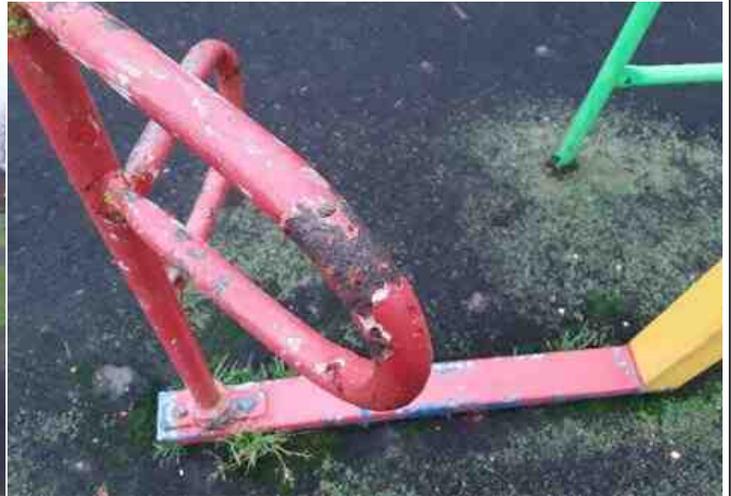
Item: Activity Equipment - Multi Play (Junior)
Manufacturer: Wicksteed Playgrounds

Finding: The paintwork on this item has been damaged or worn exposing the metal underneath which is rusting / corroding

Action: Treat affected areas and repaint

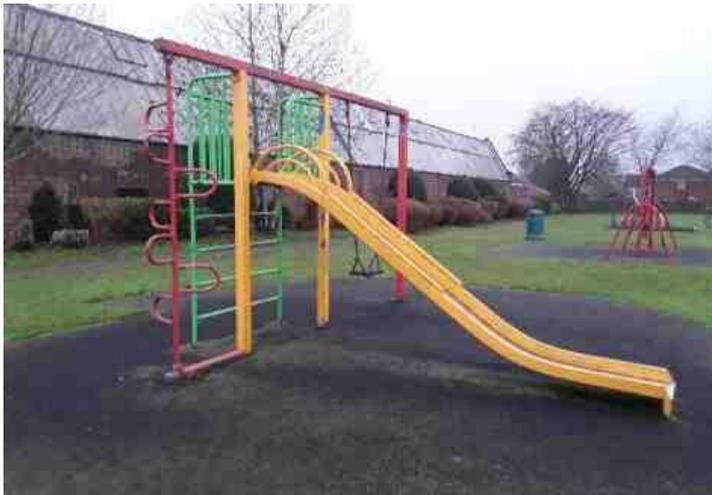
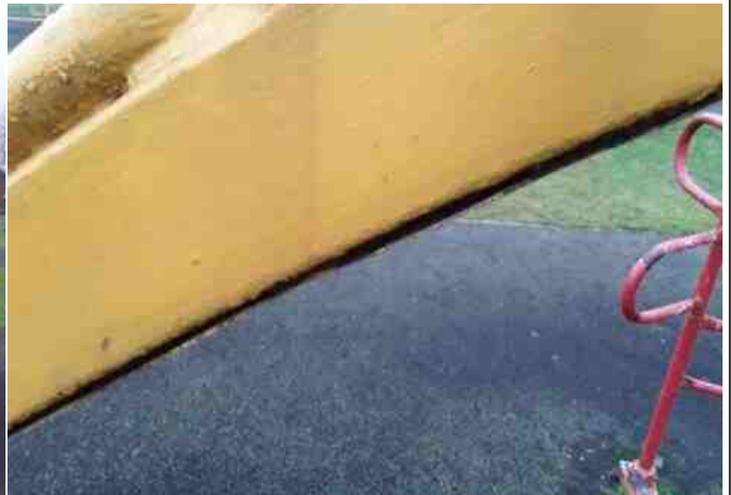
Item: Activity Equipment - Multi Play (Junior)
Manufacturer: Wicksteed Playgrounds

Finding: The weld(s) on this item have failed

Action: Repair item

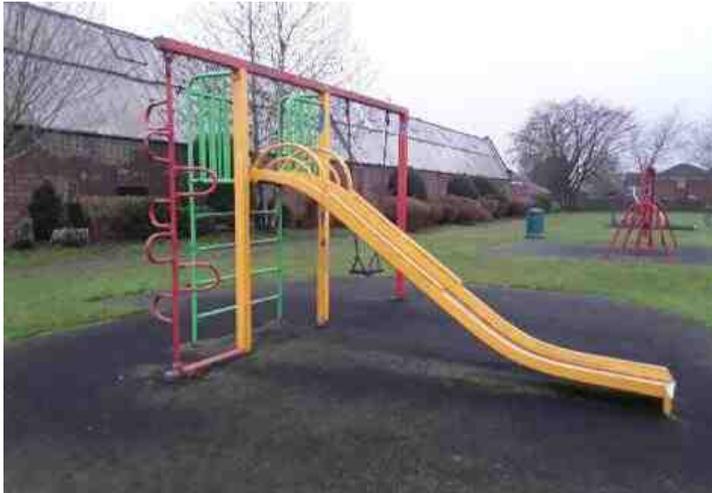
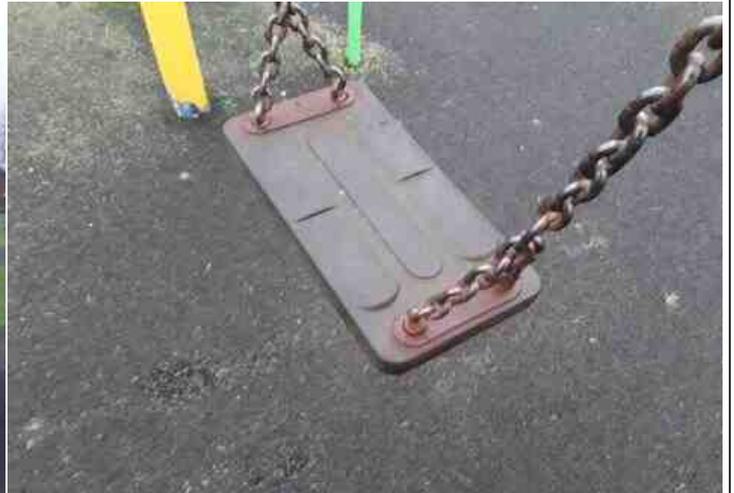
Item: Activity Equipment - Multi Play (Junior)
Manufacturer: Wicksteed Playgrounds

Finding: The swing seat connectors are loose

Action: Tighten to secure

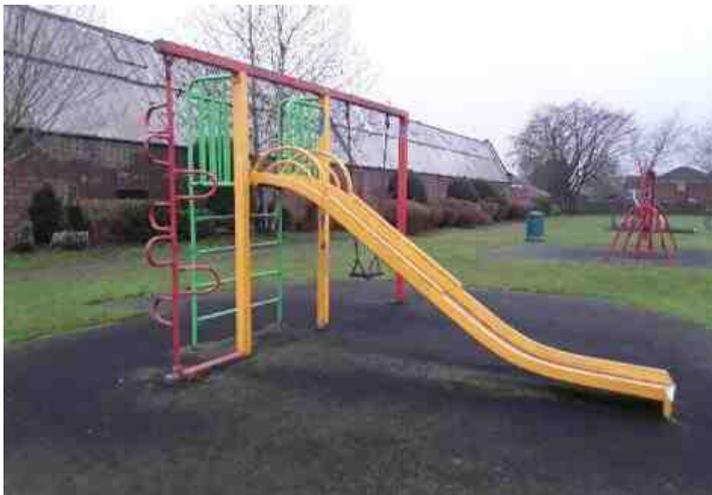
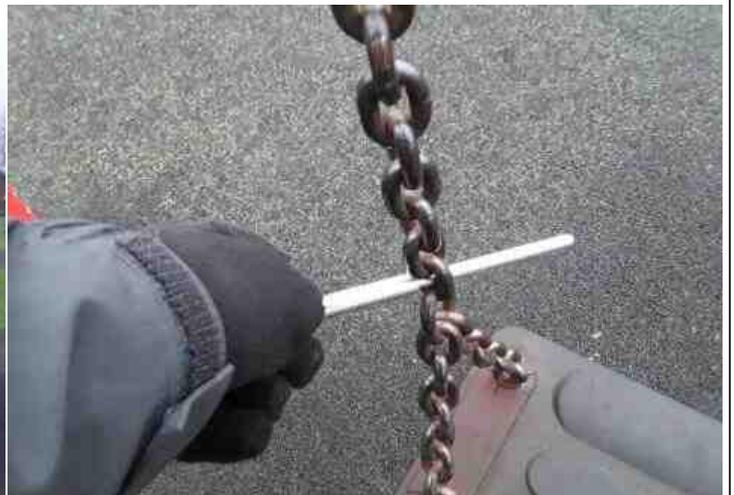
Item: Activity Equipment - Multi Play (Junior)
Manufacturer: Wicksteed Playgrounds

Finding: The chain openings are in excess of the 8.6mm as recommended by BS EN 1176

Action: Monitor - No action given the risk assessment

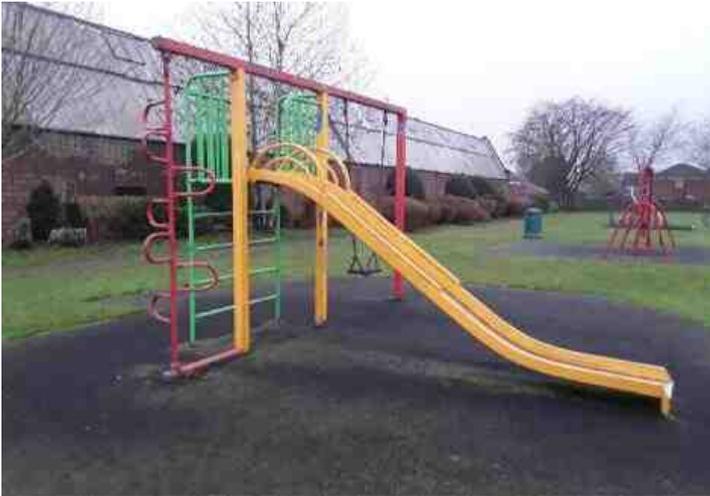
Item: Activity Equipment - Multi Play (Junior)
Manufacturer: Wicksteed Playgrounds

Finding: There is some notable evidence of chain wear

Action: Monitor for any further deterioration and replace when 40% worn

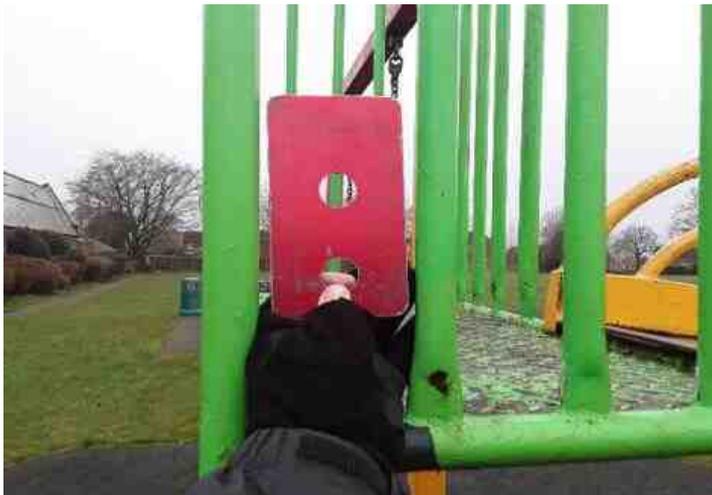
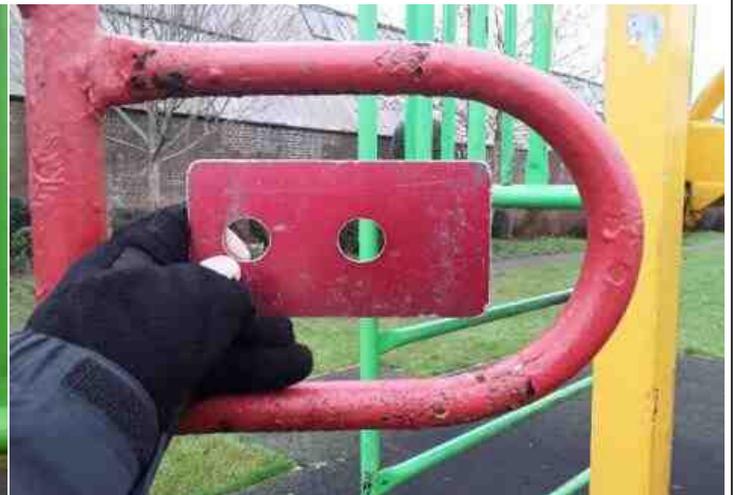
Item: Activity Equipment - Multi Play (Junior)
Manufacturer: Wicksteed Playgrounds

Finding: The item fails to meet the requirements of BS EN 1176 Part 1 4.2.7.2 for head and neck entrapment in the framework

Action: Monitor - No action given the risk assessment

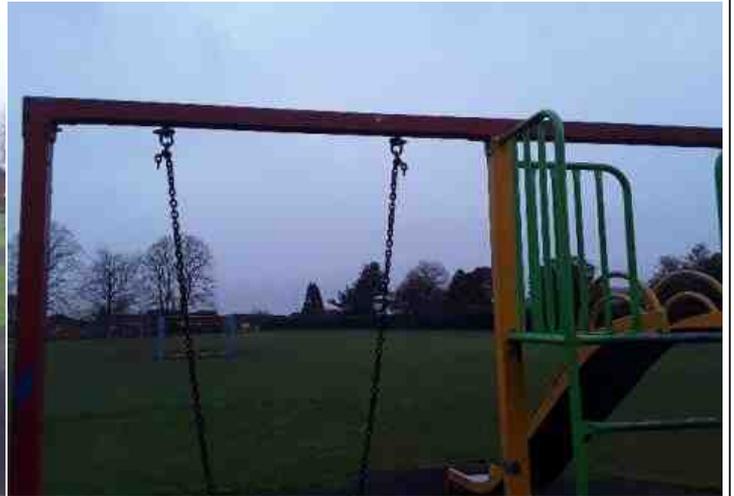
Item: Activity Equipment - Multi Play (Junior)
Manufacturer: Wicksteed Playgrounds

Finding: Swing frames or their top bar should only be attached to other equipment where specific measures are undertaken to segregate them from other activities, eg. additional 1.50m circulation area, barrier, or enclosures - BS EN 1176 Part 2 - 4.9

Action: Monitor - No action given the risk assessment

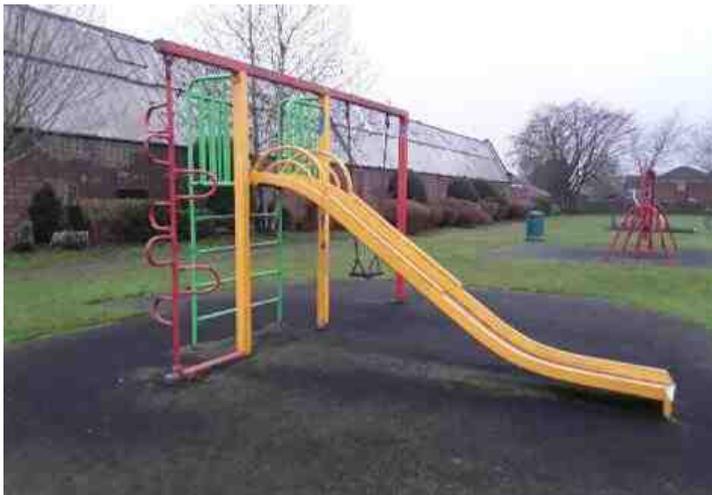
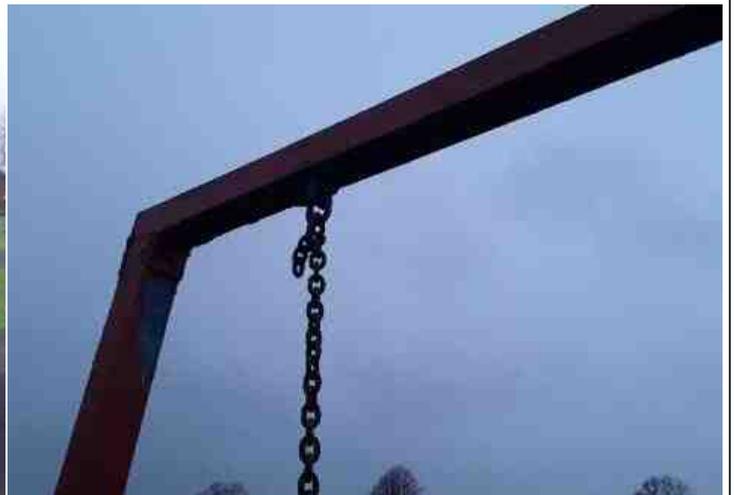
Item: Activity Equipment - Multi Play (Junior)
Manufacturer: Wicksteed Playgrounds

Finding: The bushes are worn or missing

Action: Replace worn or missing bushes

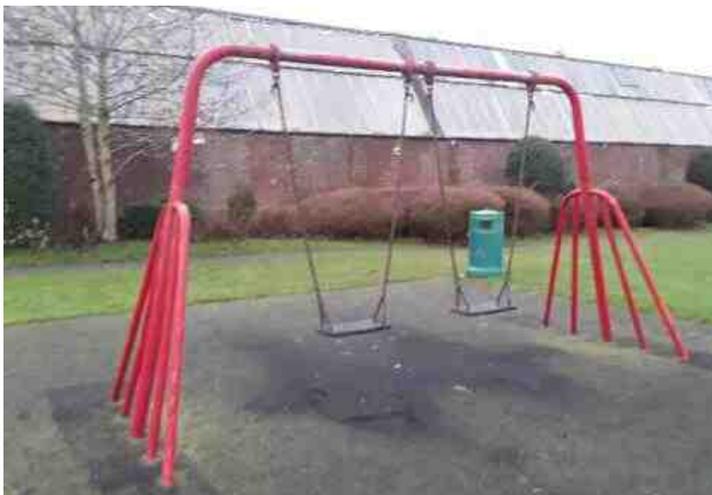
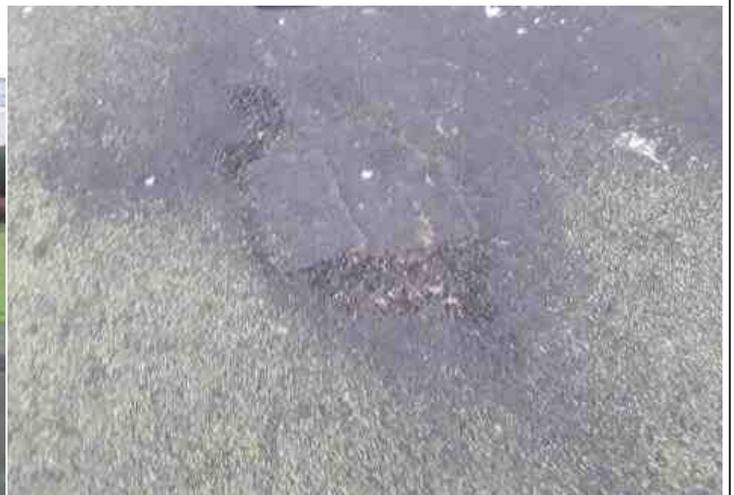
Item: Swings - 1 Bay 2 Seat (Flat)
Manufacturer: Wicksteed Playgrounds

Finding: The surfacing is damaged

Action: Repair damaged areas of surfacing

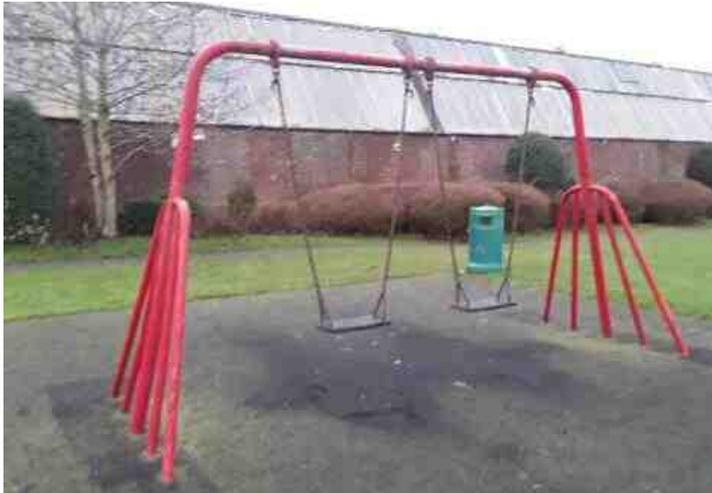
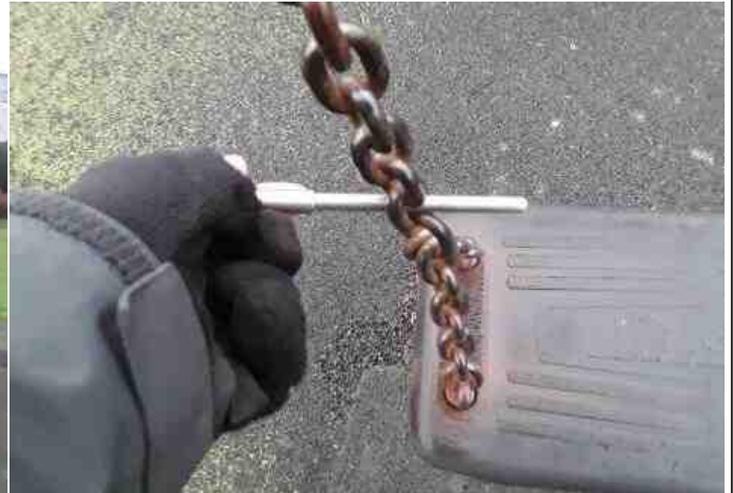
Item: Swings - 1 Bay 2 Seat (Flat)
Manufacturer: Wicksteed Playgrounds

Finding: The chain openings are in excess of the 8.6mm as recommended by BS EN 1176
Action: Monitor - No action given the risk assessment

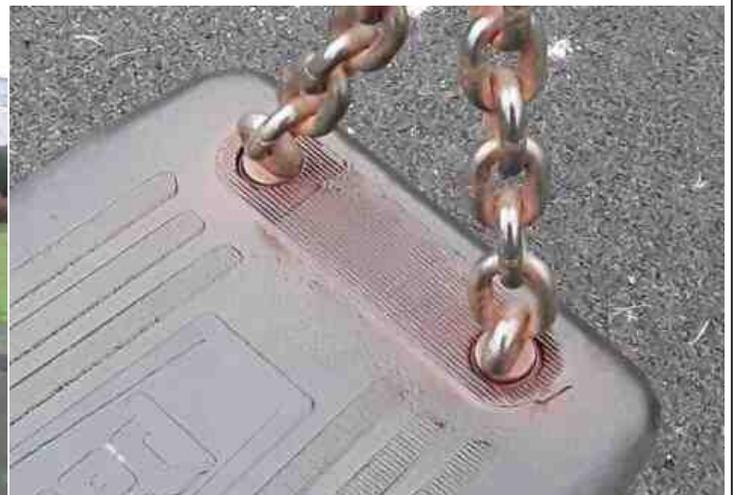
Item: Swings - 1 Bay 2 Seat (Flat)
Manufacturer: Wicksteed Playgrounds

Finding: The swing seat connectors are loose
Action: Tighten to secure

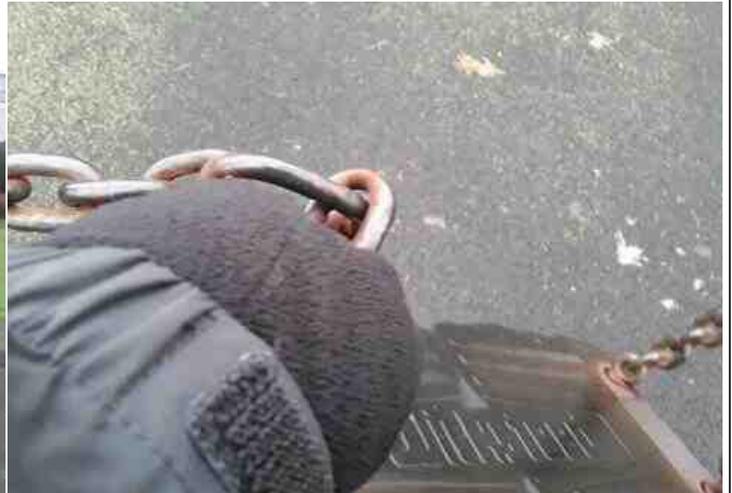
Item: Swings - 1 Bay 2 Seat (Flat)
Manufacturer: Wicksteed Playgrounds

Finding: There is some notable evidence of chain wear

Action: Monitor for any further deterioration and replace when 40% worn

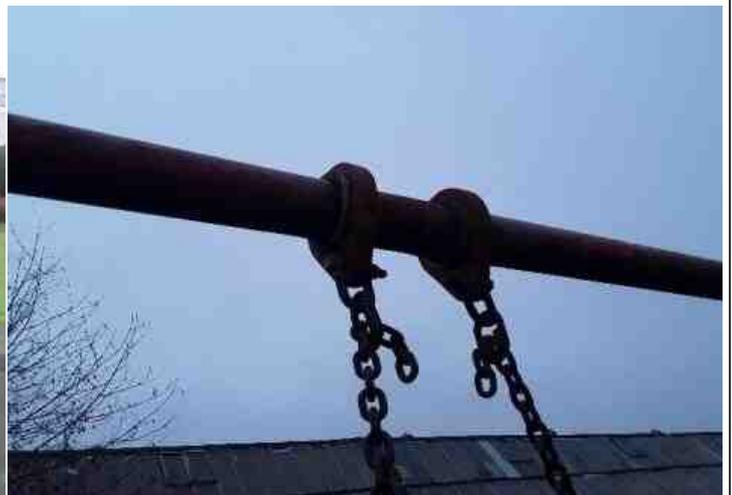
Item: Swings - 1 Bay 2 Seat (Flat)
Manufacturer: Wicksteed Playgrounds

Finding: The Anti Wrap bearings are worn

Action: Replace the anti wrap bearings

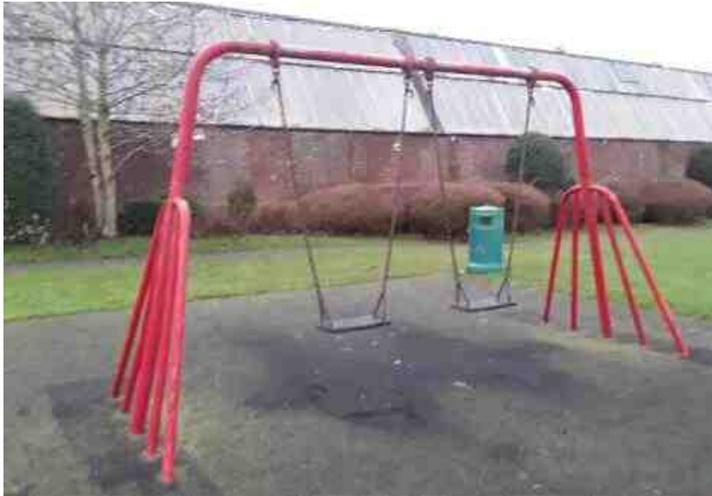
Item: Swings - 1 Bay 2 Seat (Flat)
Manufacturer: Wicksteed Playgrounds

Finding: The bush / bushes is / are worn or missing

Action: Replace worn or missing bushes

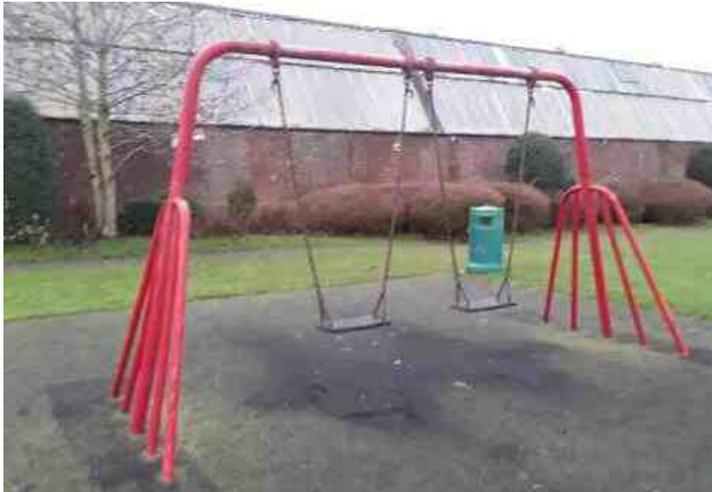
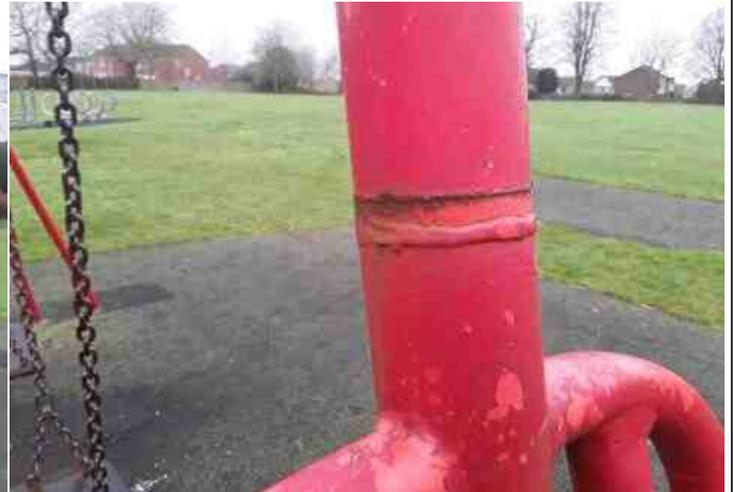
Item: Swings - 1 Bay 2 Seat (Flat)
Manufacturer: Wicksteed Playgrounds

Finding: The paintwork on this item has been damaged or worn exposing the metal underneath which is rusting / corroding

Action: Treat affected areas and repaint

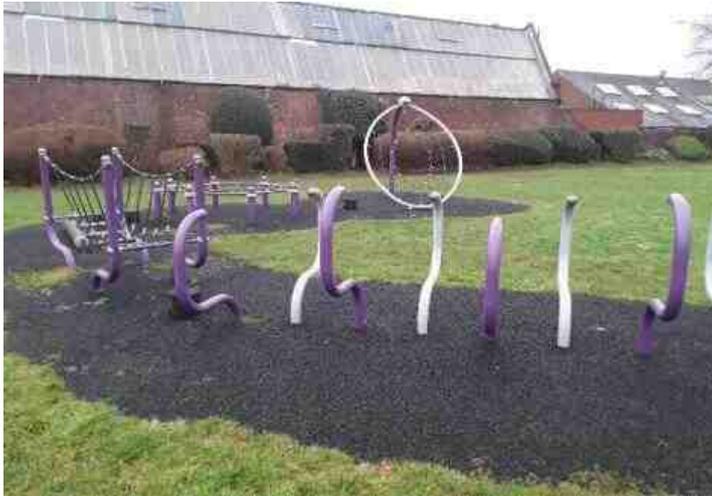
Item: Activity Equipment - Activity Trail
Manufacturer: Wicksteed Playgrounds

Finding: The surface has subsided in some areas

Action: Monitor for any further deterioration and repair as required

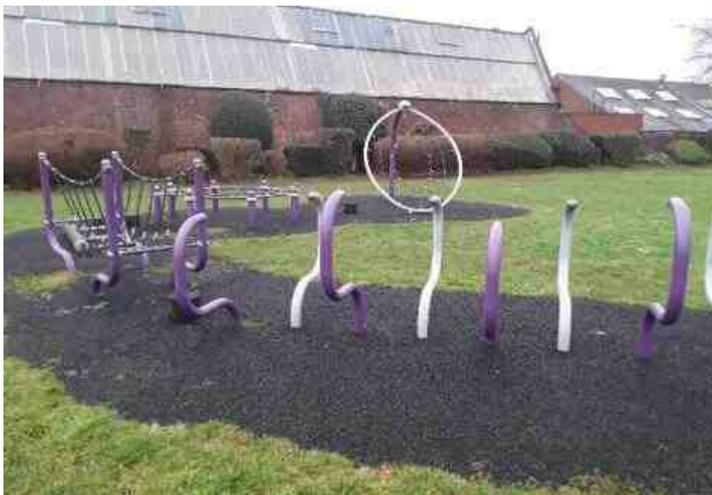
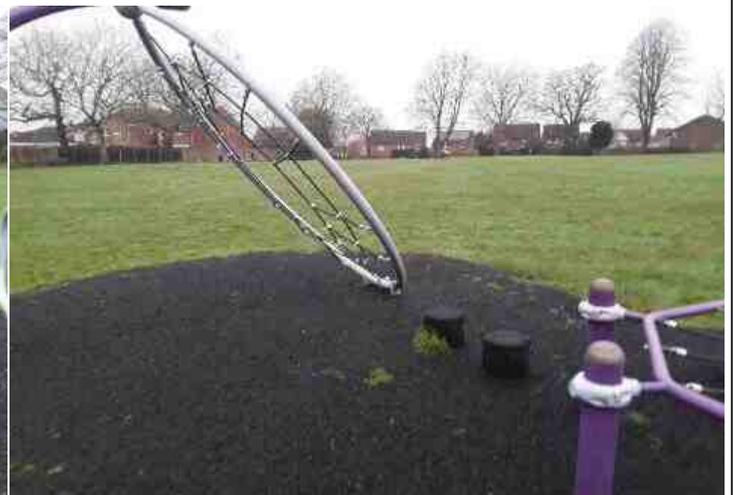
Item: Activity Equipment - Activity Trail
Manufacturer: Wicksteed Playgrounds

Finding: There are falls in excess of 600mm between adjacent components on the structure, in contravention of the recommendations set out in BS EN 1176 Part 1; 4.2.8.4

Action: Monitor - No action given the risk assessment

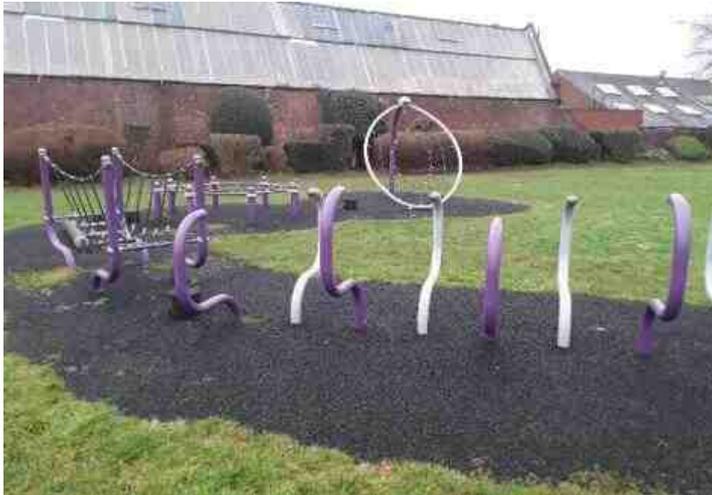
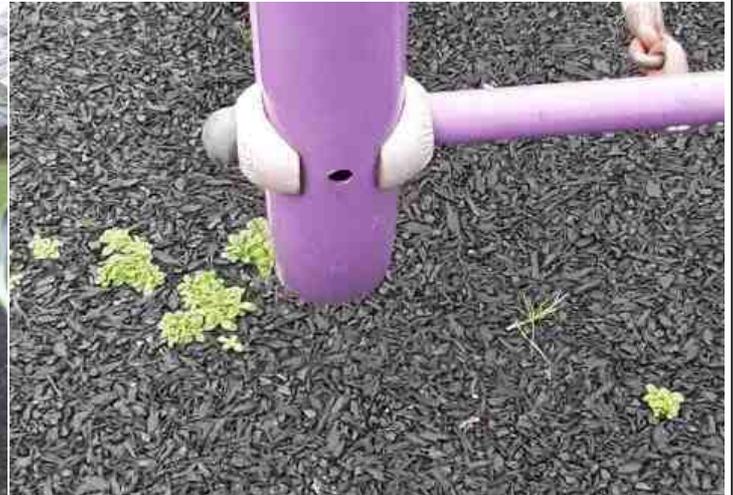
Item: Activity Equipment - Activity Trail
Manufacturer: Wicksteed Playgrounds

Finding: There is/are inserts missing

Action: Replace missing inserts

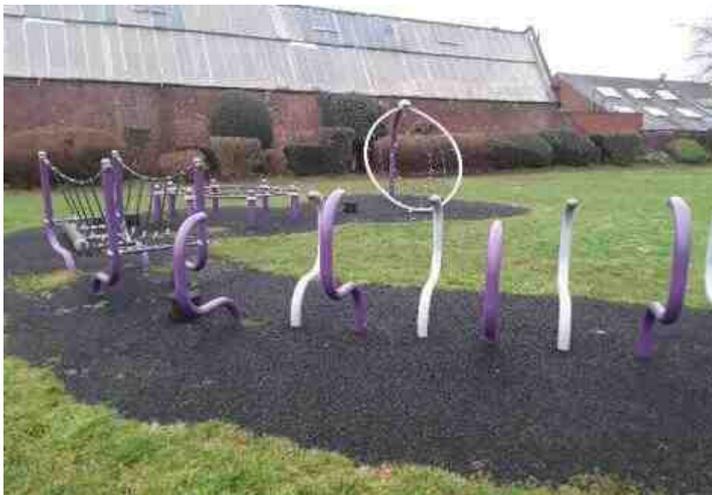
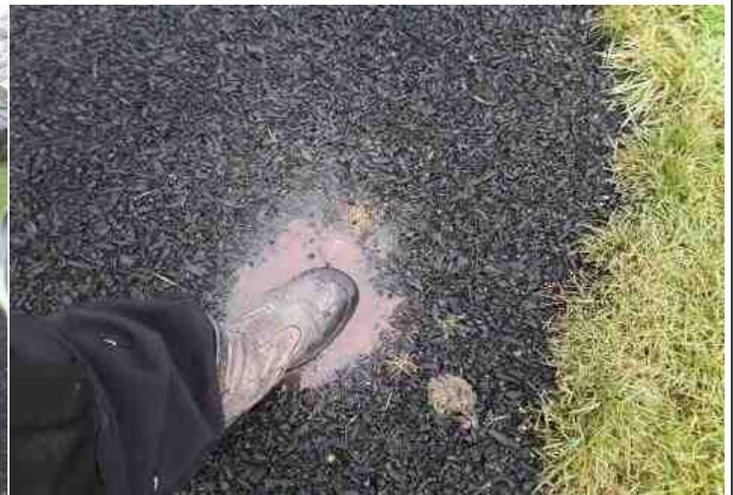
Item: Activity Equipment - Activity Trail
Manufacturer: Wicksteed Playgrounds

Finding: There is leeching through the bonded rubber mulch

Action: Consider providing additional drainage

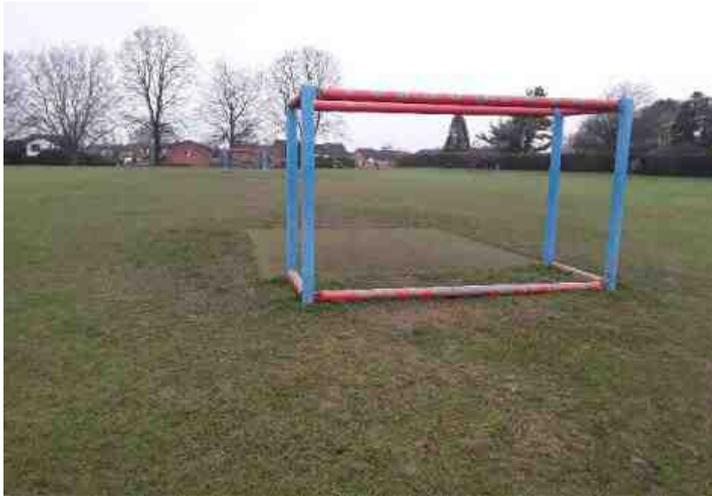
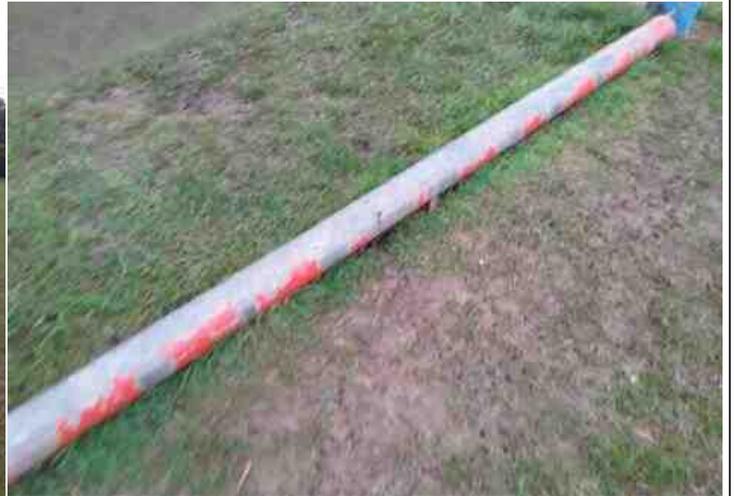
Item: Multi Use Games Area - Goal End
Manufacturer: Parkdale Play & Leisure Ltd

Finding: The paint is flaking off the metalwork

Action: Rub down and re-paint

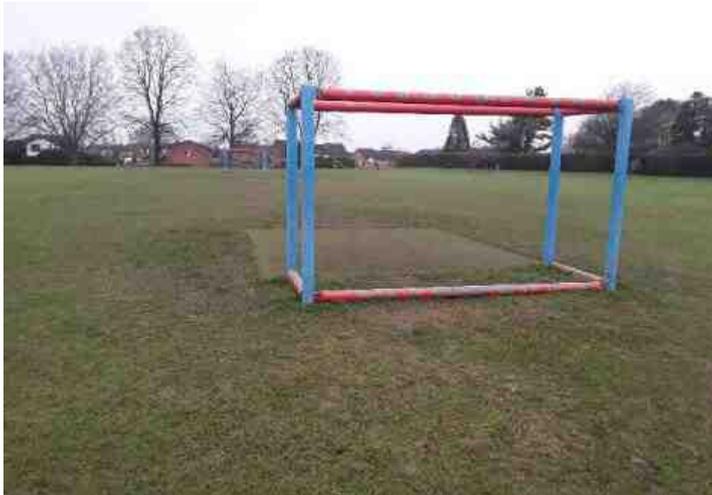
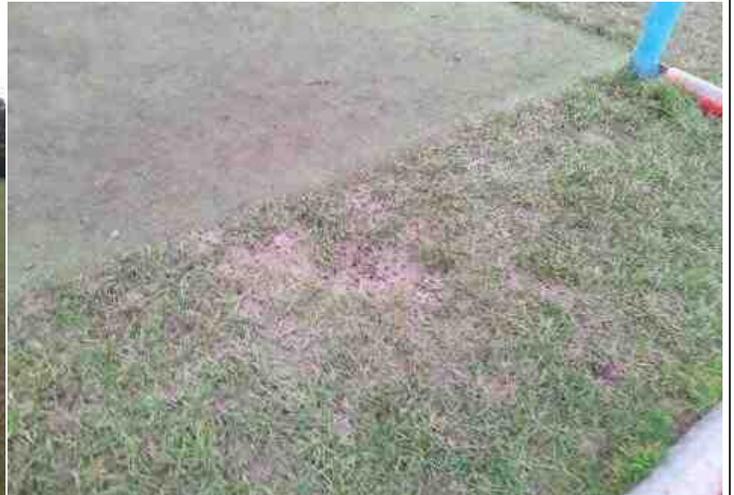
Item: Multi Use Games Area - Goal End
Manufacturer: Parkdale Play & Leisure Ltd

Finding: The area around the item has eroded and may become slippery

Action: Reinstate eroded area

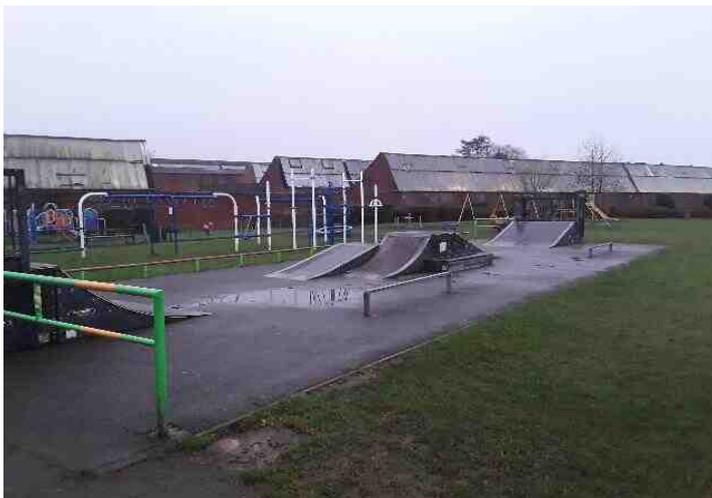
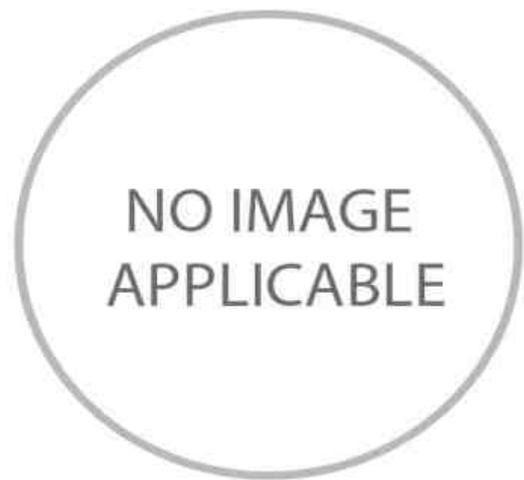
Item: Ancillary Items - Sign
Manufacturer: Not Identified

Finding: Signage of the wheeled sports area should be provided as recommended in BS EN 14974; this will include, but not exclusively, the use of the area, a recommendation to wear protective equipment, emergency contact details etc

Action: Provide signage as recommended by BS EN 14974 for wheeled sports areas

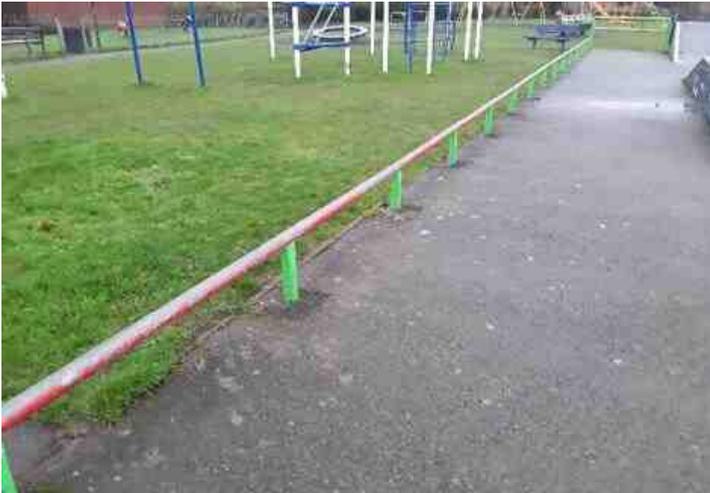
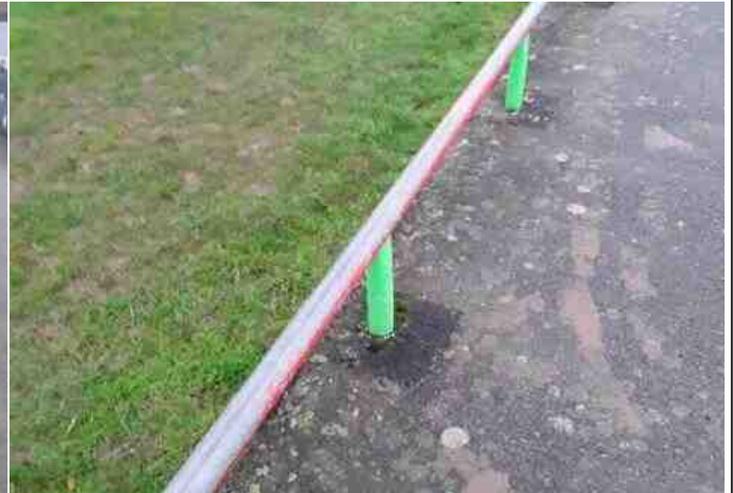
Item: Fences - Fencing - Post & Rail
Manufacturer: Not Identified

Finding: The paint is flaking off the metalwork

Action: Rub down and re-paint

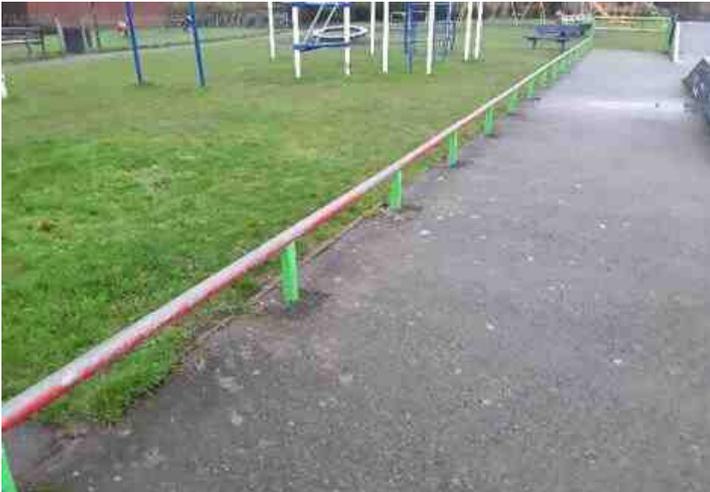
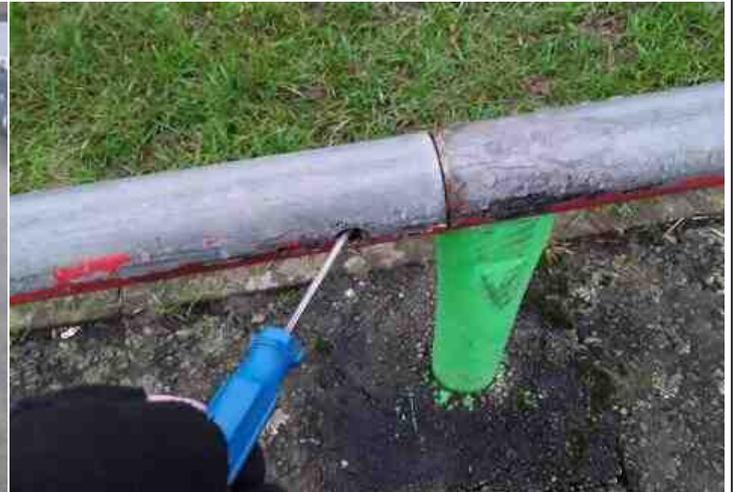
Item: Fences - Fencing - Post & Rail
Manufacturer: Not Identified

Finding: There is or are fixings missing on the item

Action: Replace all missing fixings

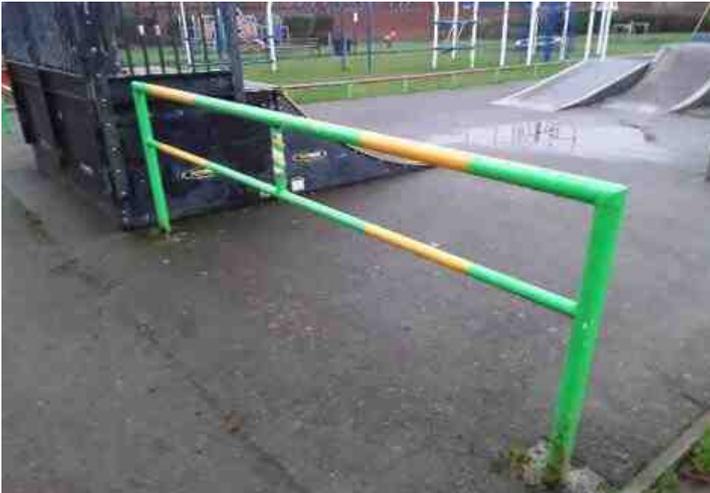
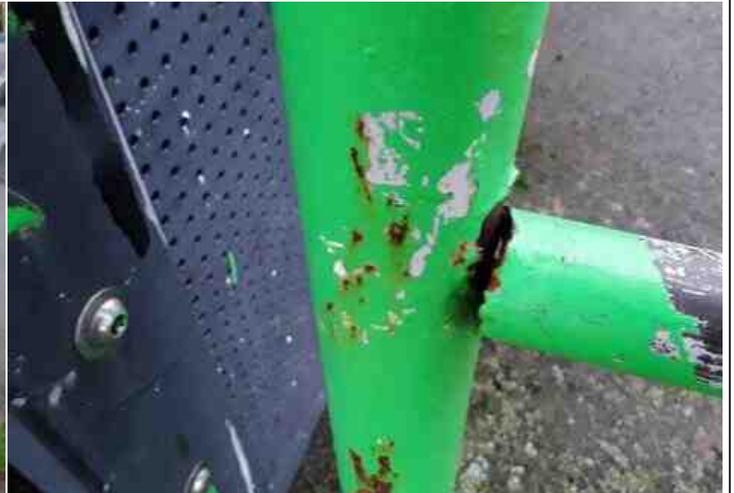
Item: Ancillary Items - Barrier
Manufacturer: Not Identified

Risk Level: L - Low Risk
Surface: Bitmac

Finding: The weld(s) on this item have failed

Action: Repair item

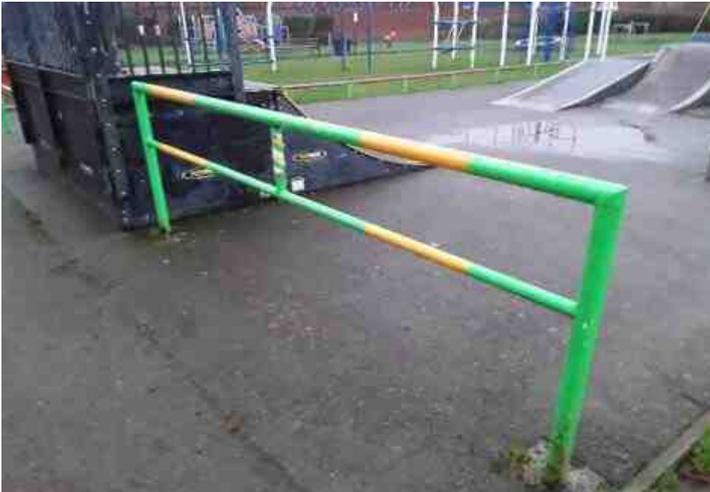
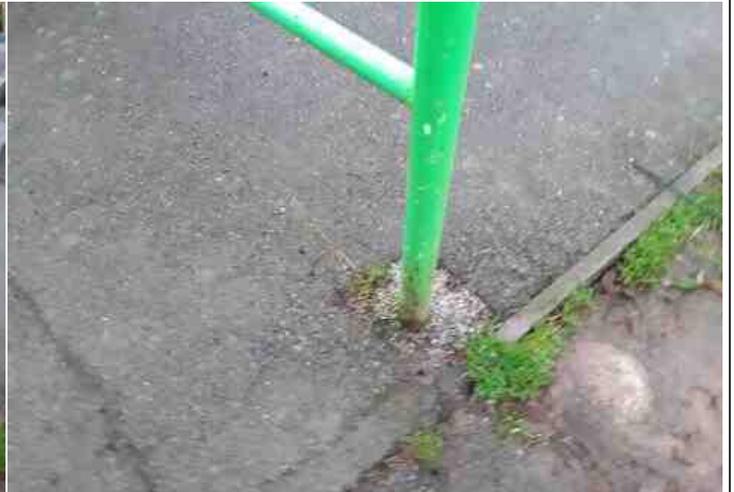
Item: Ancillary Items - Barrier
Manufacturer: Not Identified

Risk Level: L - Low Risk
Surface: Bitmac

Finding: The paintwork on this item has been damaged or worn exposing the metal underneath which is rusting / corroding

Action: Treat affected areas and repaint

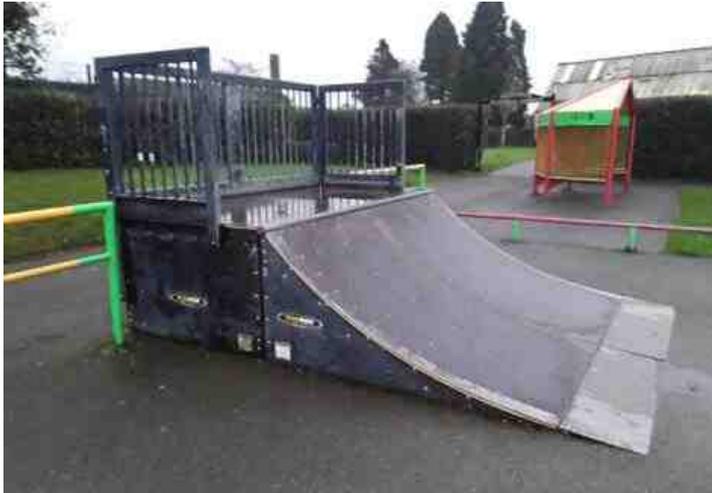
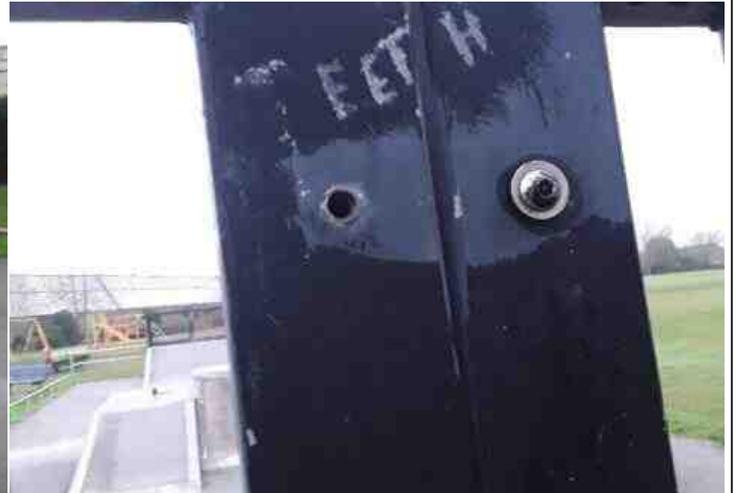
Item: Wheeled Sports - Quarter Pipe
Manufacturer: Woodward

Risk Level: L - Low Risk
Surface: Bitmac

Finding: There is or are fixings missing on the item

Action: Replace all missing fixings
