NOTICE OF PROPERTY MANAGEMENT AND GENERAL PURPOSES COMMITTEE MEETING

Thursday 5th March 2026 7pm

AGENDA

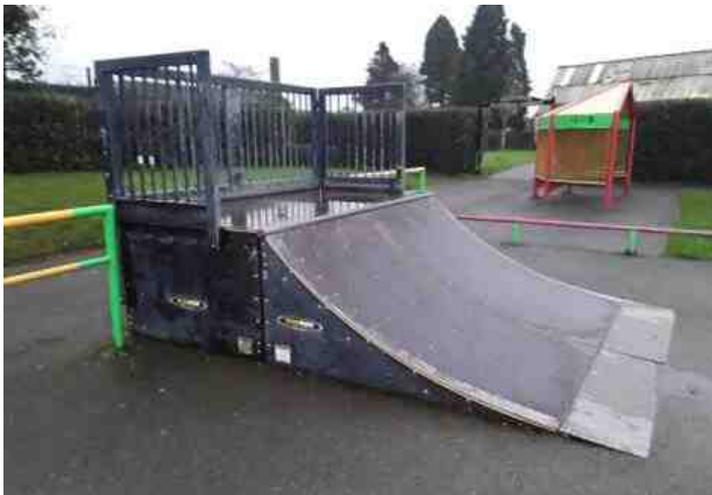
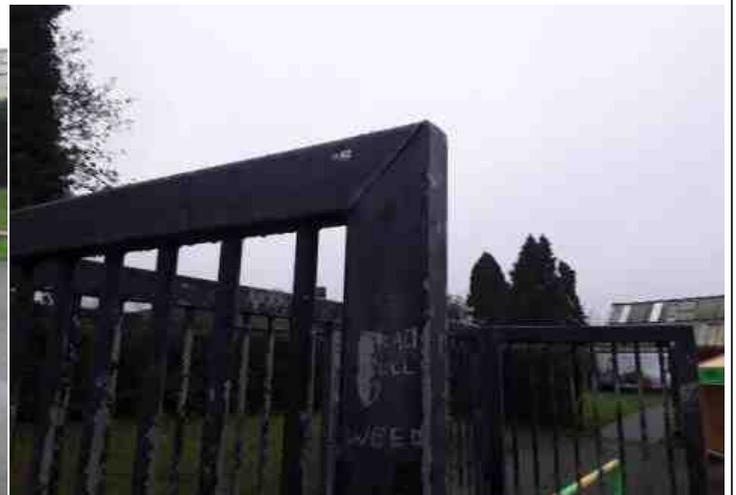
Item: Wheeled Sports - Quarter Pipe
Manufacturer: Woodward

Risk Level: V - Very Low Risk
Surface: Bitmac

Finding: The ends of the barrier do not have a radius of at least 50mm or are not chamfered by at least 50mm x 50mm in contravention of the requirements of BS EN 14974 - 6.2.6

Action: Monitor - no reasonably practicable action given the risk assessment

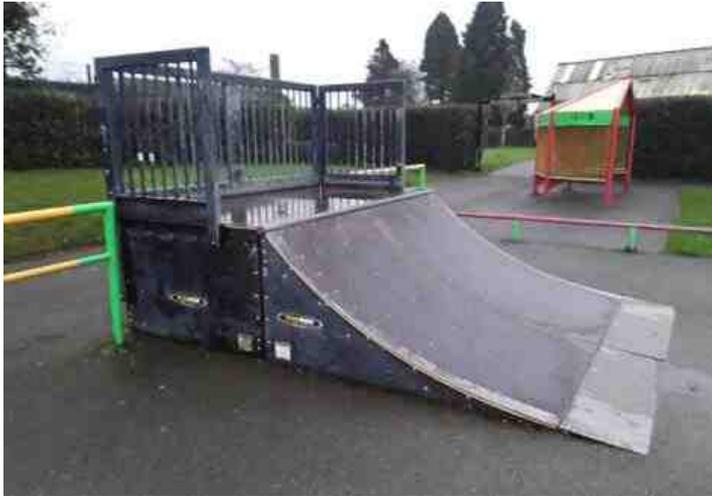
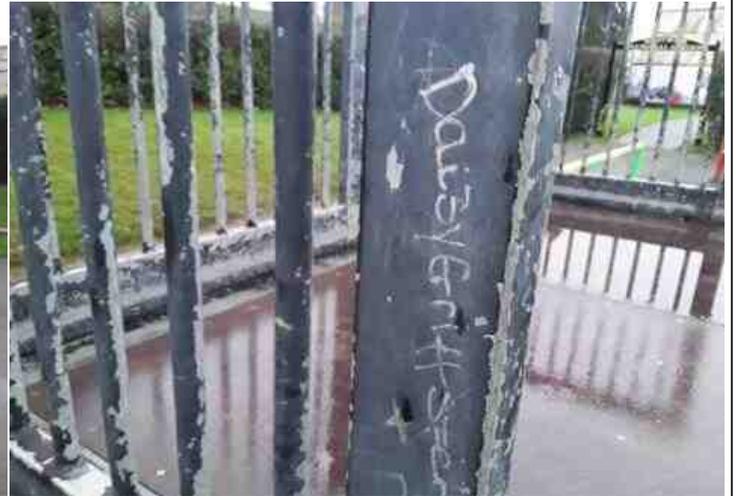
Item: Wheeled Sports - Quarter Pipe
Manufacturer: Woodward

Risk Level: L - Low Risk
Surface: Bitmac

Finding: The paint is flaking off the metalwork

Action: Rub down and re-paint

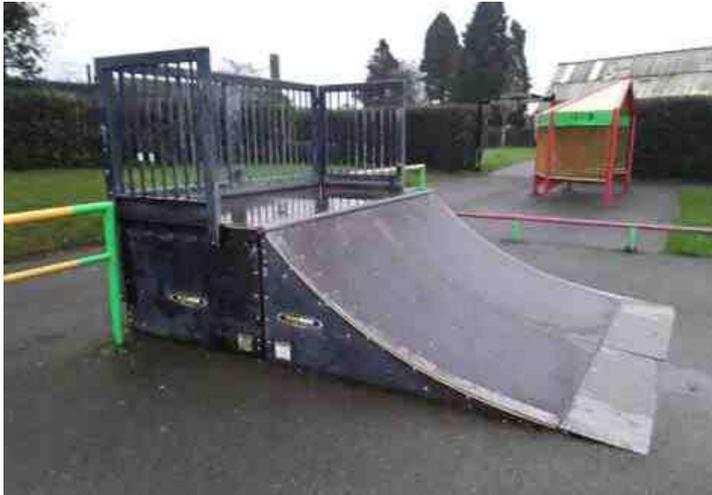
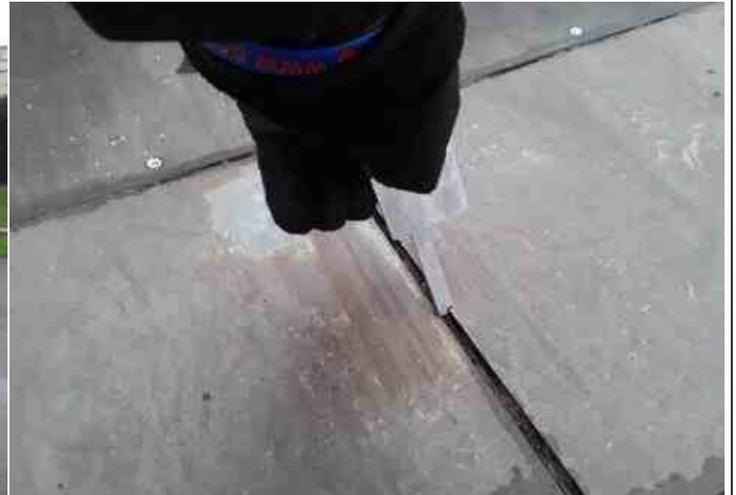
Item: Wheeled Sports - Quarter Pipe
Manufacturer: Woodward

Risk Level: V - Very Low Risk
Surface: Bitmac

Finding: Joints between the riding / rolling surfaces shall not be greater than 5mm in contravention of the requirements of BS EN 14974 – 6.2.4
Action: Take corrective action to ensure that the gaps between the joints do not exceed 5mm

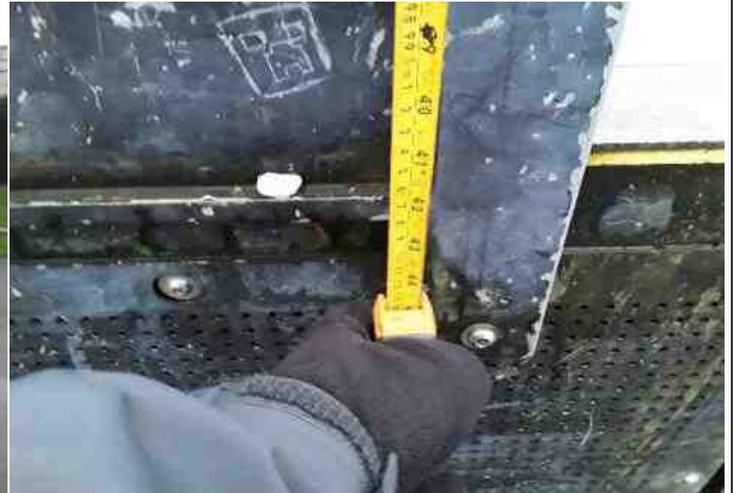
Item: Wheeled Sports - Quarter Pipe
Manufacturer: Woodward

Risk Level: L - Low Risk
Surface: Bitmac

Finding: The height of the barrier is less than 1200mm in contravention of BS EN 14974 - 6.2.6. This height must be achieved all around the platform and at a maximum distance of 300mm from the front of the platform.

Action: Monitor - no reasonably practicable action given the risk assessment

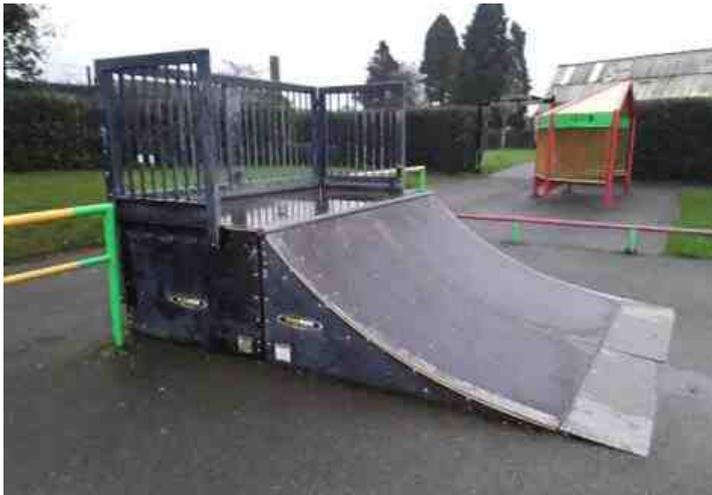
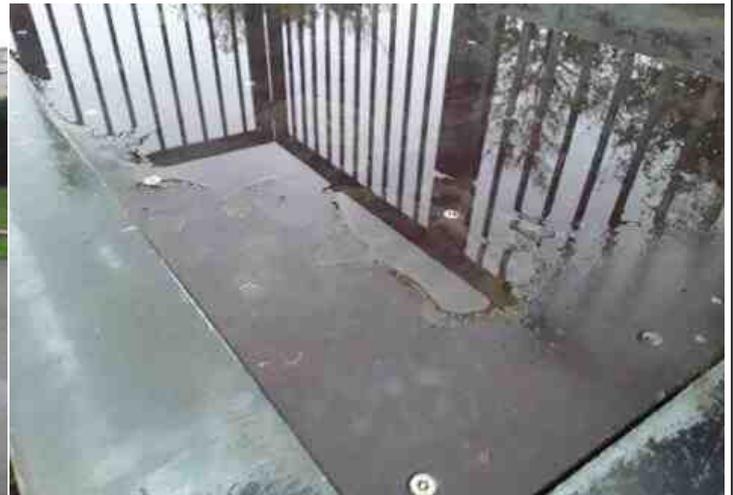
Item: Wheeled Sports - Quarter Pipe
Manufacturer: Woodward

Risk Level: L - Low Risk
Surface: Bitmac

Finding: The riding surface has minor damage apparent

Action: Monitor for any further deterioration and repair as required

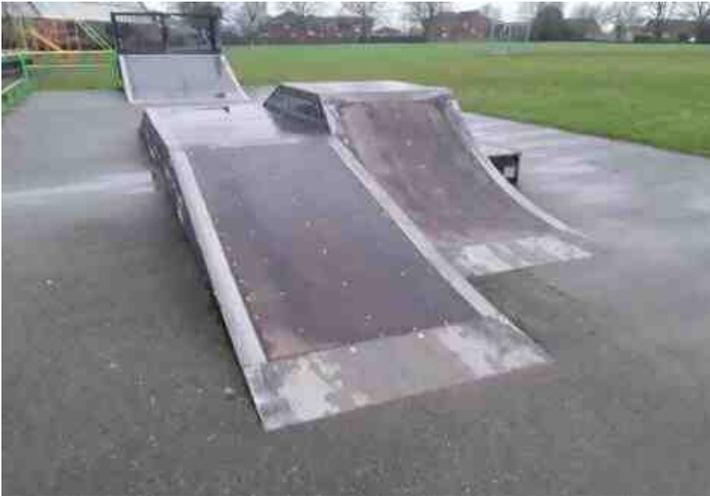
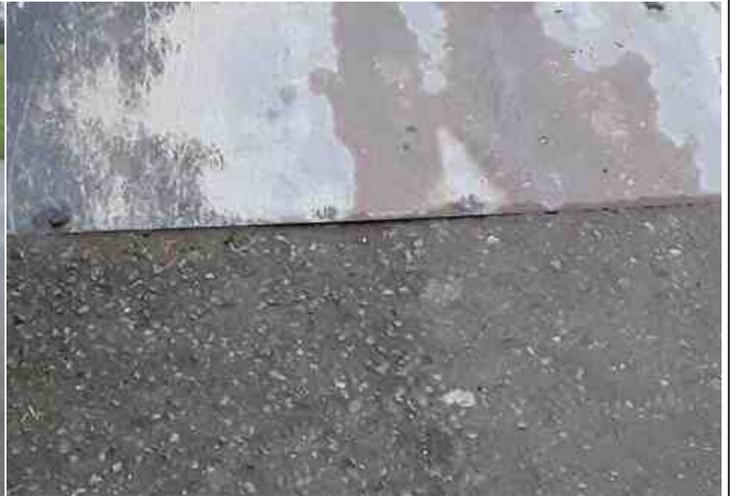
Item: Wheeled Sports - Combination Ramp
Manufacturer: Woodward

Risk Level: L - Low Risk
Surface: Bitmac

Finding: The kicker plate protrudes more than 5mm above the surrounding surface level, BS EN 14974 - 6.1.4 recommends a maximum of 5mm

Action: Adjust height to ensure a maximum of 5mm change in level

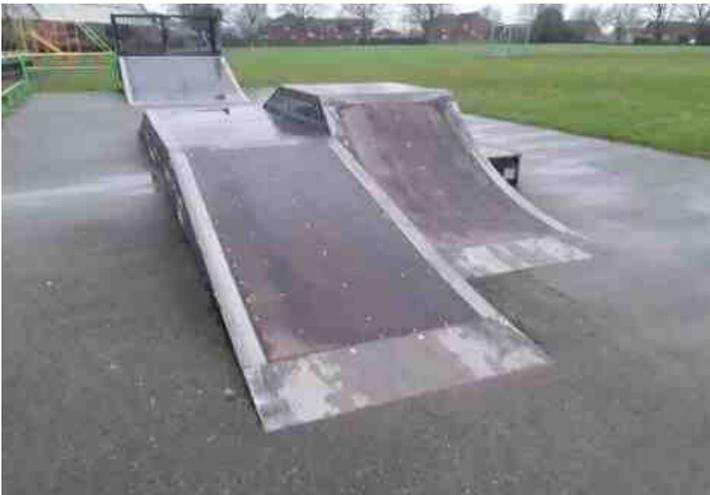
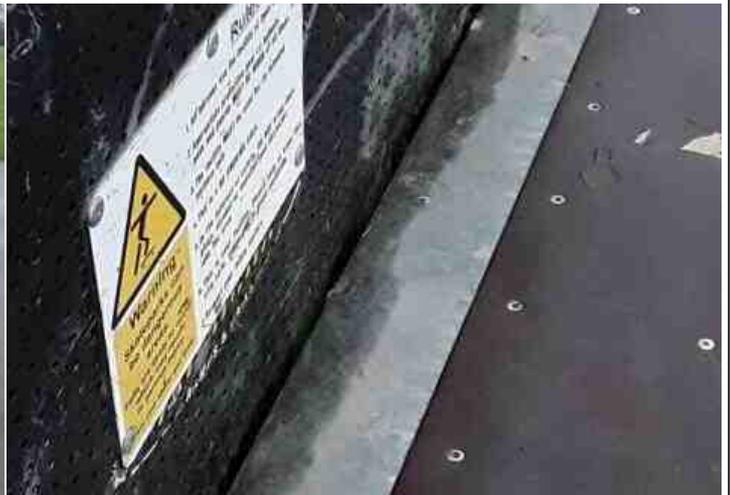
Item: Wheeled Sports - Combination Ramp
Manufacturer: Woodward

Risk Level: L - Low Risk
Surface: Bitmac

Finding: There should be no gaps between adjacent components to meet the requirements of BS EN 14974 - 6.2.6

Action: Remove the gaps

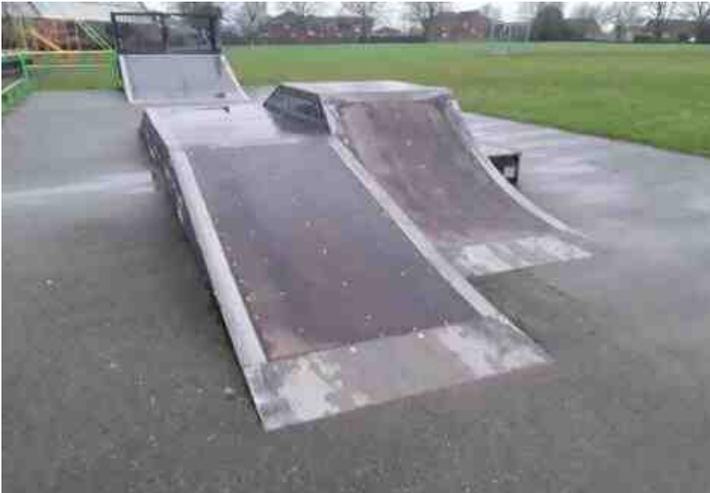
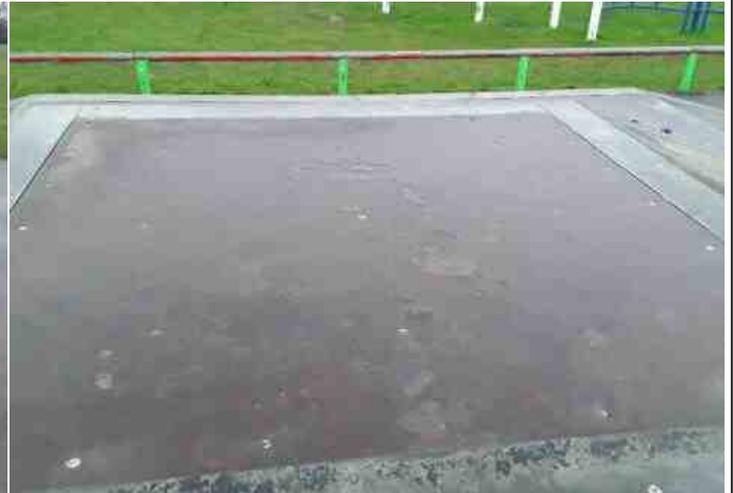
Item: Wheeled Sports - Combination Ramp
Manufacturer: Woodward

Risk Level: L - Low Risk
Surface: Bitmac

Finding: The riding surface has minor damage apparent

Action: Monitor for any further deterioration and repair as required

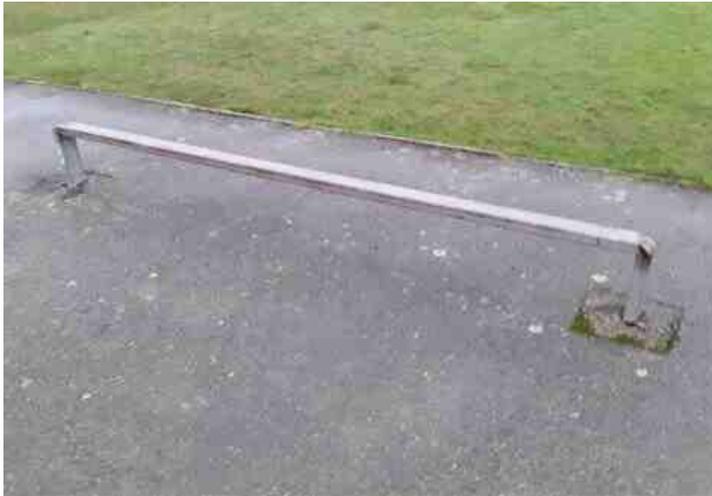
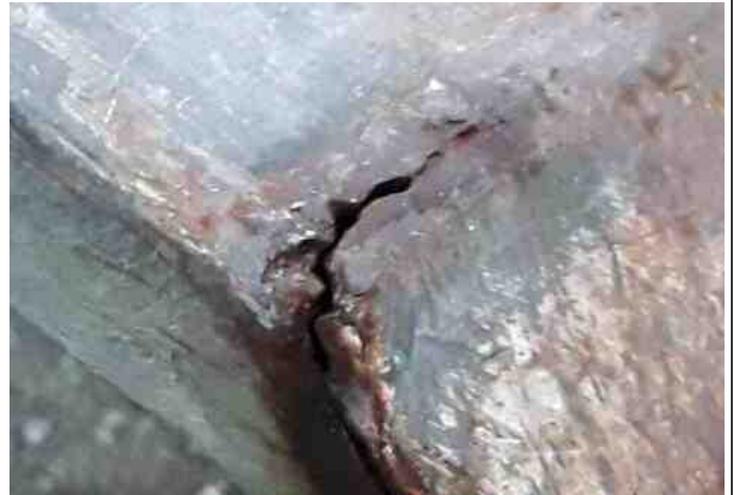
Item: Wheeled Sports - Grind Rail
Manufacturer: Not Identified

Risk Level: L - Low Risk
Surface: Bitmac

Finding: The weld(s) on this item have failed

Action: Repair item

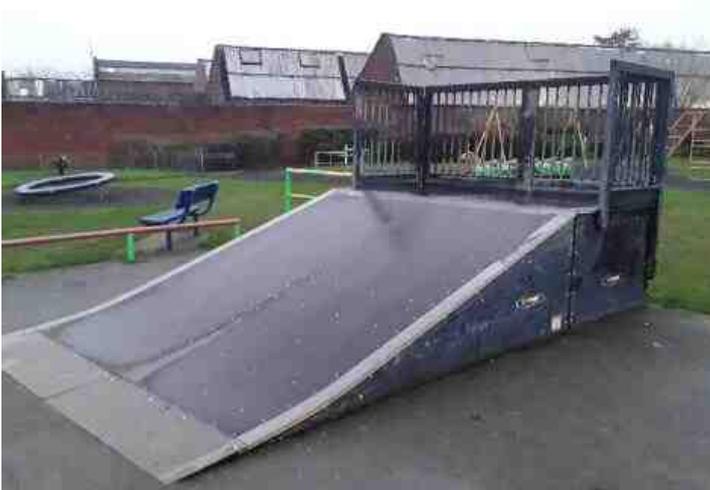
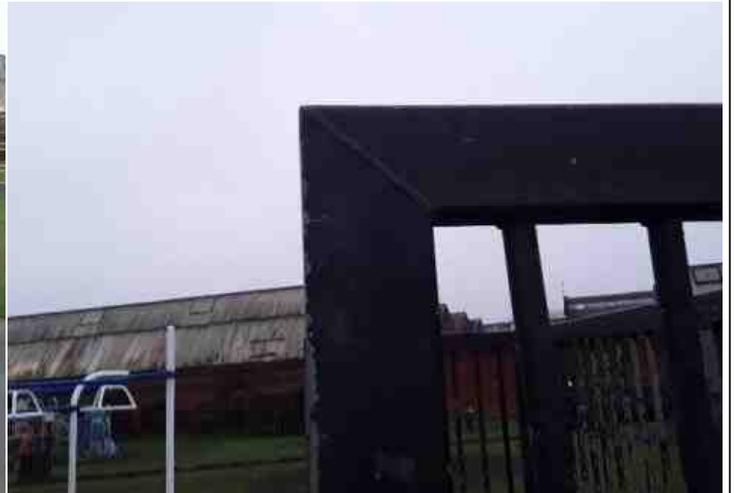
Item: Wheeled Sports - Flat Bank
Manufacturer: Woodward

Risk Level: V - Very Low Risk
Surface: Bitmac

Finding: The ends of the barrier do not have a radius of at least 50mm or are not chamfered by at least 50mm x 50mm in contravention of the requirements of BS EN 14974 - 6.2.6

Action: Monitor - no reasonably practicable action given the risk assessment

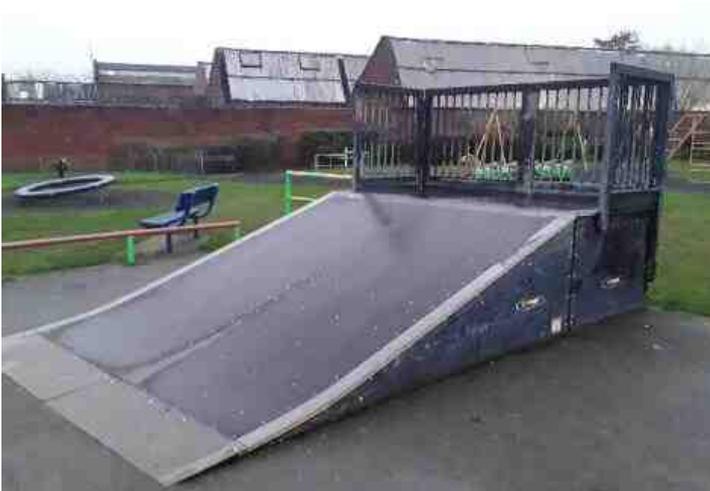
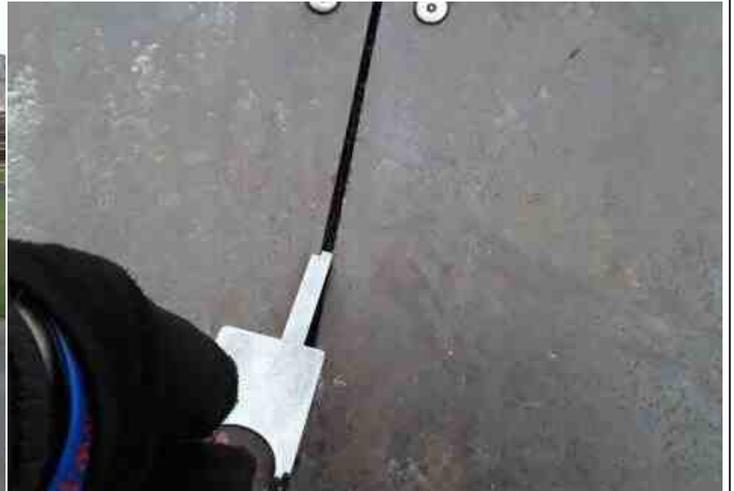
Item: Wheeled Sports - Flat Bank
Manufacturer: Woodward

Risk Level: V - Very Low Risk
Surface: Bitmac

Finding: Joints between the riding / rolling surfaces shall not be greater than 5mm in contravention of the requirements of BS EN 14974 - 6.2.4

Action: Take corrective action to ensure that the gaps between the joints do not exceed 5mm

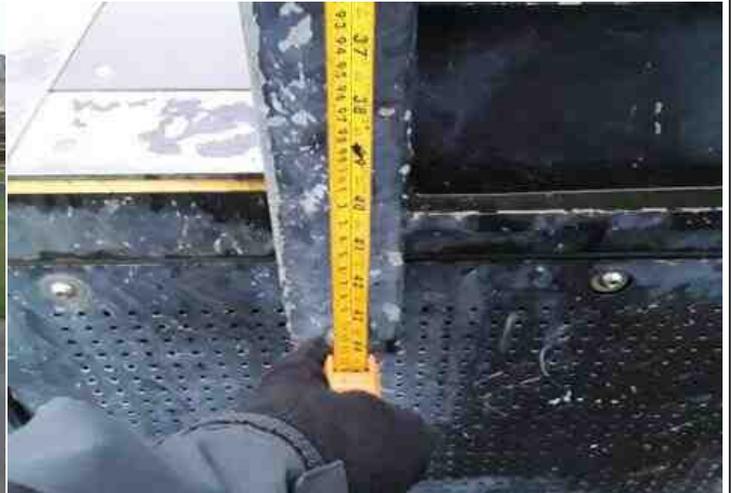
Item: Wheeled Sports - Flat Bank
Manufacturer: Woodward

Risk Level: L - Low Risk
Surface: Bitmac

Finding: The height of the barrier is less than 1200mm in contravention of BS EN 14974 - 6.2.6. This height must be achieved all around the platform and at a maximum distance of 300mm from the front of the platform.

Action: Monitor - no reasonably practicable action given the risk assessment

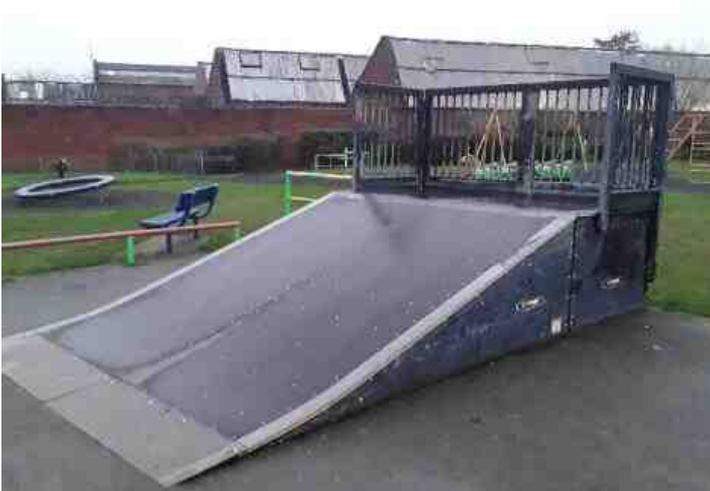
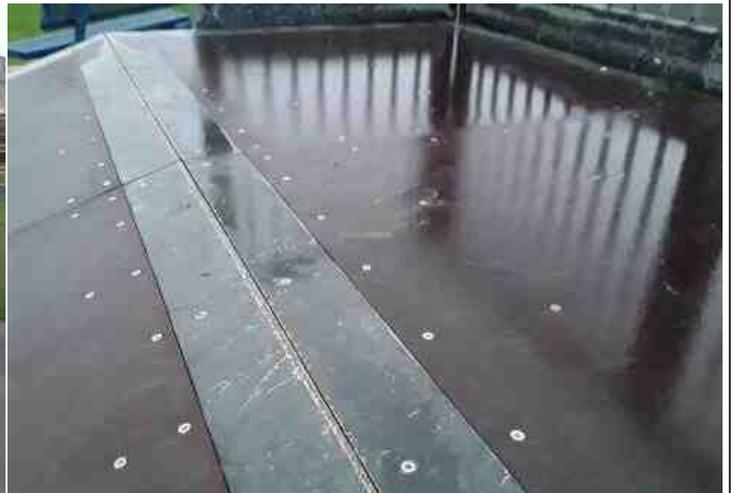
Item: Wheeled Sports - Flat Bank
Manufacturer: Woodward

Risk Level: L - Low Risk
Surface: Bitmac

Finding: The riding surface has minor damage apparent

Action: Monitor for any further deterioration and repair as required

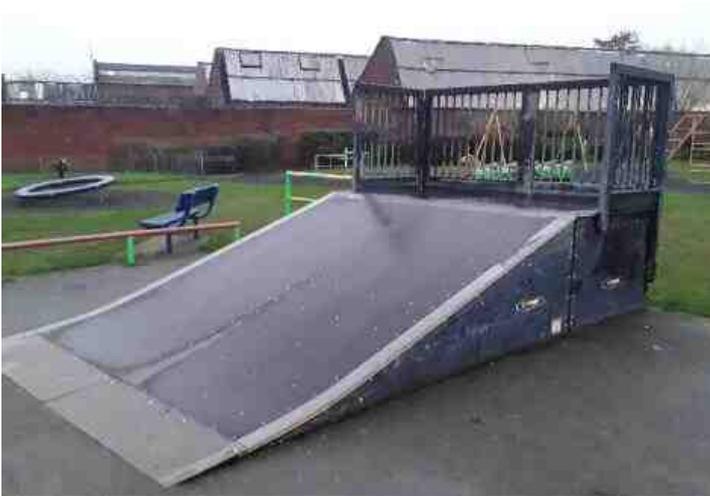
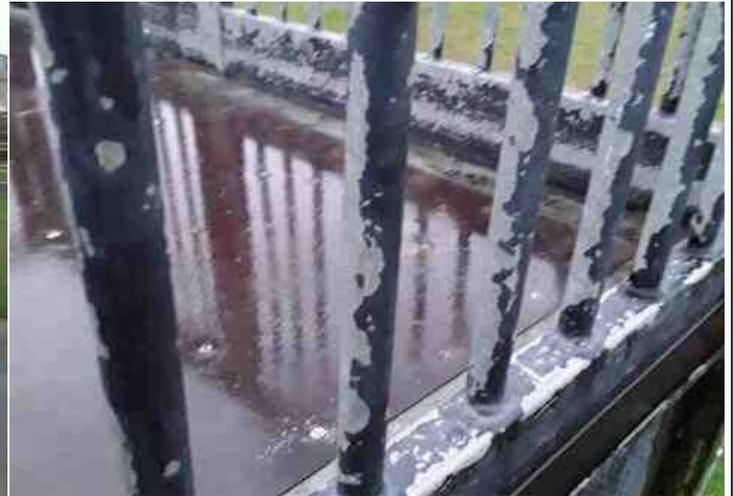
Item: Wheeled Sports - Flat Bank
Manufacturer: Woodward

Risk Level: L - Low Risk
Surface: Bitmac

Finding: The paint is flaking off the metalwork

Action: Rub down and re-paint

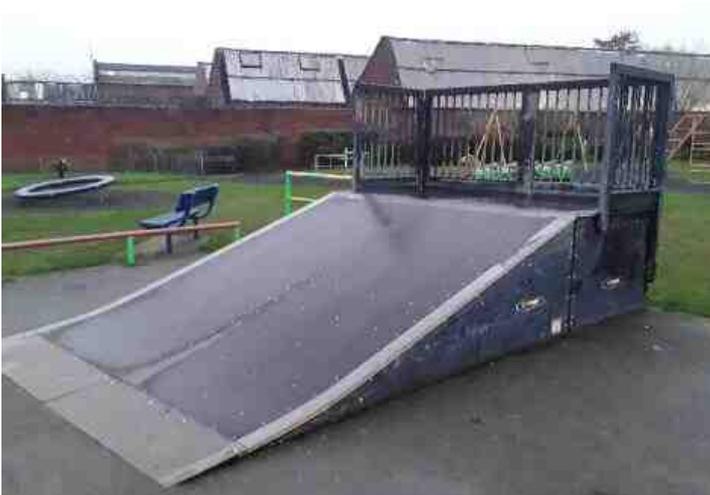
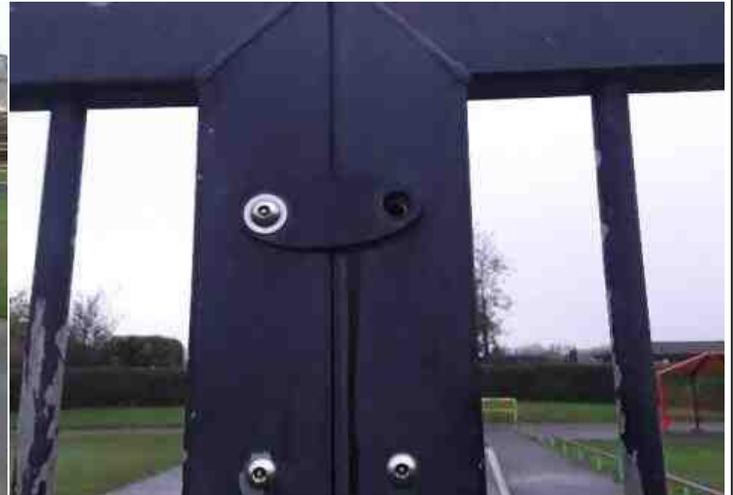
Item: Wheeled Sports - Flat Bank
Manufacturer: Woodward

Risk Level: L - Low Risk
Surface: Bitmac

Finding: There is or are fixings missing on the item

Action: Replace all missing fixings

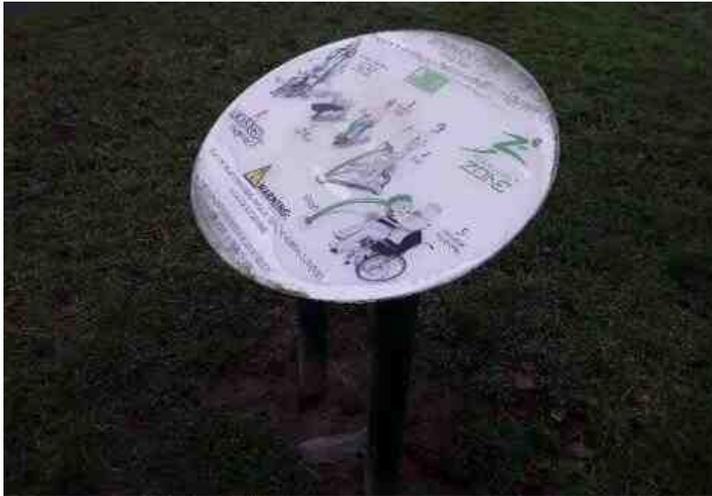
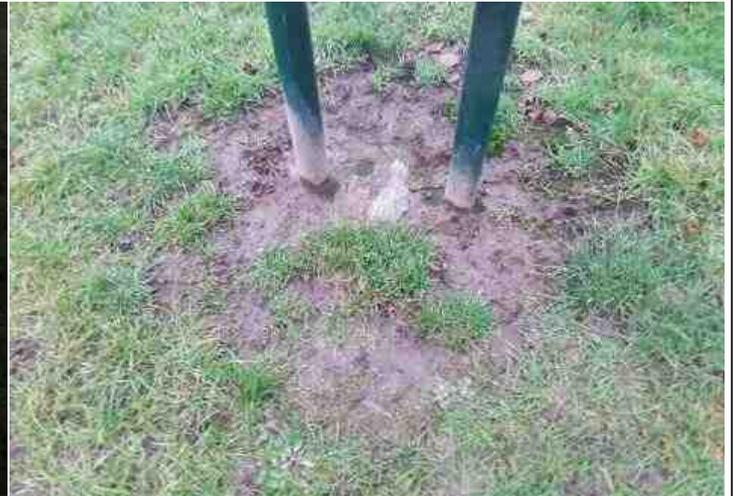
Item: Ancillary Items - Sign
Manufacturer: Wicksteed Playgrounds

Risk Level: L - Low Risk
Surface: Grass

Finding: The area around the item has eroded exposing stones and may become slippery when wet

Action: Remove the stones and reinstate eroded area

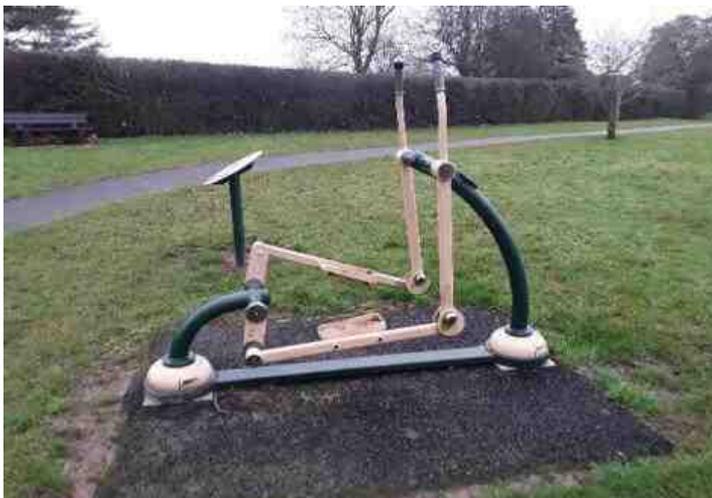
Item: Outdoor Fitness Equipment - Cross Trainer
Manufacturer: Wicksteed Playgrounds

Risk Level: V - Very Low Risk
Surface: Bonded Rubber Mulch

Finding: There is/are inserts missing

Action: Replace missing inserts

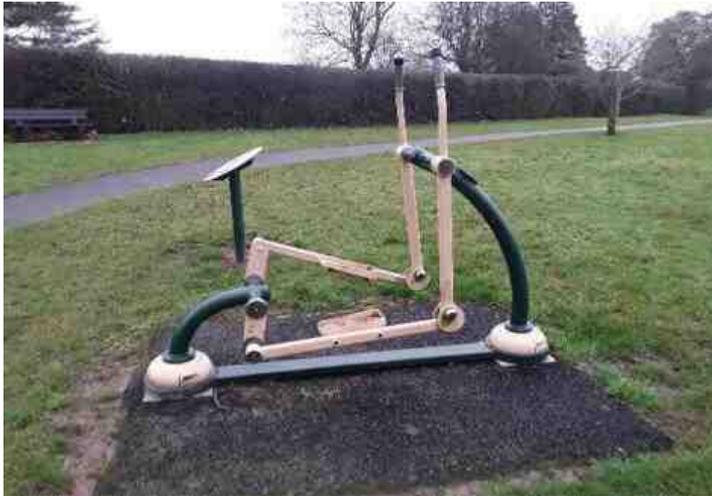
Item: Outdoor Fitness Equipment - Cross Trainer **Risk Level:** L - Low Risk
Manufacturer: Wicksteed Playgrounds **Surface:** Bonded Rubber Mulch

Finding: There is/are bolt cap covers missing or damaged on the item **Action:** Replace missing or damaged bolt cap covers

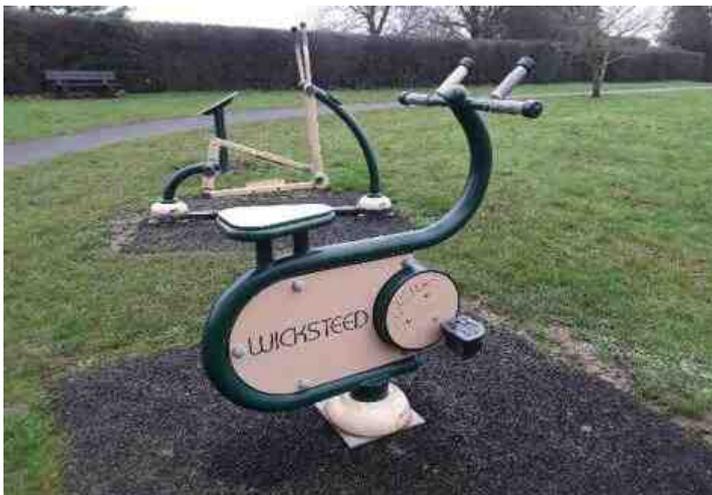
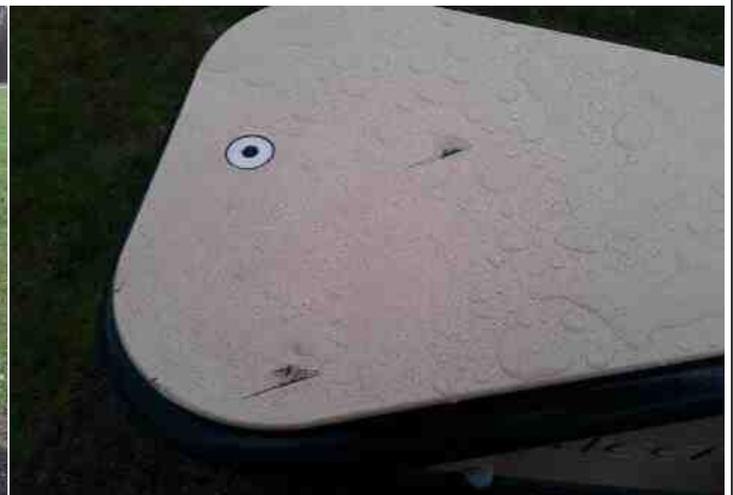
Item: Outdoor Fitness Equipment - Cycle **Risk Level:** L - Low Risk
Manufacturer: Wicksteed Playgrounds **Surface:** Bonded Rubber Mulch

Finding: The seat has been damaged **Action:** Monitor for any further deterioration and replace as required

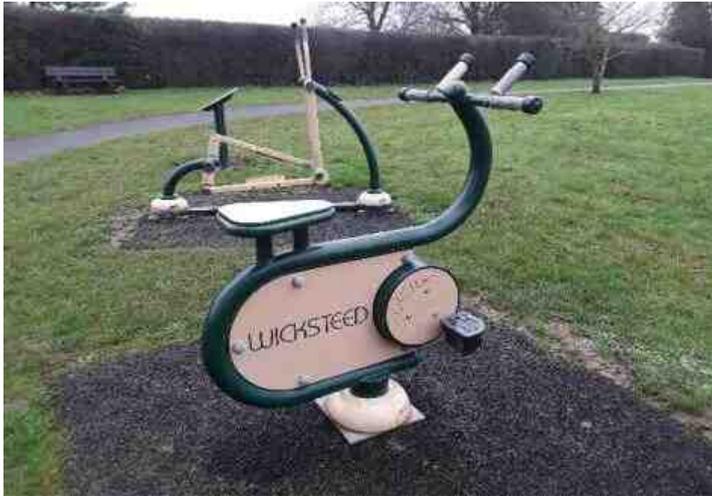
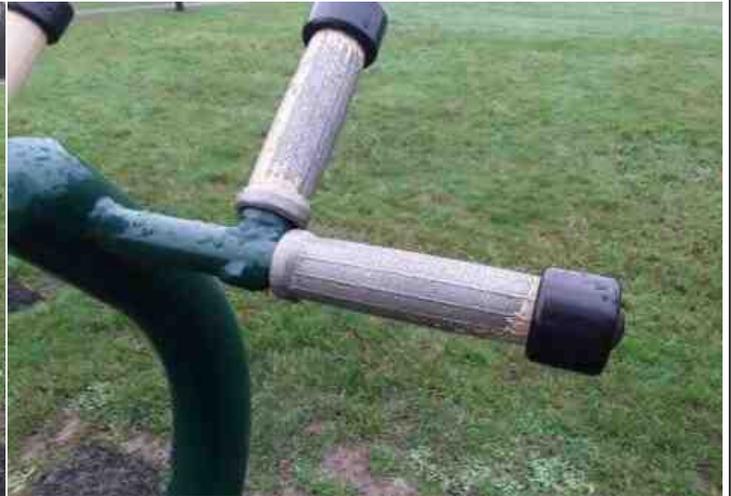
Item: Outdoor Fitness Equipment - Cycle
Manufacturer: Wicksteed Playgrounds

Finding: The paint is flaking off the metalwork

Action: Rub down and re-paint

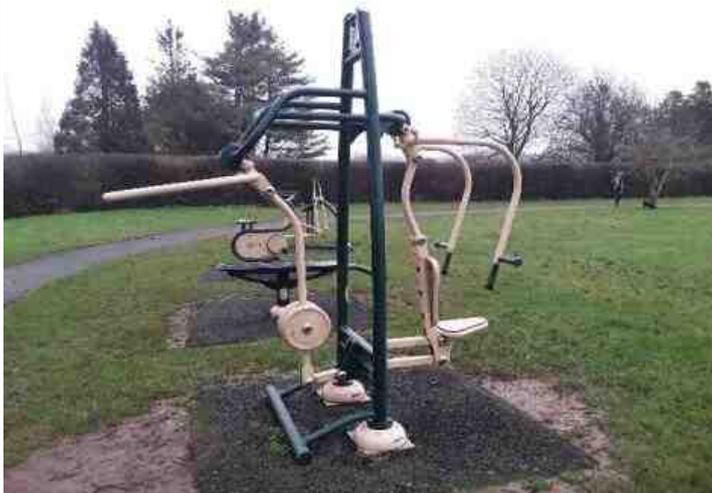
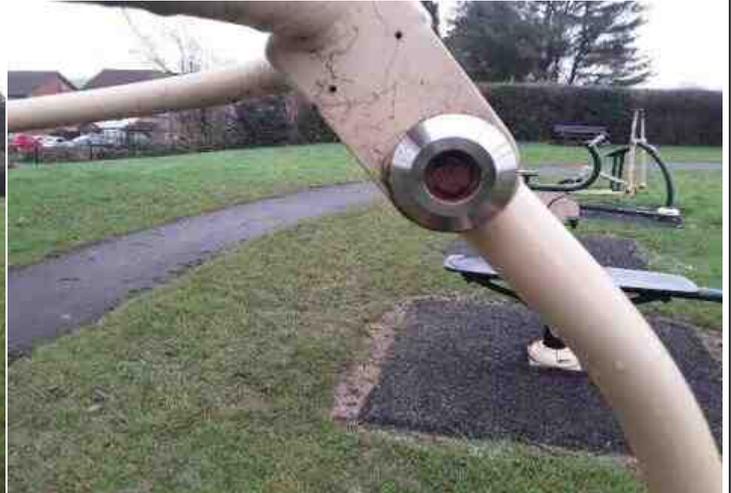
Item: Outdoor Fitness Equipment - Double Fitness Station
Manufacturer: Wicksteed Playgrounds

Finding: There is/are bolt cap covers missing or damaged on the item

Action: Replace missing or damaged bolt cap covers

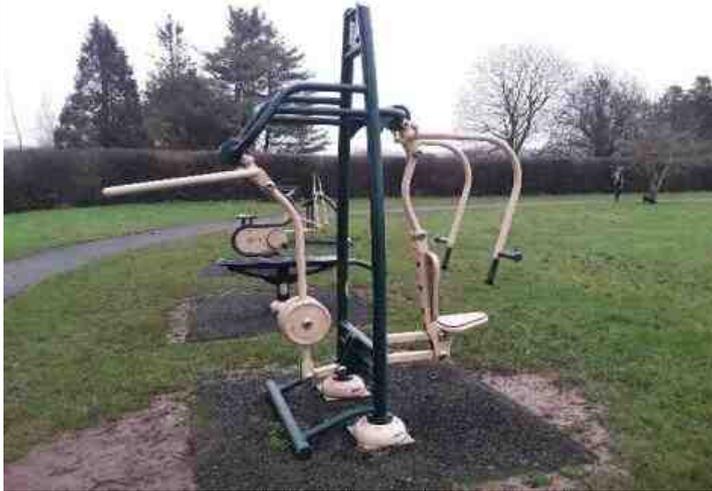
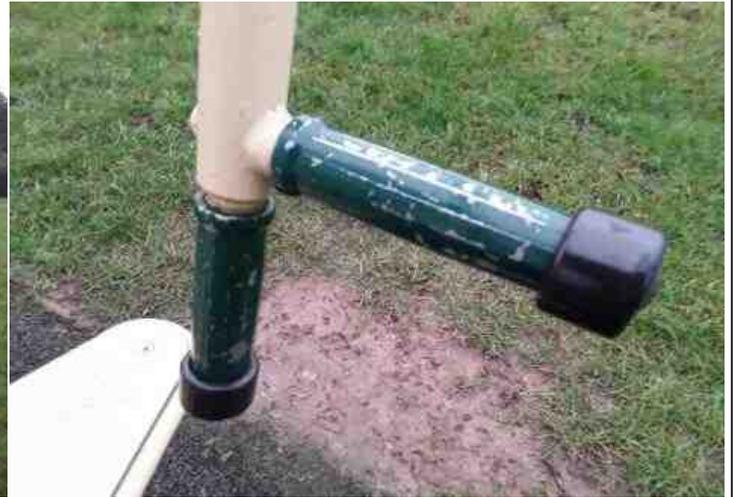
Item: Outdoor Fitness Equipment - Double Fitness Station
Manufacturer: Wicksteed Playgrounds

Finding: The paint is flaking off the metalwork

Action: Rub down and re-paint

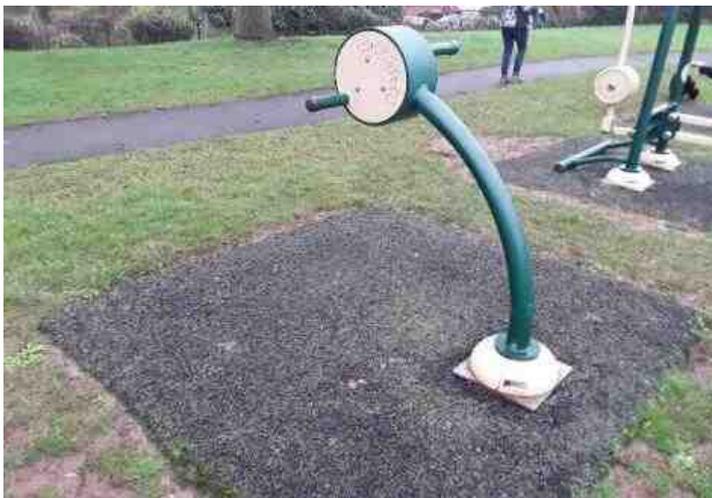
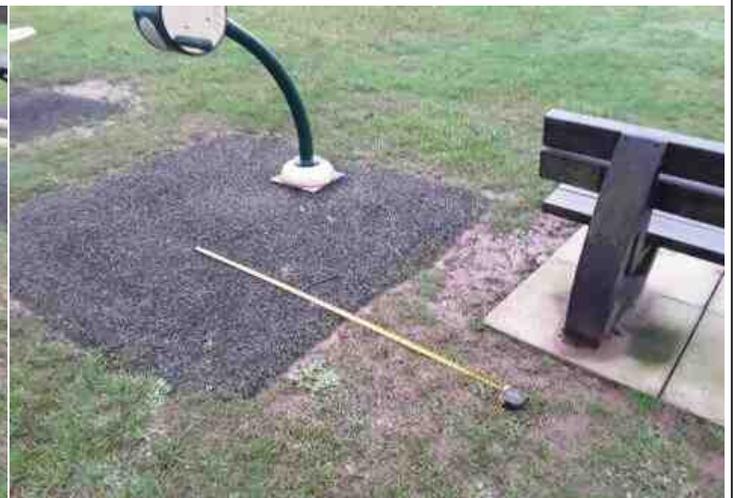
Item: Outdoor Fitness Equipment - Hand Bike
Manufacturer: Wicksteed Playgrounds

Finding: There are obstacles located within the movement space of the item in contravention of the requirements of BS EN 16630

Action: Monitor - No action given the risk assessment

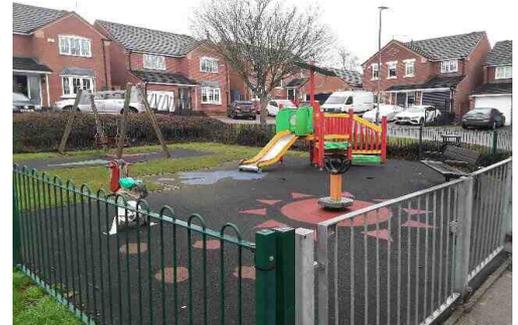
Item: Site General
Manufacturer: Owner/Operator
Surface Type: N/A
Item Quantity: 1
Equipment Compliance: N/A
Surface Area Compliance: N/A

There are gaps opening between the surfacing and the edging surround or between the joints in the surfacing - Monitor for any further deterioration and repair as required

There is algae, silt or moss growth on the surface resulting in slippery conditions - Clean and treat appropriately

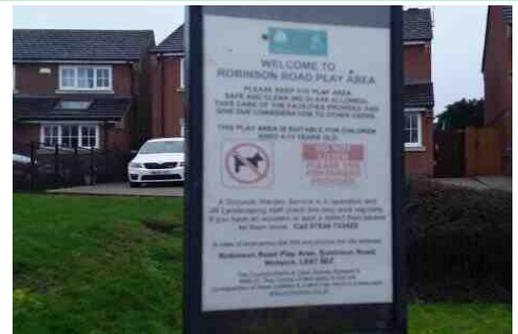
Item: Sign
Manufacturer: Not Identified
Surface Type: Grass
Item Quantity: 1
Equipment Compliance: N/A
Surface Area Compliance: N/A

The paintwork on this item has been damaged or worn exposing the metal underneath which is rusting / corroding - Treat affected areas and repaint

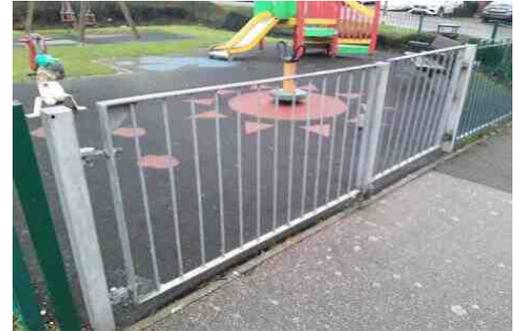
Item: Gate - Combination
Manufacturer: Not Identified
Surface Type: Wet Pour
Item Quantity: 1
Equipment Compliance: N/A
Surface Area Compliance: N/A

The weld(s) on this item have failed - Repair item

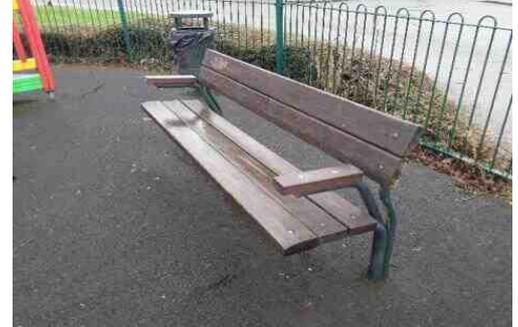
Item: Bench
Manufacturer: Not Identified
Surface Type: Wet Pour
Item Quantity: 1
Equipment Compliance: N/A
Surface Area Compliance: N/A

There is minor damage to the surface - Monitor for any further deterioration and repair as required

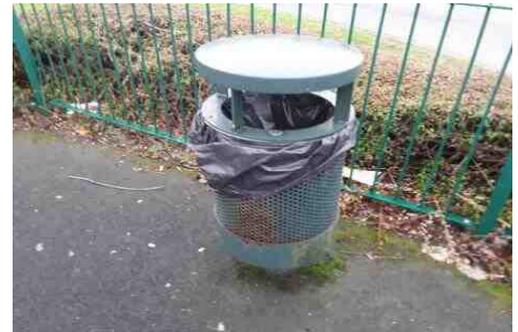
Item: Litter Bin
Manufacturer: Not Identified
Surface Type: Wet Pour
Item Quantity: 1
Equipment Compliance: N/A
Surface Area Compliance: N/A

The paintwork on this item has been damaged or worn exposing the metal underneath which is rusting / corroding - Treat affected areas and repaint

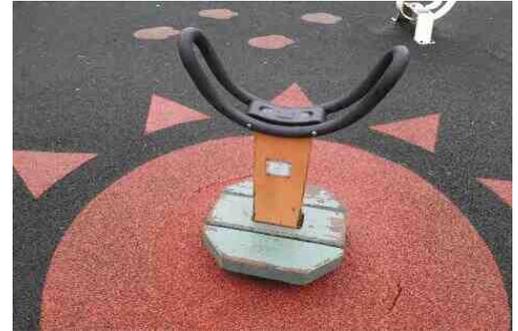
Item: Low Rotator
Manufacturer: Lappset UK Ltd
Surface Type: Wet Pour
Item Quantity: 1
Equipment Compliance: No
Surface Area Compliance: Yes
Life Expectancy: 3 - 5 Years
Total Findings: 3

The gate opens into the falling space of the equipment and users entering the play area have to cross through the falling space to access other equipment - Monitor, review the risk assessment regularly and modify the gate if required

The bearing is showing signs of wear - Monitor for any further deterioration and replace as required

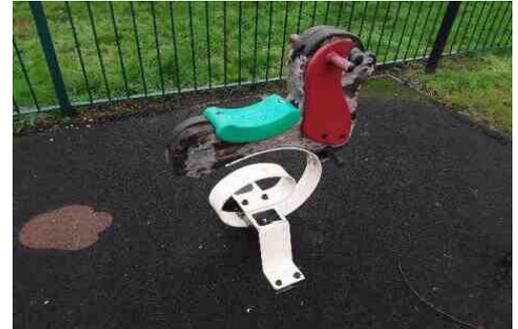
Item: Spring Rabbit
Manufacturer: Lappset UK Ltd
Surface Type: Wet Pour
Item Quantity: 1
Equipment Compliance: No
Surface Area Compliance: Yes
Life Expectancy: 1 - 3 Years
Total Findings: 6

The exposed anchoring under the item is more than 1.3 times the width of the seat, in contravention of the requirements of BS EN 1176 Part 6 - Monitor - No action given the risk assessment

There is/are bolt cap covers missing or damaged on the item - Replace missing or damaged bolt cap covers

There are parts of the timber that have rotted - Replace all affected timbers

The end of handgrips and/or footrests have a cross section of less than 15cm² and fail to meet the requirements of BS EN 1176 Part 6 - Monitor - No action given the risk assessment

The surfacing is damaged - Repair damaged areas of surfacing

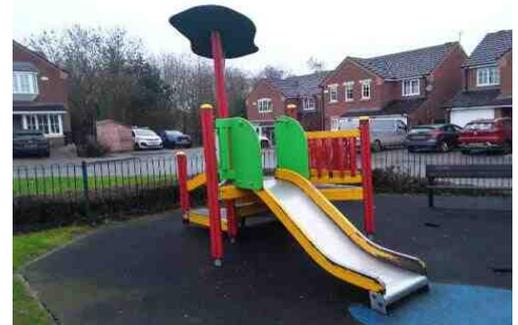
Item: Multi Play (Toddler)
Manufacturer: Lappset UK Ltd
Surface Type: Wet Pour
Item Quantity: 1
Equipment Compliance: No
Surface Area Compliance: No
Life Expectancy: 5 -10 Years
Total Findings: 12

The surfacing is damaged creating trip hazards - Repair damaged areas of surfacing

There is/are finger entrapment/s in the redundant bolt holes in the posts and the item fails to meet the requirements of BS EN 1176 Part 1 4.2.7.6 Entrapment of fingers - Provide inserts

There are parts of the timber barriers that have rotted - Replace all affected timbers

The side of the slide is damaged - Monitor for any further deterioration and repair as required

There are a number of dents in the slide surface - Monitor for any further deterioration and repair as required

The item fails to meet the requirements of BS EN 1176 Part 1 4.2.7.2 head and neck entrapment in the barriers and/or steps - Monitor - No action given the risk assessment

There is/are bolt cap covers missing or damaged on the item - Replace missing or damaged bolt cap covers

The paintwork on this item has been damaged or worn exposing the metal underneath which is rusting / corroding - Treat affected areas and repaint

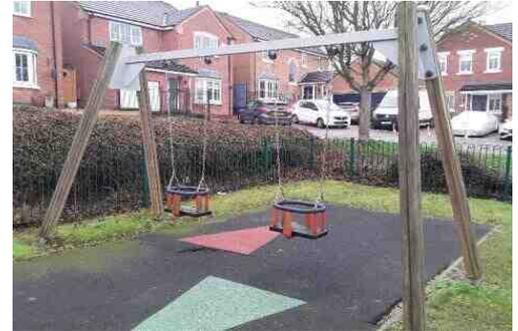
Item: 1 Bay 2 Seat (Cradle)
Manufacturer: Lappset UK Ltd
Surface Type: Wet Pour
Item Quantity: 1
Equipment Compliance: Yes
Surface Area Compliance: Yes
Life Expectancy: 5 -10 Years
Total Findings: 2

The surfacing is severely damaged - Repair damaged areas of surfacing

There are significant gaps (over 30mm) between the surface and the edging or between the joints in the surface; these are large enough for a small foot to enter - Repair surfacing

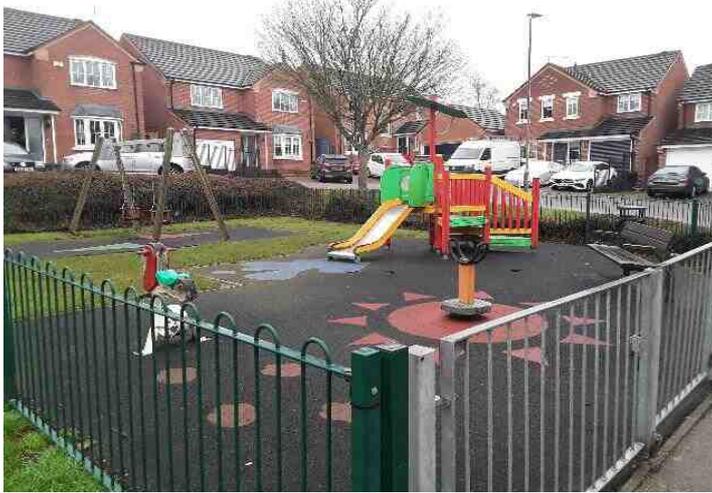
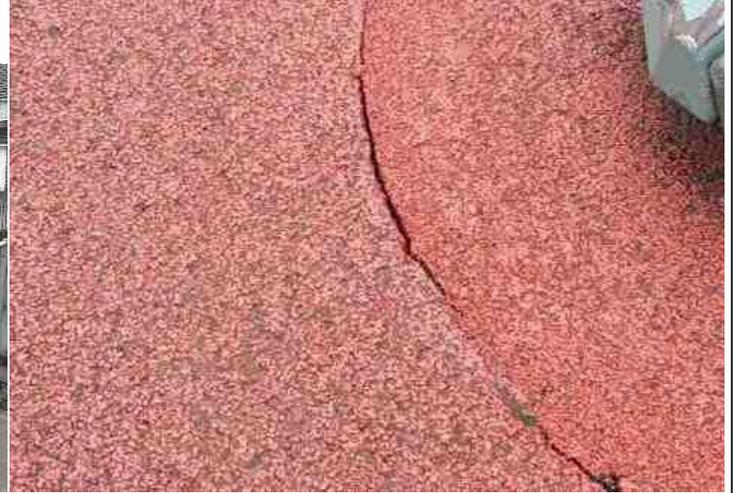
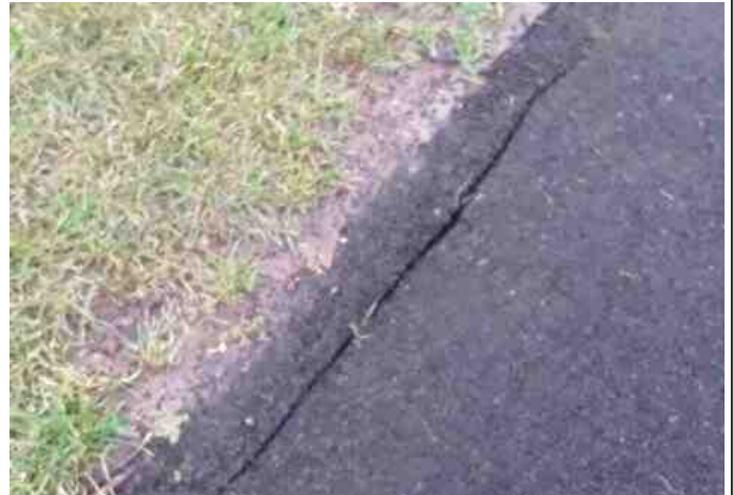
Item: Ancillary Items - Site General
Manufacturer: Owner/Operator

Finding: There are gaps opening between the surfacing and the edging surround or between the joints in the surfacing
Action: Monitor for any further deterioration and repair as required

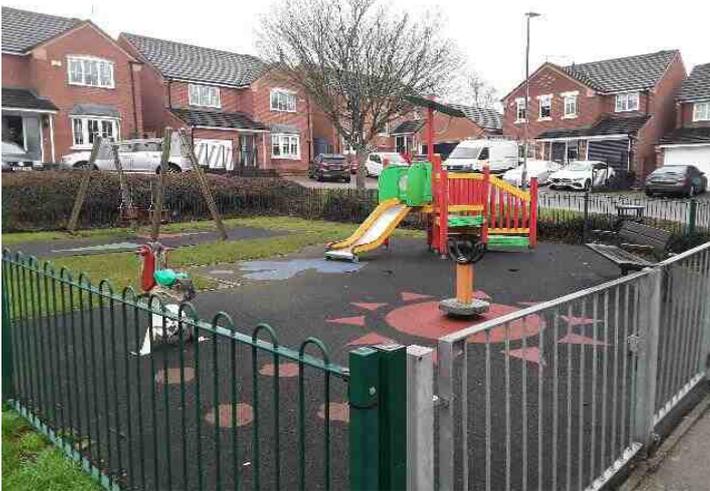
Item: Ancillary Items - Site General
Manufacturer: Owner/Operator

Finding: There is algae, silt or moss growth on the surface resulting in slippery conditions
Action: Clean and treat appropriately

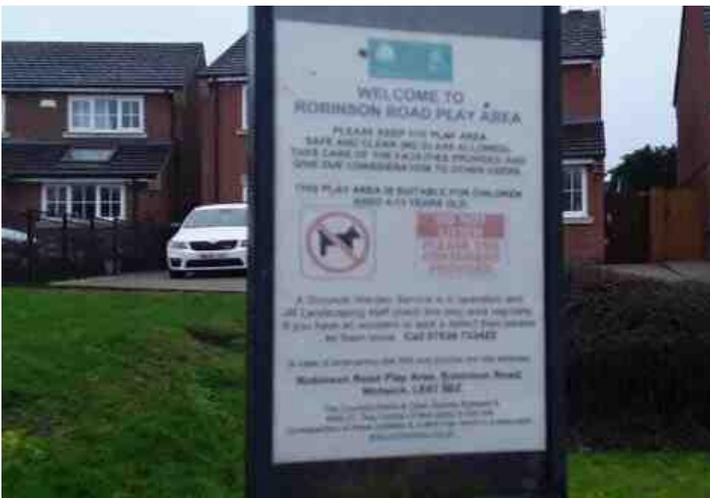
Item: Ancillary Items - Sign
Manufacturer: Not Identified

Finding: The paintwork on this item has been damaged or worn exposing the metal underneath which is rusting / corroding
Action: Treat affected areas and repaint

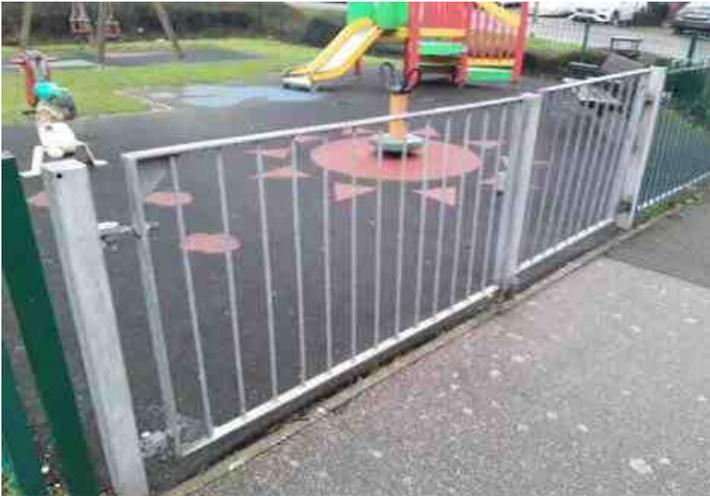
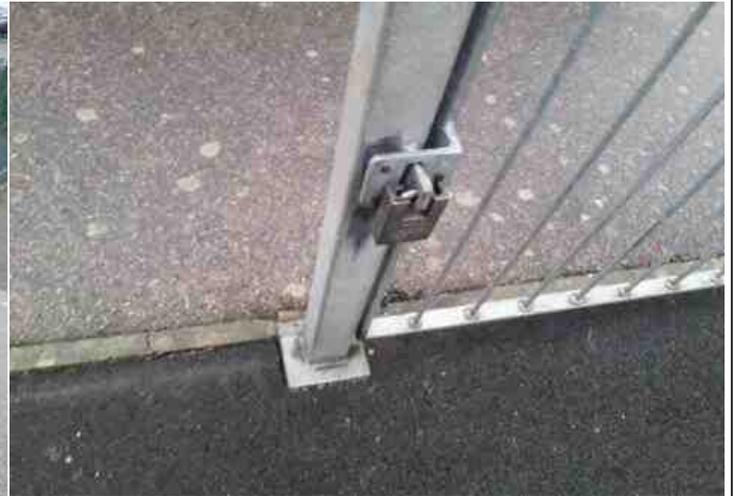
Item: Gates - Gate - Combination
Manufacturer: Not Identified

Finding: The maintenance gate was correctly padlocked at the time of inspection, however this means that the inspector was unable to fully assess the gate

Action: Ensure that there are 12mm gaps throughout the full range of motion on gate/s and between leaves where relevant

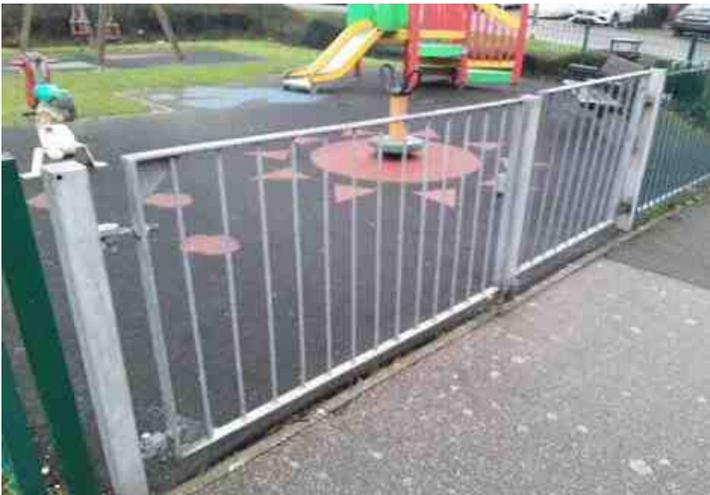
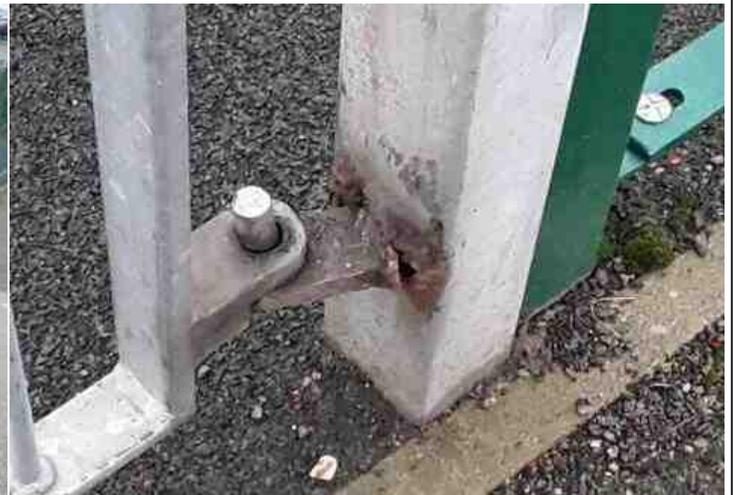
Item: Gates - Gate - Combination
Manufacturer: Not Identified

Finding: The weld(s) on this item have failed

Action: Repair item
