NOTICE OF PROPERTY MANAGEMENT AND GENERAL PURPOSES COMMITTEE MEETING

Thursday 5th March 2026 7pm

AGENDA

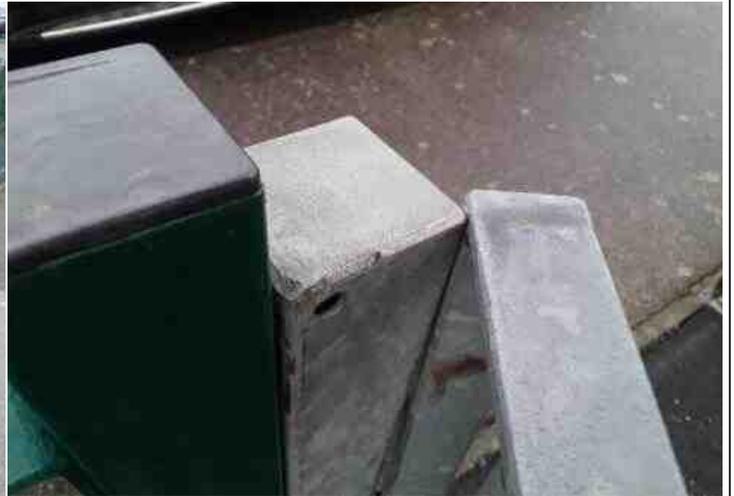
Item: Gates - Gate - Combination
Manufacturer: Not Identified

Finding: There are openings that are less than 12mm that could trap or crush fingers

Action: Provide a 12mm gap throughout full range of motion at both sides of gate

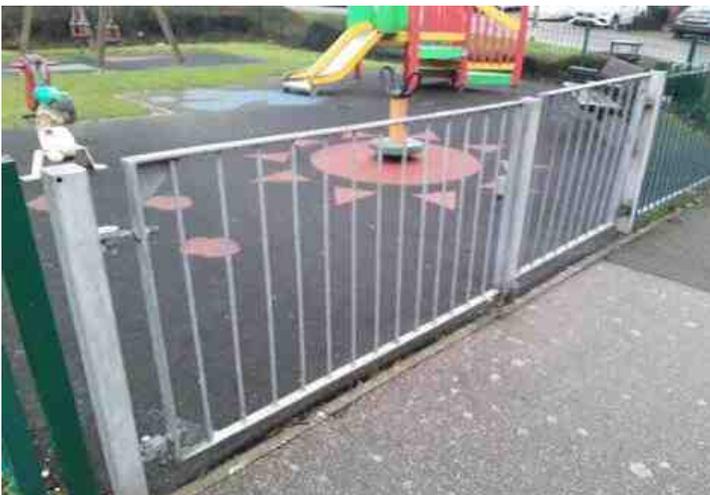
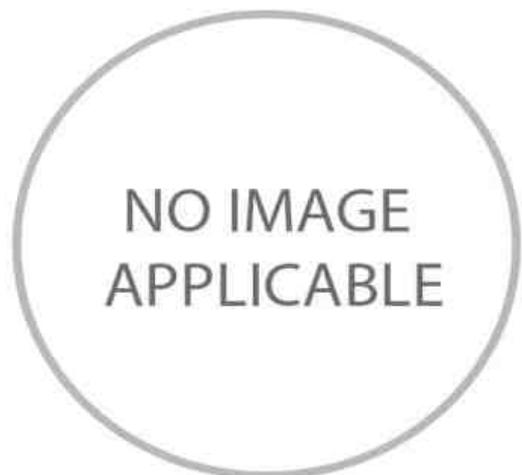
Item: Gates - Gate - Combination
Manufacturer: Not Identified

Finding: The gate is closing too quickly (less than 4 seconds)

Action: Take corrective action to ensure that the gate closes in 4-8 seconds from 90 degrees

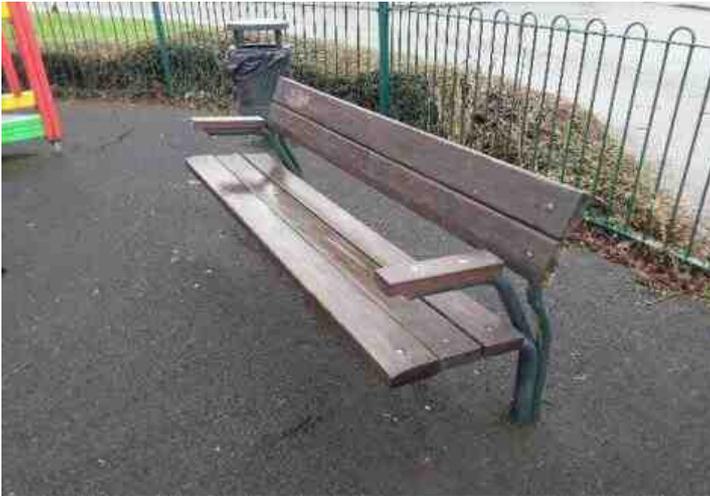
Item: Ancillary Items - Bench
Manufacturer: Not Identified

Finding: There is minor damage to the surface

Action: Monitor for any further deterioration and repair as required

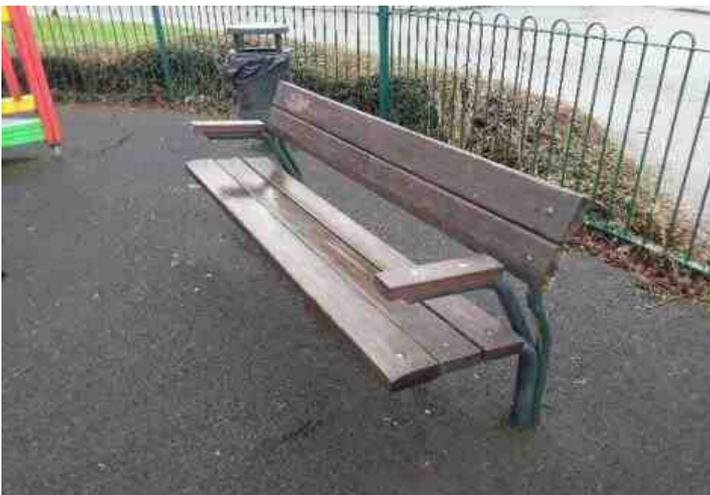
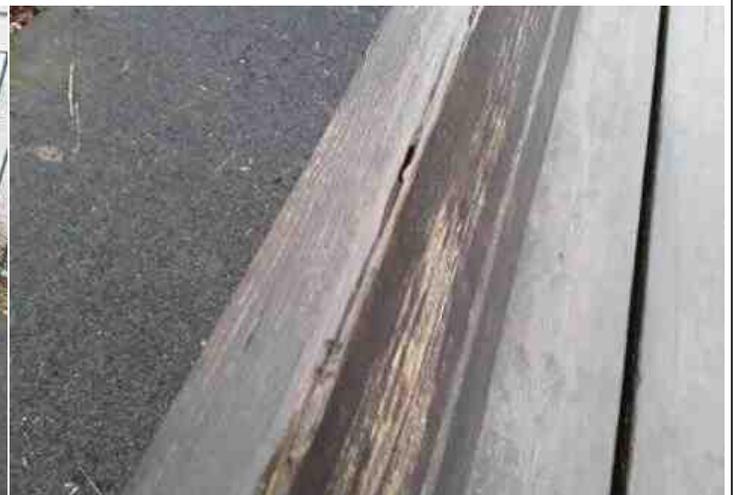
Item: Ancillary Items - Bench
Manufacturer: Not Identified

Finding: Parts of the timber are rough or splintered

Action: Remove all rough or sharp edges

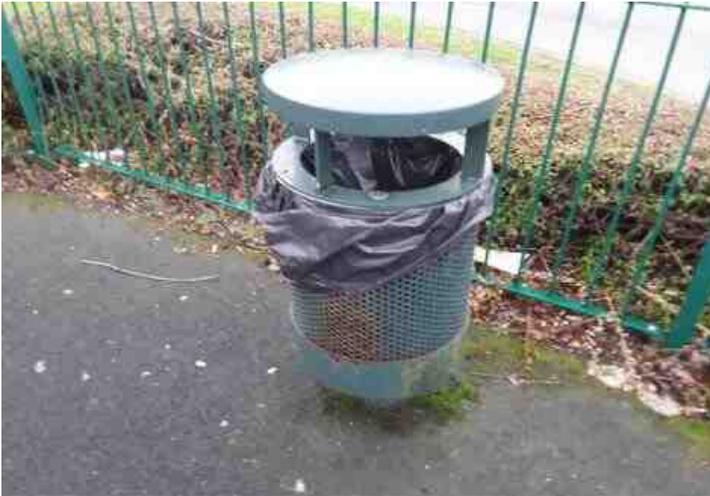
Item: Ancillary Items - Litter Bin
Manufacturer: Not Identified

Finding: The paintwork on this item has been damaged or worn exposing the metal underneath which is rusting / corroding

Action: Treat affected areas and repaint

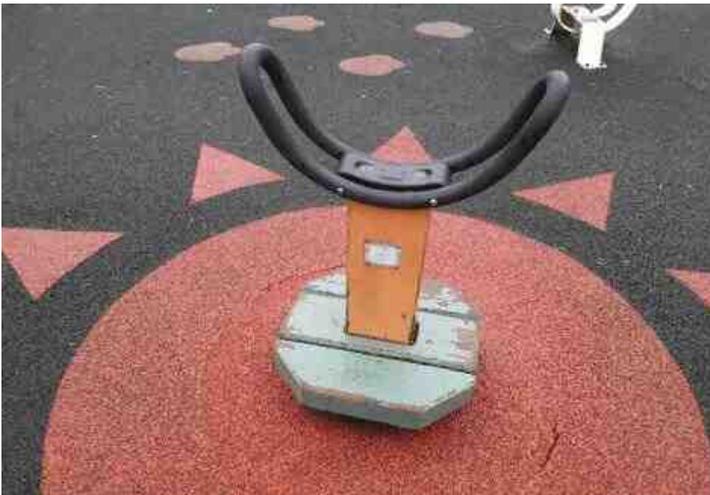
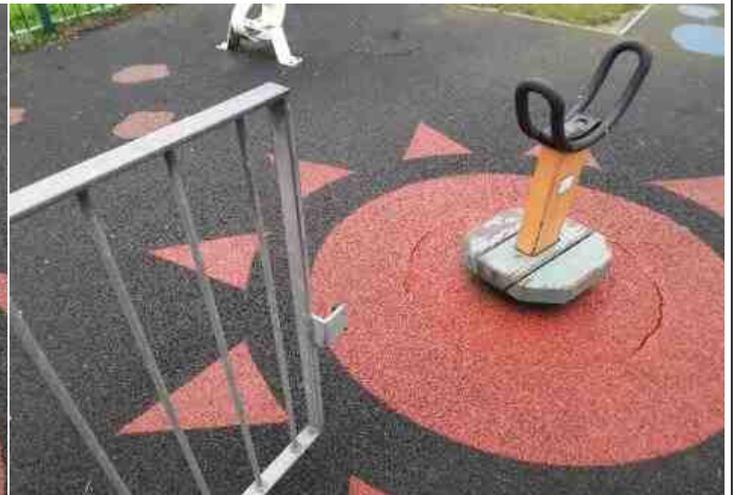
Item: Rotor Play - Low Rotator
Manufacturer: Lappset UK Ltd

Finding: The gate opens into the falling space of the equipment and users entering the play area have to cross through the falling space to access other equipment

Action: Monitor, review the risk assessment regularly and modify the gate if required

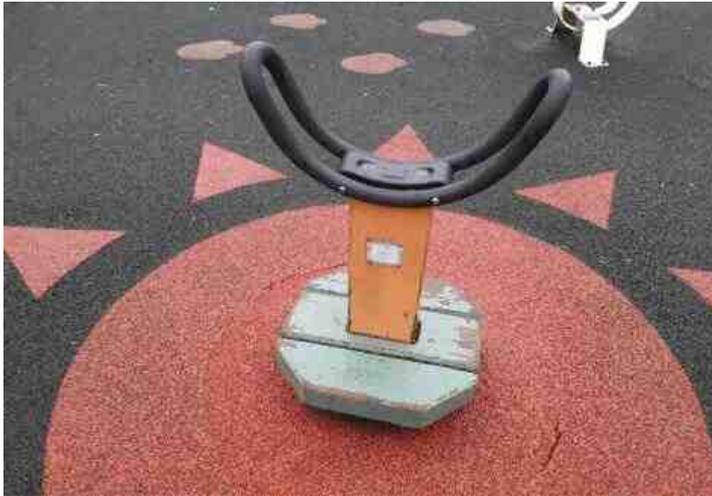
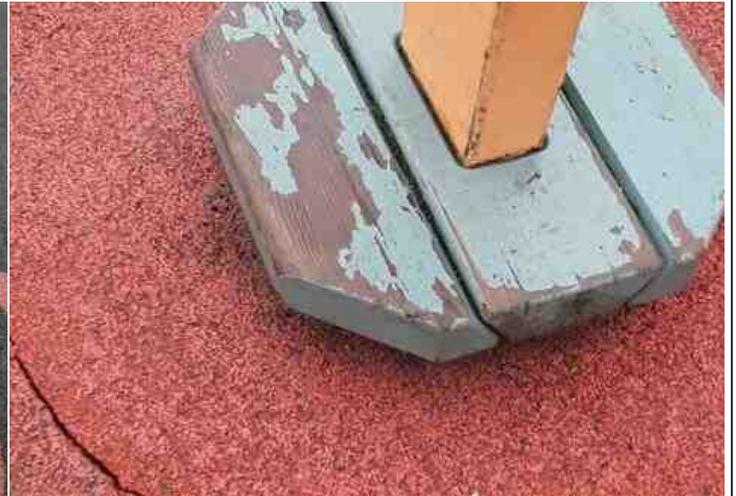
Item: Rotor Play - Low Rotator
Manufacturer: Lappset UK Ltd

Finding: Parts of the timber are rough or splintered

Action: Remove all rough or sharp edges

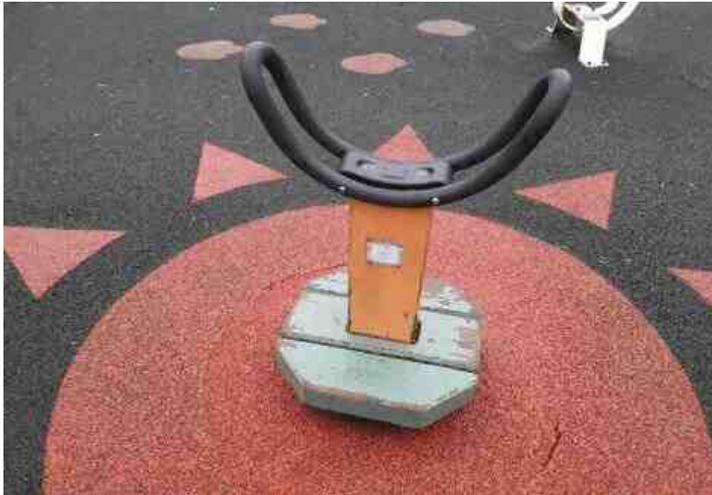
Item: Rotor Play - Low Rotator
Manufacturer: Lappset UK Ltd

Finding: The bearing is showing signs of wear

Action: Monitor for any further deterioration and replace as required

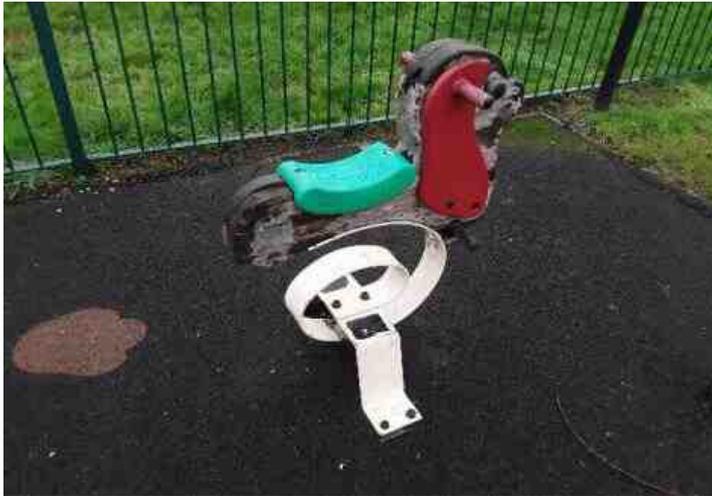
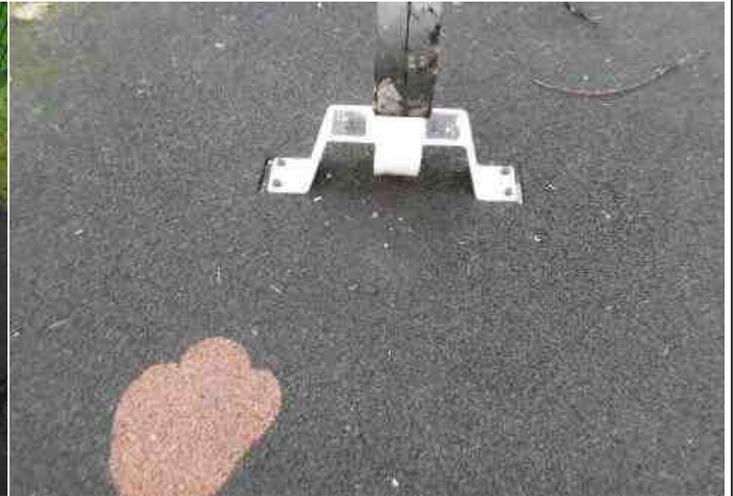
Item: Rocking Equipment - Spring Rabbit
Manufacturer: Lappset UK Ltd

Finding: The exposed anchoring under the item is more than 1.3 times the width of the seat, in contravention of the requirements of BS EN 1176 Part 6

Action: Monitor - No action given the risk assessment

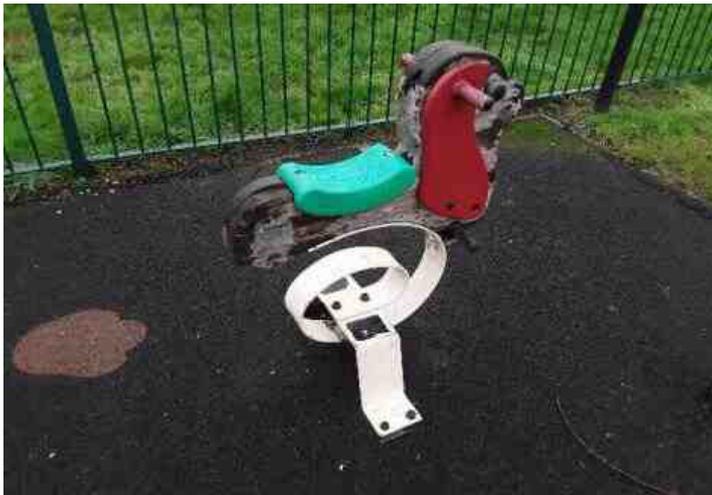
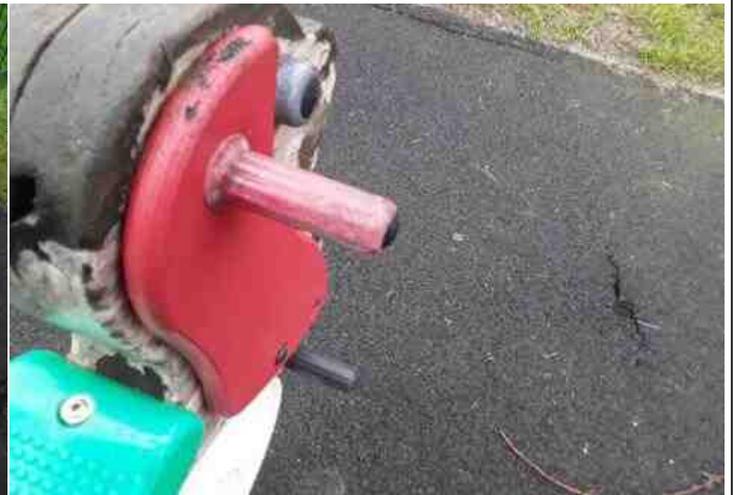
Item: Rocking Equipment - Spring Rabbit
Manufacturer: Lappset UK Ltd

Finding: The end of handgrips and/or footrests have a cross section of less than 15cm² and fail to meet the requirements of BS EN 1176 Part 6

Action: Monitor - No action given the risk assessment

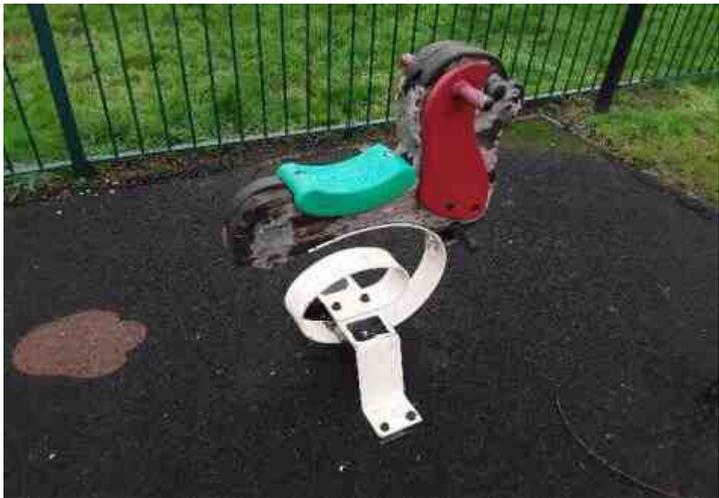
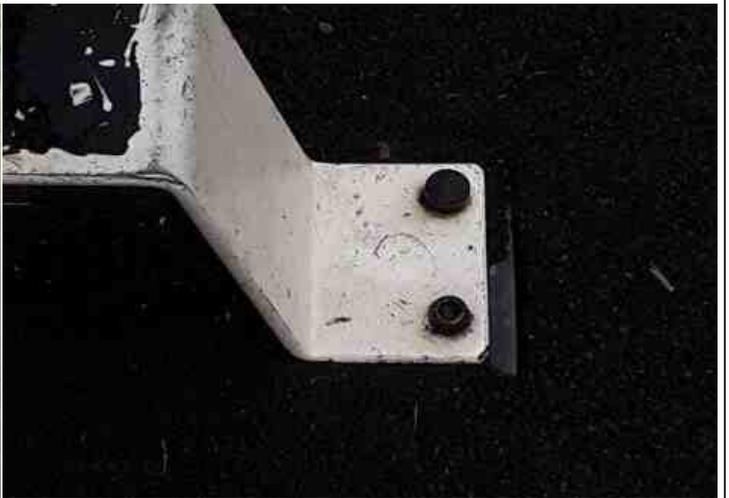
Item: Rocking Equipment - Spring Rabbit
Manufacturer: Lappset UK Ltd
Risk Level: V - Very Low Risk
Surface: Wet Pour

Finding: There is/are bolt cap covers missing or damaged on the item
Action: Replace missing or damaged bolt cap covers

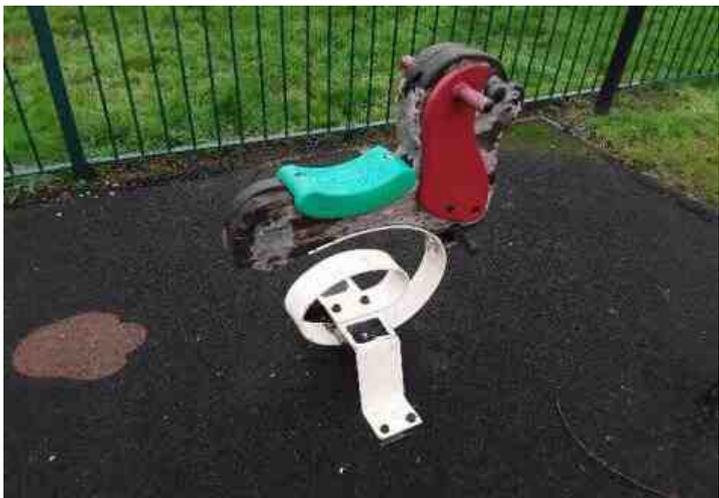
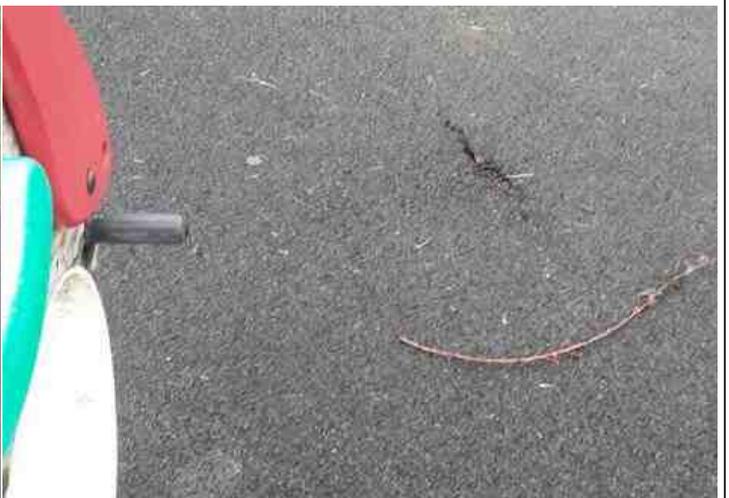
Item: Rocking Equipment - Spring Rabbit
Manufacturer: Lappset UK Ltd
Risk Level: L - Low Risk
Surface: Wet Pour

Finding: The surfacing is damaged
Action: Repair damaged areas of surfacing

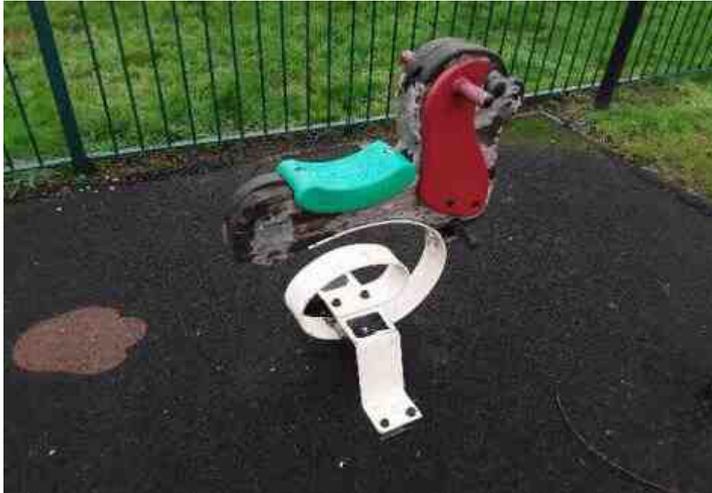
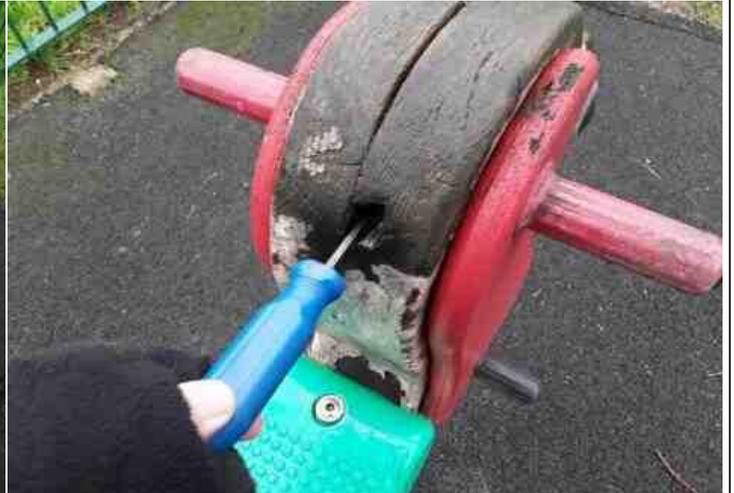
Item: Rocking Equipment - Spring Rabbit
Manufacturer: Lappset UK Ltd

Finding: There are parts of the timber that have rotted

Action: Replace all affected timbers

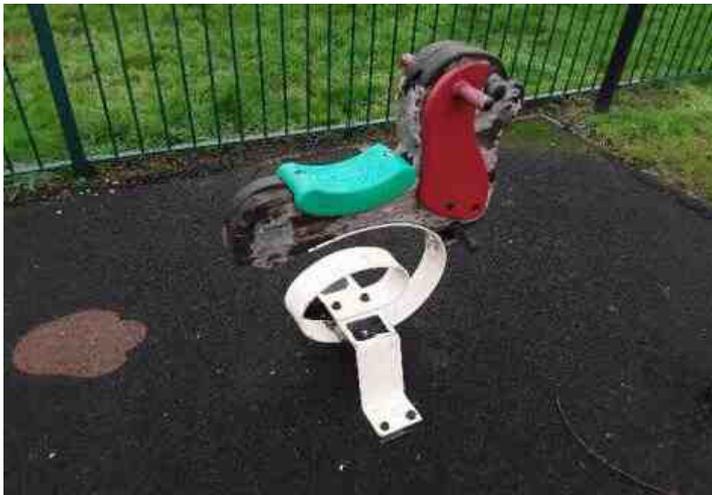
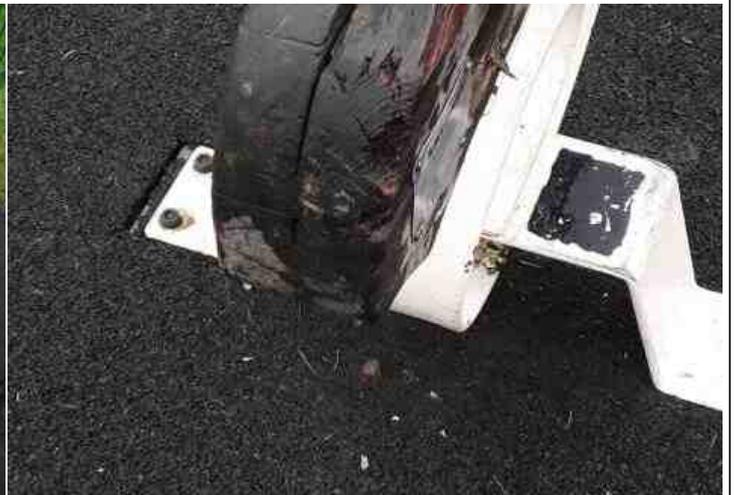
Item: Rocking Equipment - Spring Rabbit
Manufacturer: Lappset UK Ltd

Finding: Parts of the timber are rough or splintered

Action: Remove all rough or sharp edges

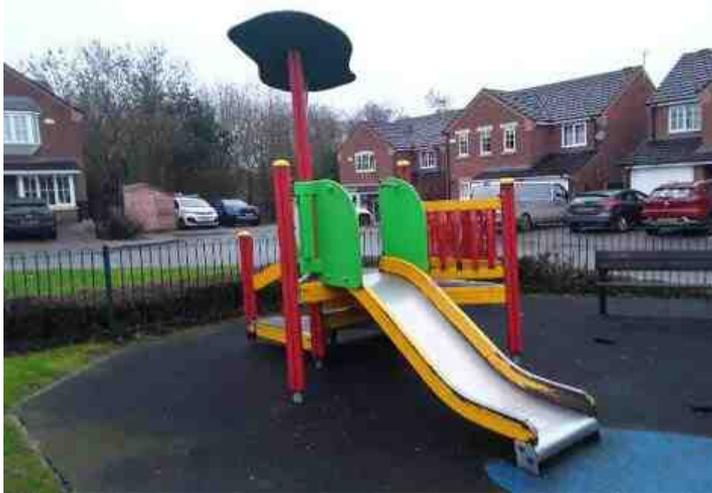
Item: Activity Equipment - Multi Play (Toddler)
Manufacturer: Lappset UK Ltd

Finding: The surfacing is damaged creating trip hazards

Action: Repair damaged areas of surfacing

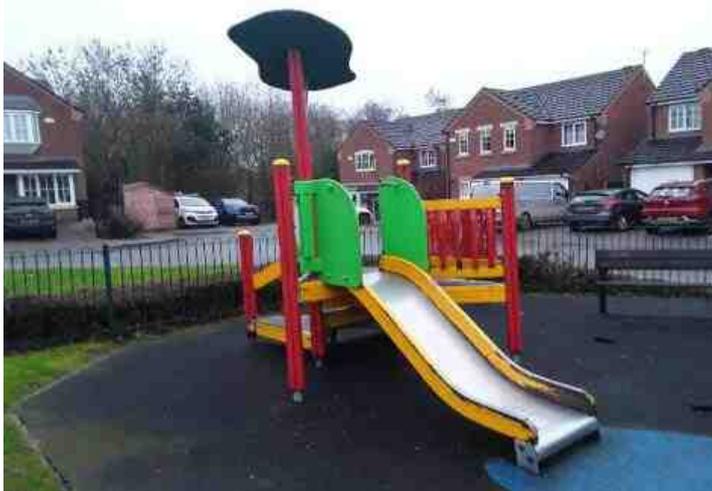
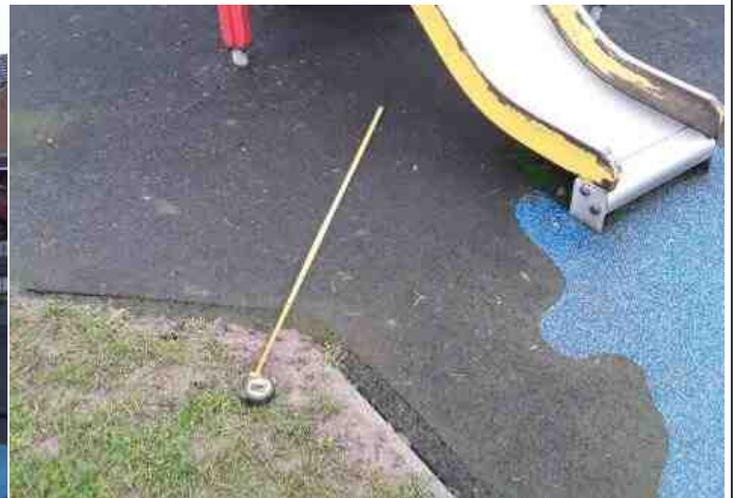
Item: Activity Equipment - Multi Play (Toddler)
Manufacturer: Lappset UK Ltd

Finding: The surfacing dimensions are short and do not meet with the requirements of the current applicable standard

Action: Monitor - No action given the risk assessment

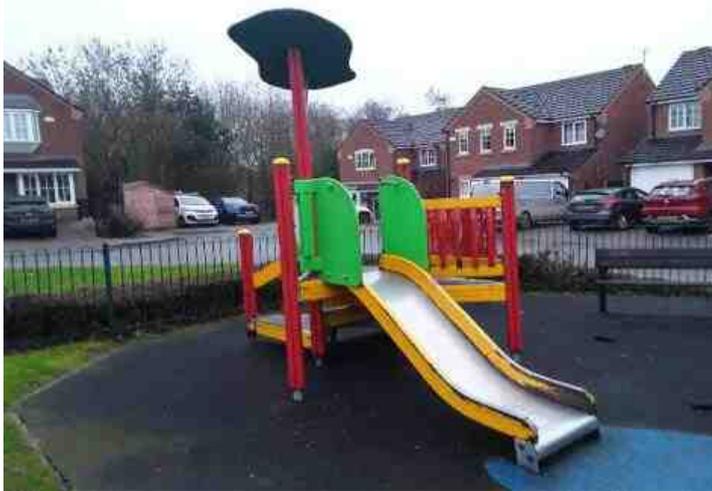
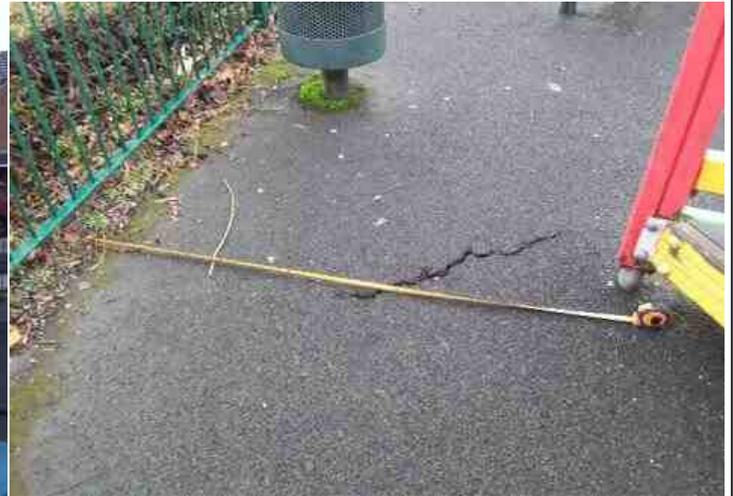
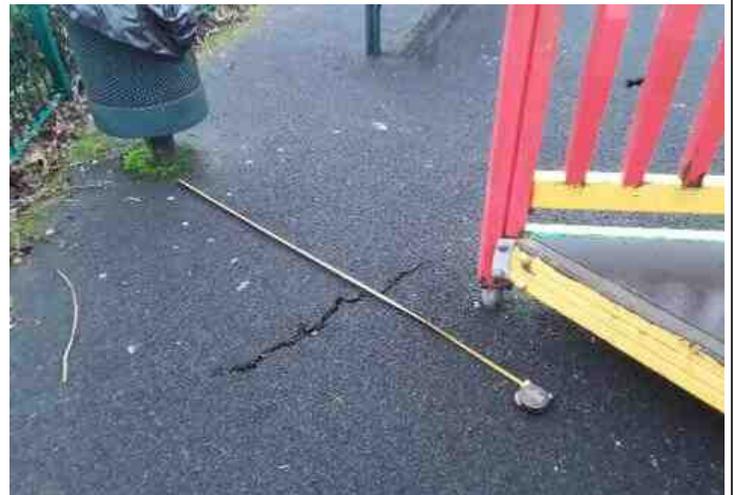
Item: Activity Equipment - Multi Play (Toddler)
Manufacturer: Lappset UK Ltd

Finding: The adjacent fence and litter bin form projecting obstacles / hard objects within the falling space of the equipment, in contravention of the requirements of BS EN 1176 Part 1

Action: Monitor - No action given the risk assessment

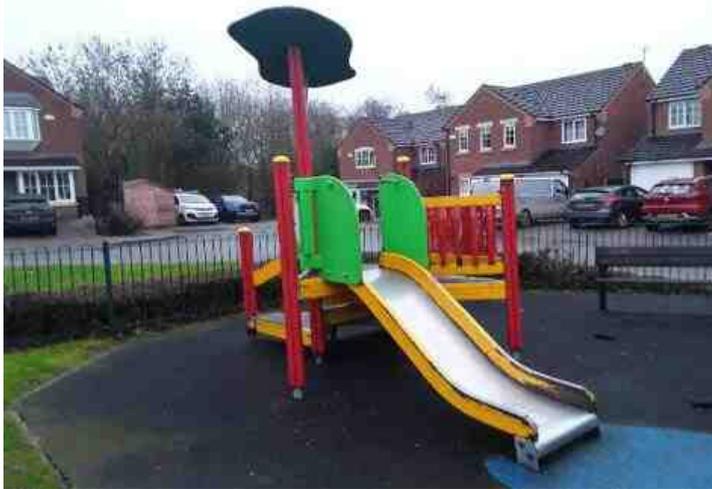
Item: Activity Equipment - Multi Play (Toddler)
Manufacturer: Lappset UK Ltd

Finding: There is/are finger entrapment/s in the redundant bolt holes in the posts and the item fails to meet the requirements of BS EN 1176 Part 1 4.2.7.6 Entrapment of fingers

Action: Provide inserts

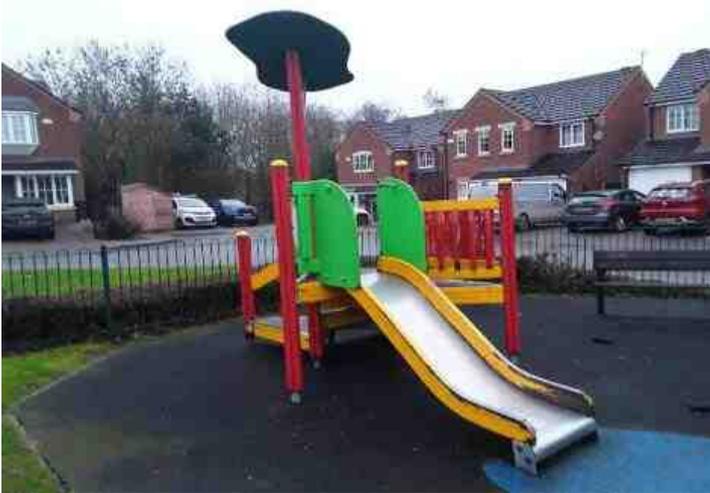
Item: Activity Equipment - Multi Play (Toddler)
Manufacturer: Lappset UK Ltd

Finding: The side of the slide is damaged

Action: Monitor for any further deterioration and repair as required

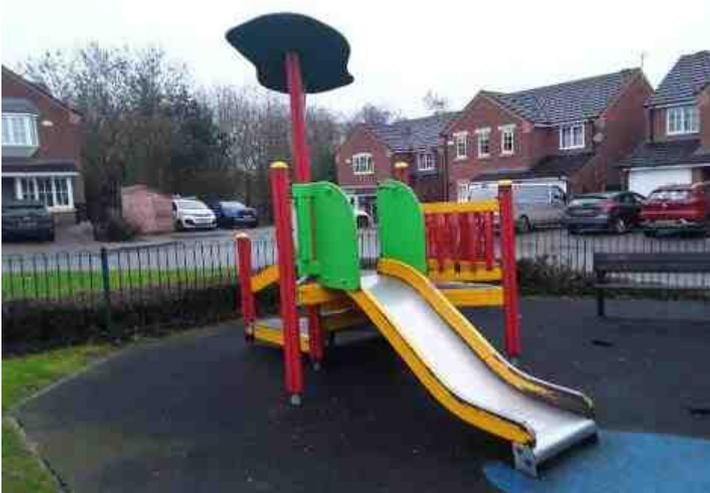
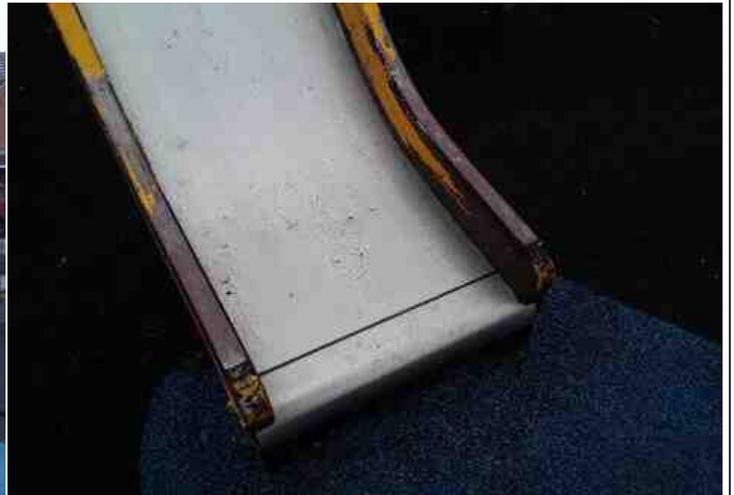
Item: Activity Equipment - Multi Play (Toddler)
Manufacturer: Lappset UK Ltd

Finding: There are a number of dents in the slide surface

Action: Monitor for any further deterioration and repair as required

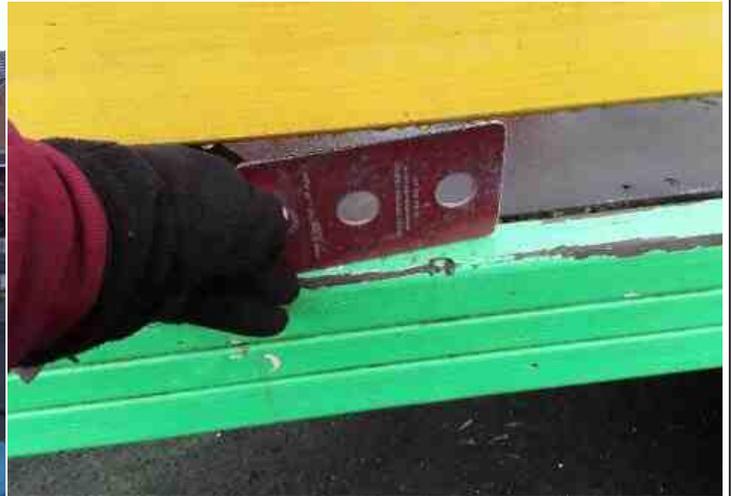
Item: Activity Equipment - Multi Play (Toddler)
Manufacturer: Lappset UK Ltd

Finding: The item fails to meet the requirements of BS EN 1176 Part 1 4.2.7.2 head and neck entrapment in the barriers and/or steps

Action: Monitor - No action given the risk assessment

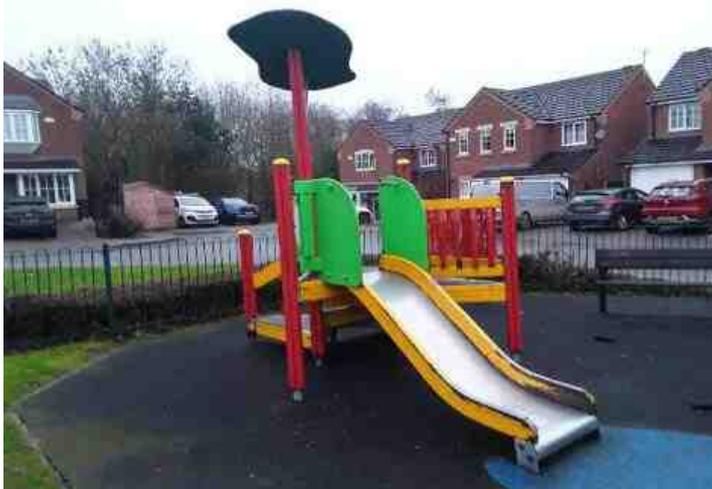
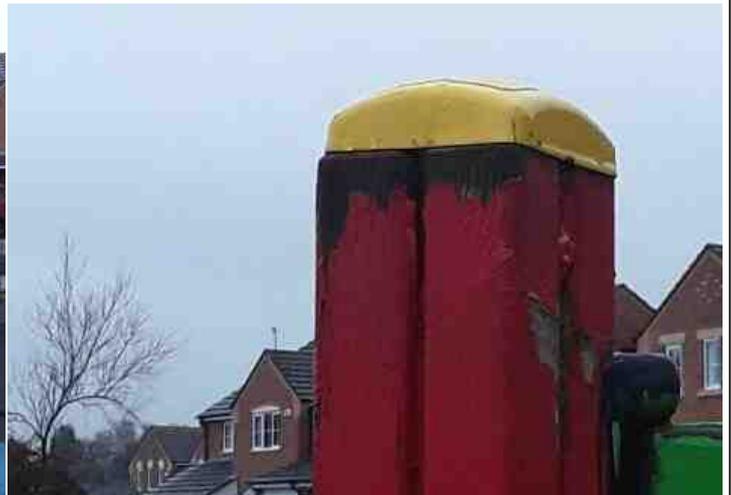
Item: Activity Equipment - Multi Play (Toddler)
Manufacturer: Lappset UK Ltd

Finding: The paint is flaking off the wood work

Action: Rub down and re-paint

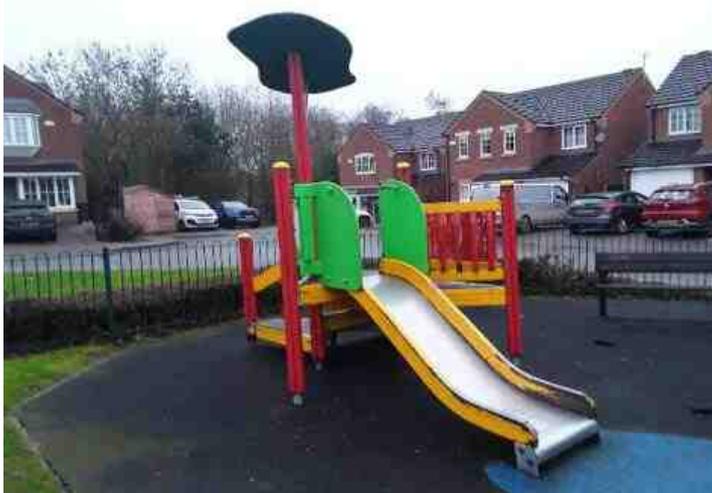
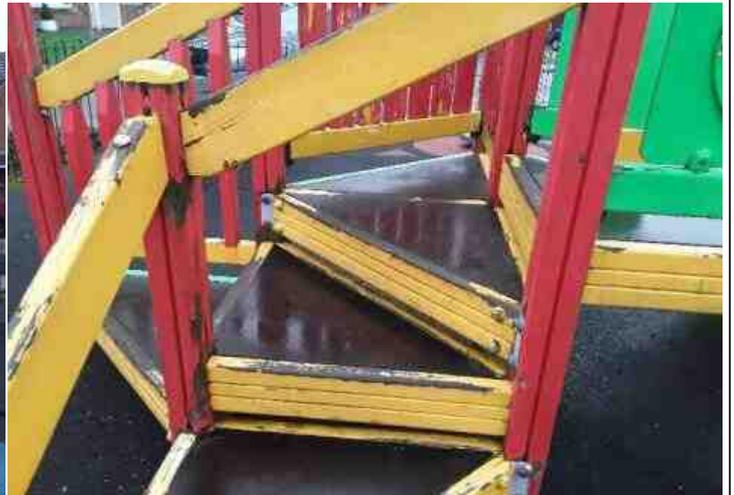
Item: Activity Equipment - Multi Play (Toddler)
Manufacturer: Lappset UK Ltd

Finding: The unit is easily accessible and should have the appropriate barriers installed to meet the requirements of BS EN 1176 Part 1 as the height of the unit exceeds 600mm

Action: Monitor - No action given the risk assessment

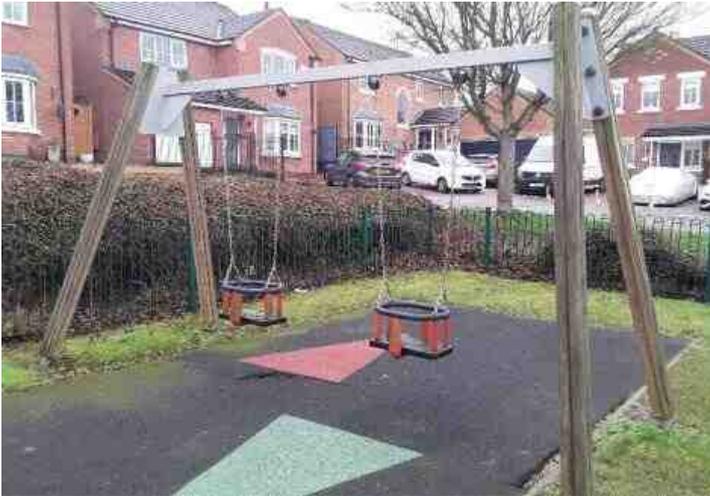
Item: Swings - 1 Bay 2 Seat (Cradle)
Manufacturer: Lappset UK Ltd

Finding: The surfacing is severely damaged

Action: Repair damaged areas of surfacing

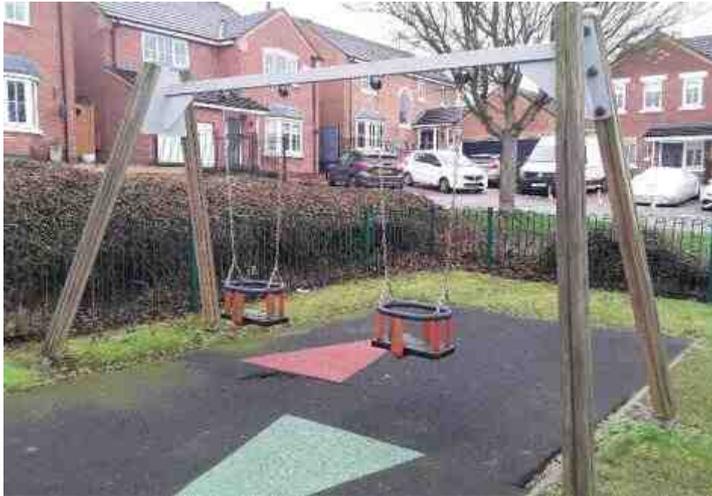
Item: Swings - 1 Bay 2 Seat (Cradle)
Manufacturer: Lappset UK Ltd

Finding: There are significant gaps (over 30mm) between the surface and the edging or between the joints in the surface; these are large enough for a small foot to enter

Action: Repair surfacing

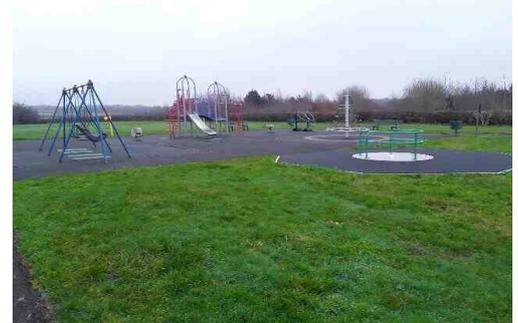
Item: Site General
Manufacturer: Owner/Operator
Surface Type: N/A
Item Quantity: 1
Equipment Compliance: N/A
Surface Area Compliance: N/A

There are trip hazards at the edges of the surface - Remove trip hazard

There are significant gaps (over 30mm) between the surface and the edging or between the joints in the surface; these are large enough for a small foot to enter - Repair surfacing

The surface is lifting at the edges and creating trip points - Repair perimeter of surfacing to remove trip points

There are minor stress fractures in the tarmac surface - Monitor and repair if required

There is algae, silt or moss growth on the bitmac surface resulting in slippery conditions - Clean and treat appropriately

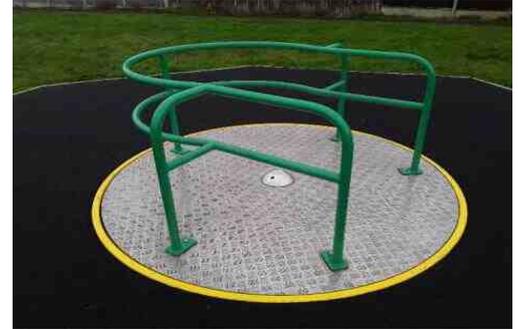
Item:	Inclusive Roundabout
Manufacturer:	Not Identified
Surface Type:	Wet Pour
Item Quantity:	1
Equipment Compliance:	No
Surface Area Compliance:	Yes
Life Expectancy:	>10 Years
Total Findings:	1

The opening to the side of the platform is in excess of 8mm and fails the requirements of BS EN 1176 Part 5 - Adjust / Refer to manufacturer

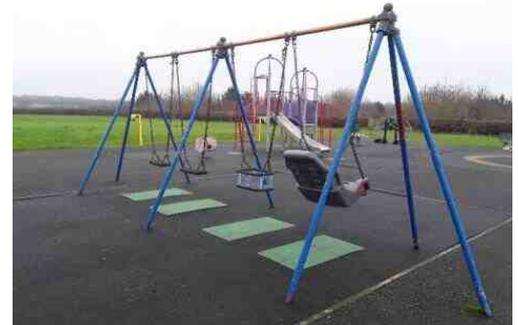
Item: 2 Bay 4 Seat Swing
Manufacturer: Wicksteed Playgrounds
Surface Type: Wet Pour
Item Quantity: 1
Equipment Compliance: No
Surface Area Compliance: No
Life Expectancy: 5 -10 Years
Total Findings: 9

The paintwork on this item has been damaged or worn exposing the metal underneath which is rusting / corroding - Treat affected areas and repaint

The surfacing width under the seat/s is / are less than 875mm when measured from the centre of the seat outwards, and fail the requirements of BS EN 1176 Part 2 - Monitor - No action given the risk assessment

The surfacing is severely damaged - Repair damaged areas of surfacing

The bush / bushes is / are worn or missing - Replace worn or missing bushes

The chain openings are in excess of the 8.6mm as recommended by BS EN 1176 - Monitor - No action given the risk assessment

There is some notable evidence of chain wear - Monitor for any further deterioration and replace when 40% worn

The seat is damaged and requires replacing - Replace damaged seat

The swing seat frames are corroding - Monitor for any further deterioration and replace as required

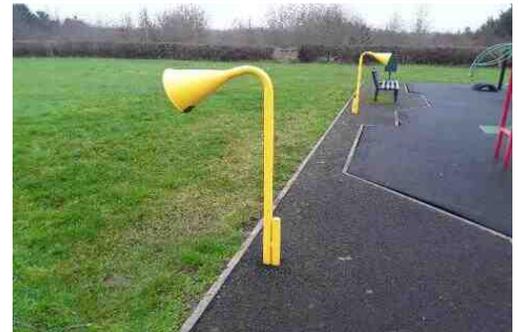
Item: Talk Tubes
Manufacturer: Tayplay Ltd
Surface Type: Bitmac
Item Quantity: 1
Equipment Compliance: Yes
Surface Area Compliance: N/A
Life Expectancy: 5 -10 Years
Total Findings: 1

The paintwork on this item has been damaged or worn exposing the metal underneath which is rusting / corroding - Treat affected areas and repaint

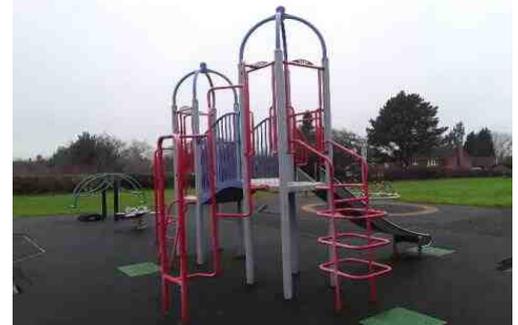
Item: Multi Play (Junior)
Manufacturer: Hags
Surface Type: Wet Pour
Item Quantity: 1
Equipment Compliance: No
Surface Area Compliance: Yes
Life Expectancy: >10 Years
Total Findings: 6

The paintwork on this item has been damaged or worn exposing the metal underneath which is rusting / corroding - Treat affected areas and repaint

There are a number of dents in the slide surface - Monitor for any further deterioration and repair as required

The fixings have corroded - Replace all corroded fixings

The surfacing is damaged - Repair damaged areas of surfacing

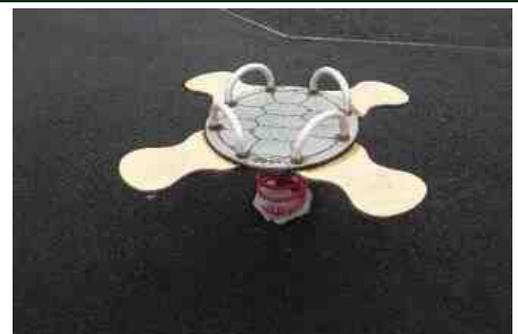
Item: Four Way Springer
Manufacturer: Hags
Surface Type: Wet Pour
Item Quantity: 1
Equipment Compliance: Yes
Surface Area Compliance: Yes
Life Expectancy: 5 -10 Years
Total Findings: 1

This item is satisfactory - no work required -

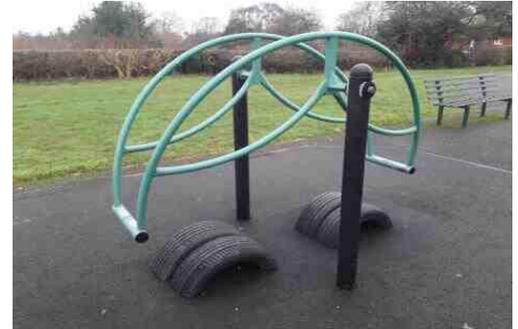
Item: Stand up SeeSaw
Manufacturer: Hags
Surface Type: Wet Pour
Item Quantity: 1
Equipment Compliance: Yes
Surface Area Compliance: Yes
Life Expectancy: 3 - 5 Years
Total Findings: 3

The paintwork on this item has been damaged or worn exposing the metal underneath which is rusting / corroding - Treat affected areas and repaint

The tyre buffers are showing signs of wear - Monitor and replace if required

The foot treads have been removed - Replace the missing components

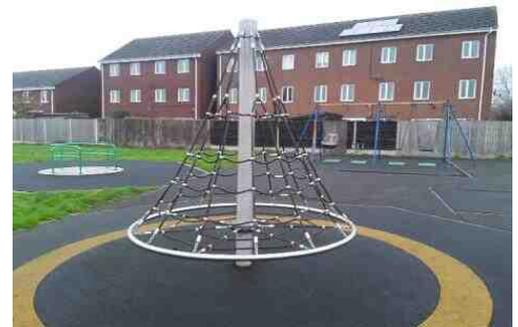
Item: Cone Climber
Manufacturer: Tayplay Ltd
Surface Type: Wet Pour
Item Quantity: 1
Equipment Compliance: Yes
Surface Area Compliance: Yes
Life Expectancy: 3 - 5 Years
Total Findings: 1

The ropes/nets are worn/damaged in places - Monitor for any further deterioration and repair or replace as required

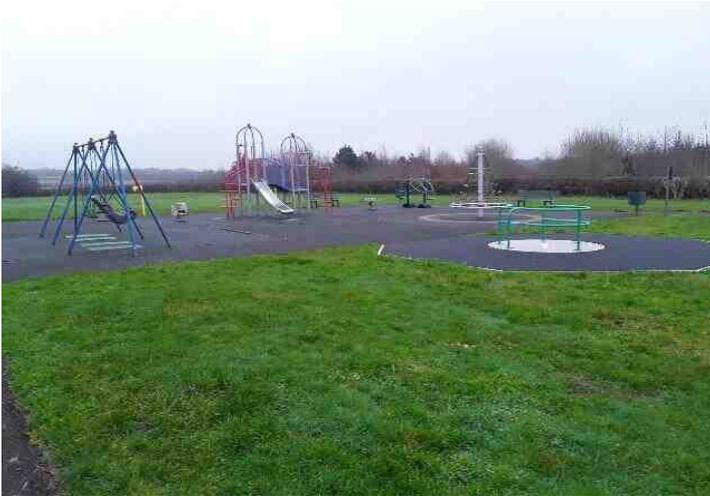
Finding: There are significant gaps (over 30mm) between the surface and the edging or between the joints in the surface; these are large enough for a small foot to enter

Action: Repair surfacing

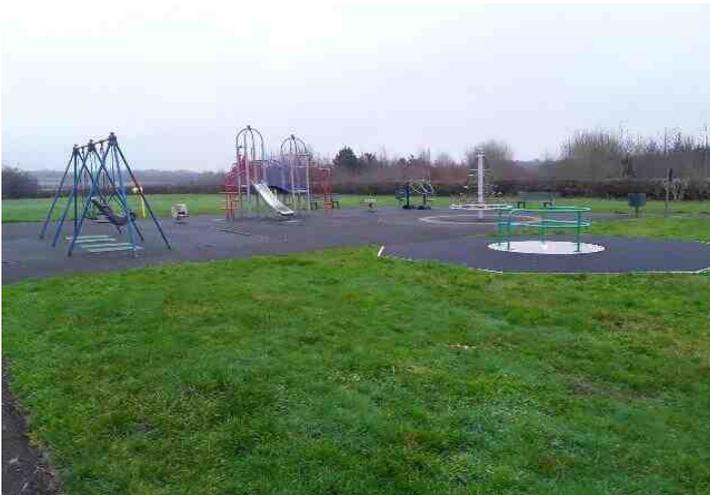
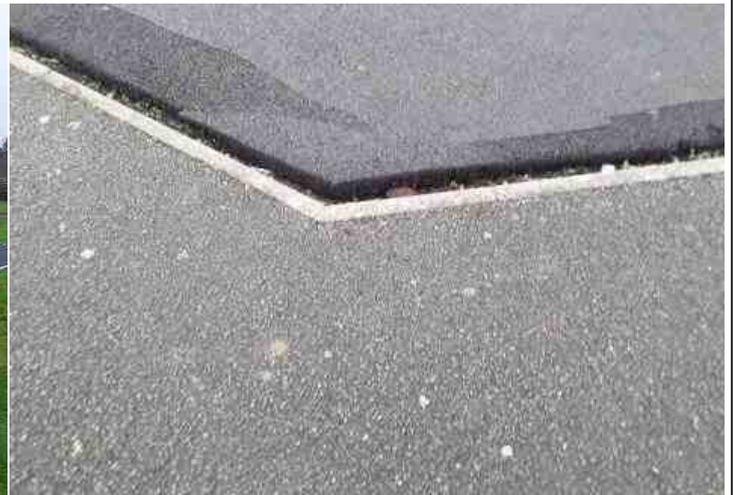
Finding: The surface is lifting at the edges and creating trip points

Action: Repair perimeter of surfacing to remove trip points

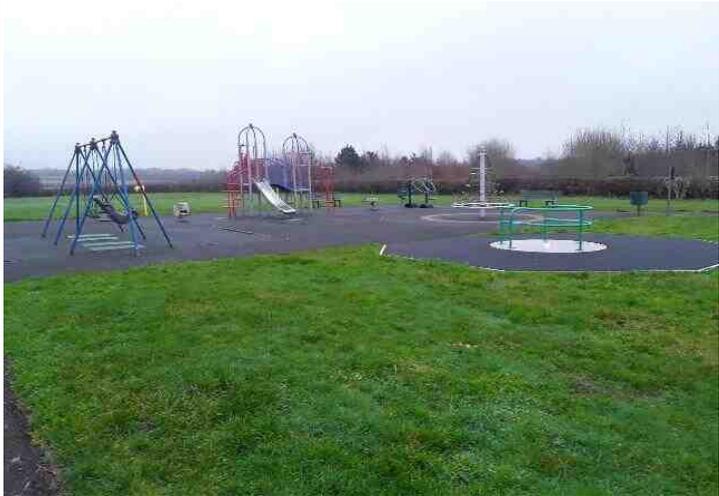
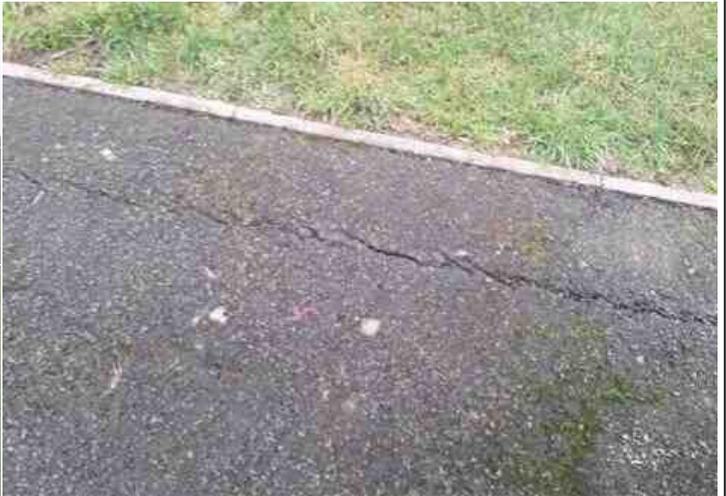
Finding: There are minor stress fractures in the tarmac surface

Action: Monitor and repair if required

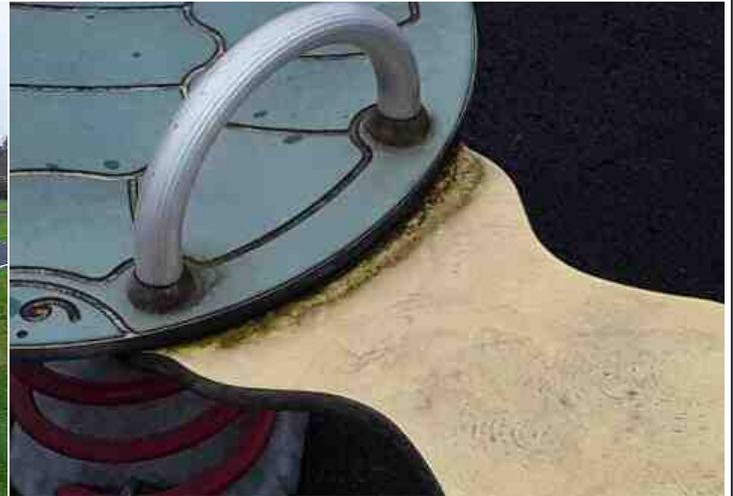
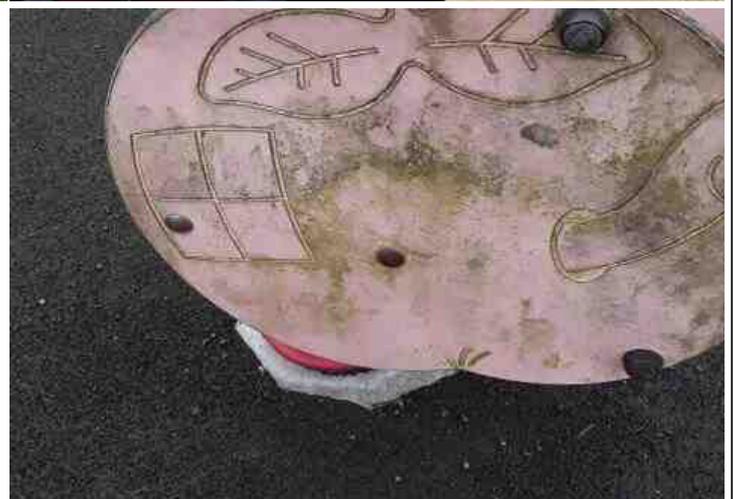
Finding: There is algae or moss on the equipment

Action: Clean and treat appropriately

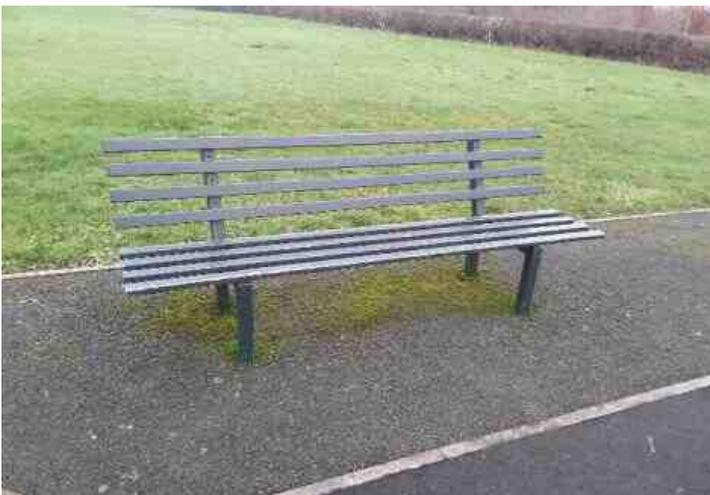
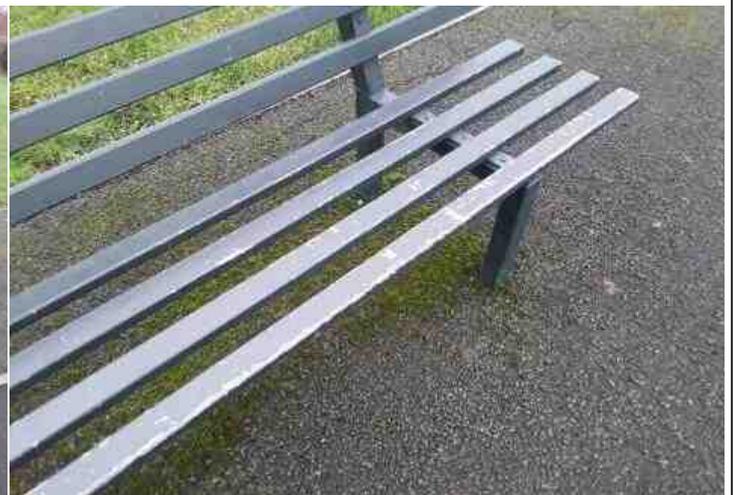
Finding: The paint is flaking off the metalwork

Action: Rub down and re-paint

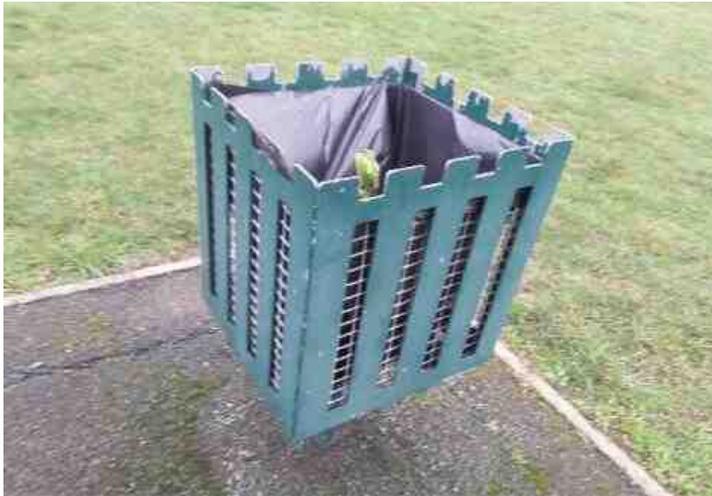
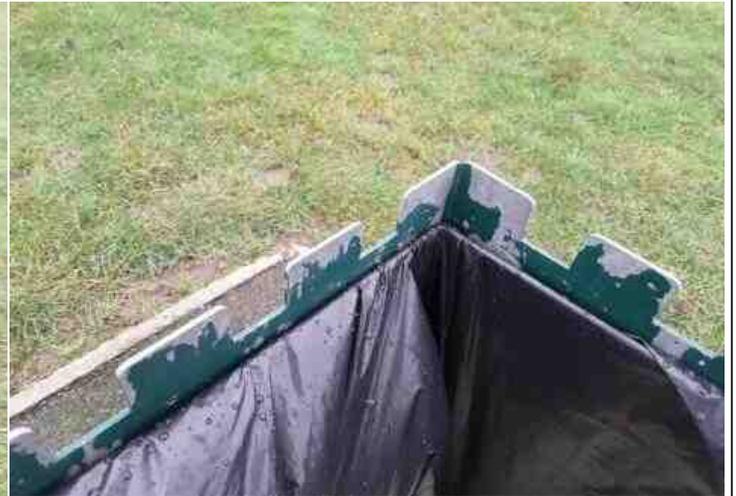
Finding: The paint is flaking off the metalwork

Action: Rub down and re-paint
