NOTICE OF PROPERTY MANAGEMENT AND GENERAL PURPOSES COMMITTEE MEETING

Thursday 5th March 2026 7pm

AGENDA

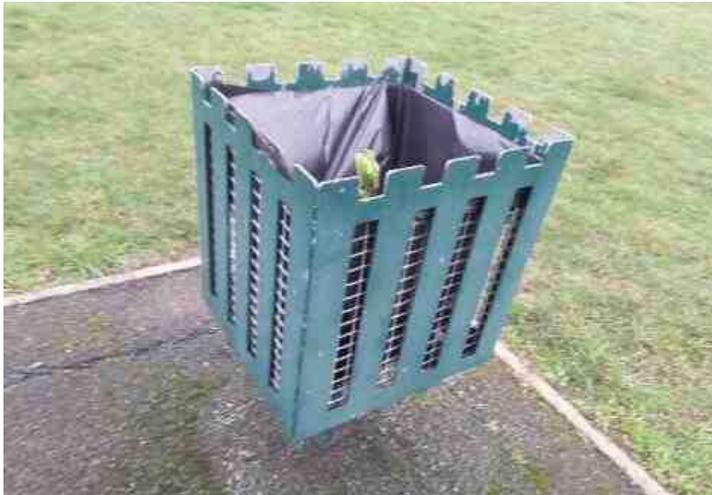
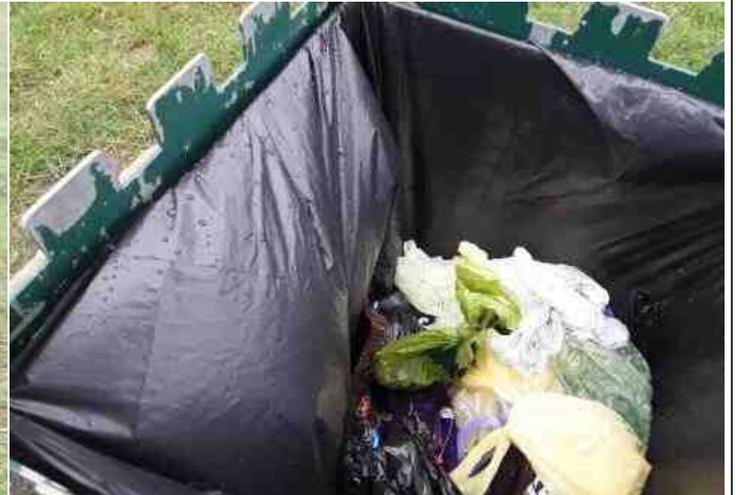
Finding: The liner of the litter bin is not secured and can be easily removed

Action: Ensure the liner is secured

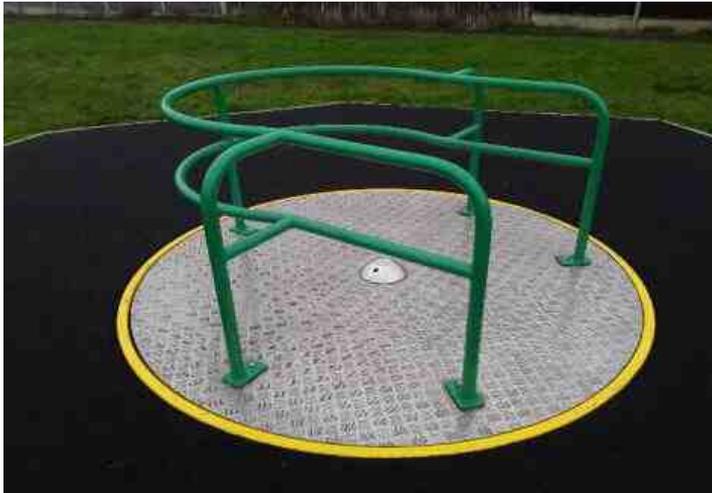
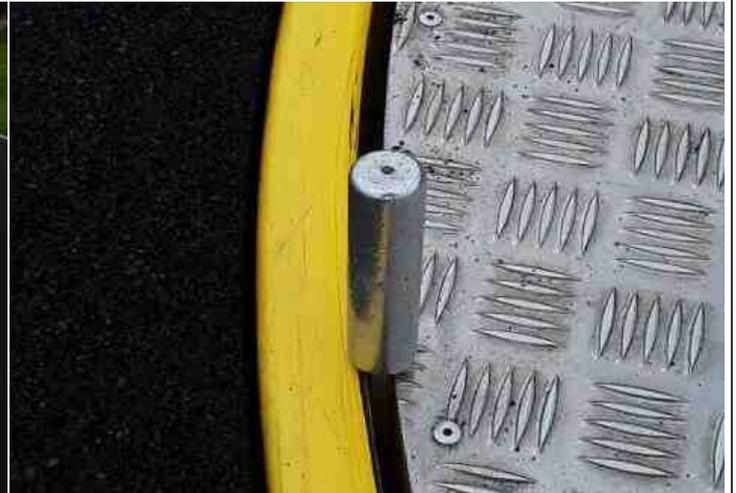
Finding: The opening to the side of the platform is in excess of 8mm and fails the requirements of BS EN 1176 Part 5
Action: Adjust / Refer to manufacturer

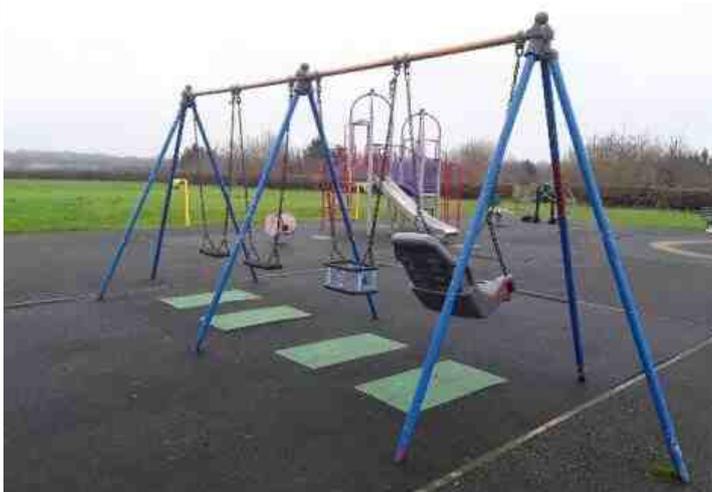
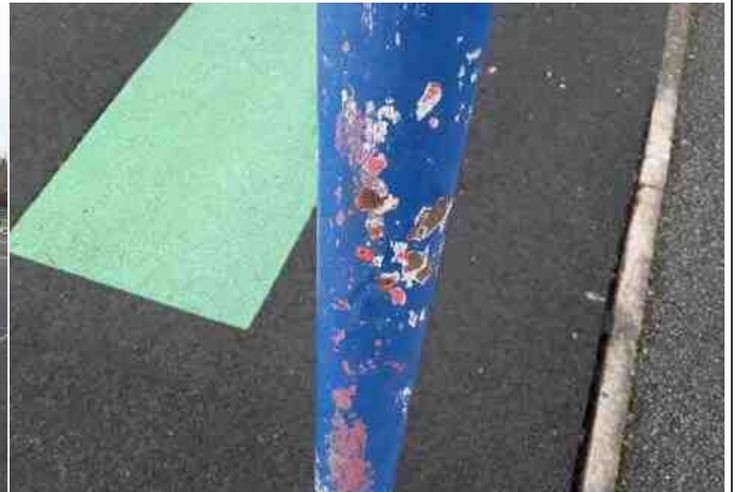
Finding: The paintwork on this item has been damaged or worn exposing the metal underneath which is rusting / corroding
Action: Treat affected areas and repaint

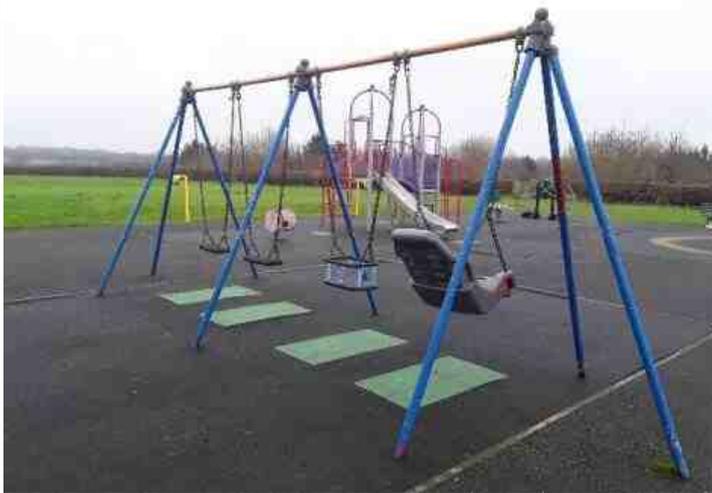
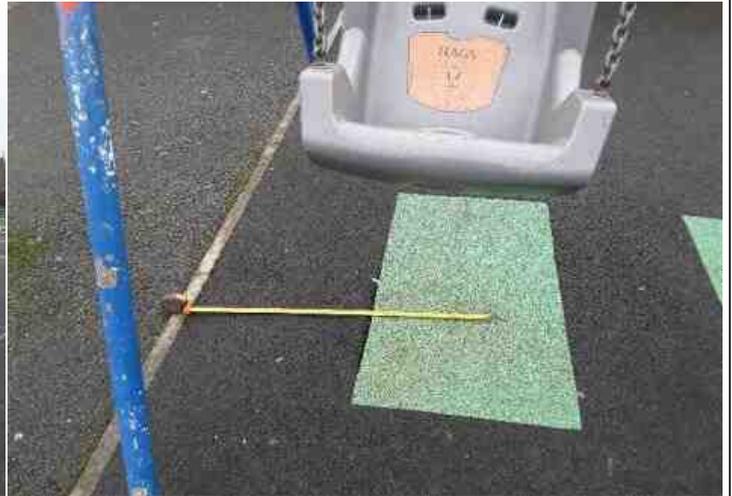
Finding: The surfacing width under the seat/s is / are less than 875mm when measured from the centre of the seat outwards, and fail the requirements of BS EN 1176 Part 2

Action: Monitor - No action given the risk assessment

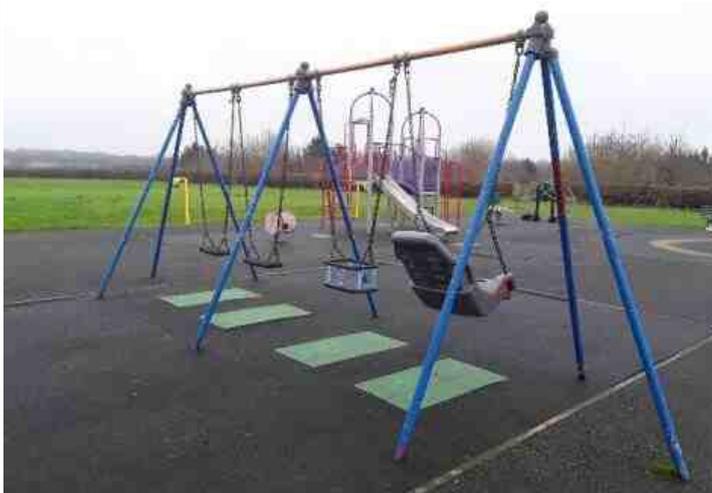
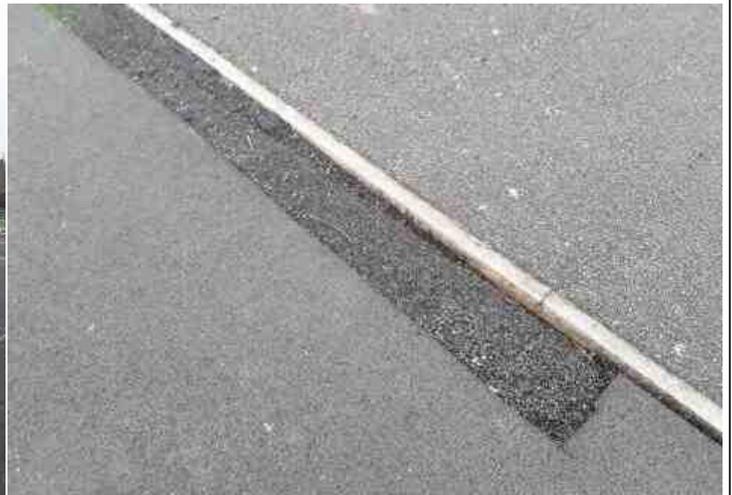
Finding: The surfacing is severely damaged

Action: Repair damaged areas of surfacing

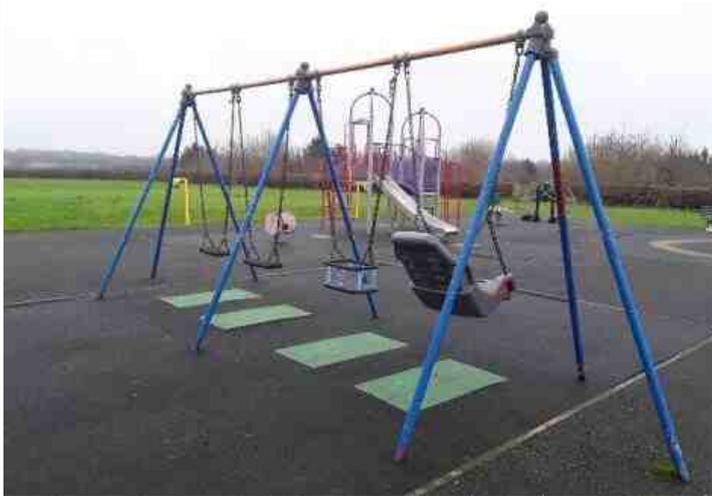
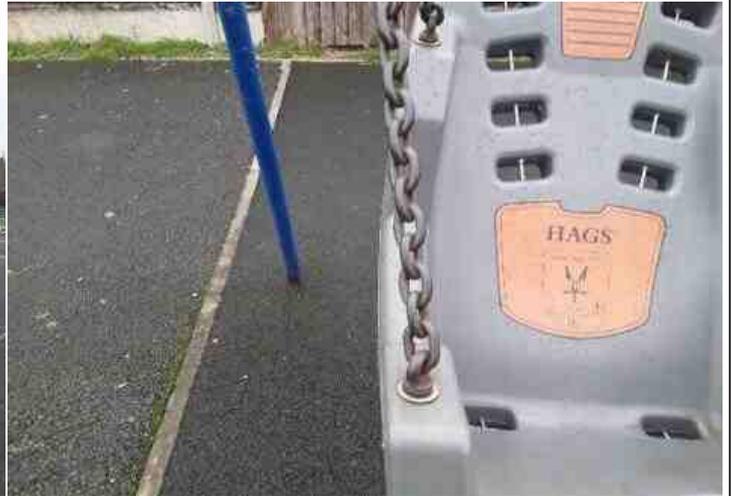
Finding: The seat/s is / are too close to the frame as defined in BS EN 1176 Part 2

Action: Monitor - No action given the risk assessment

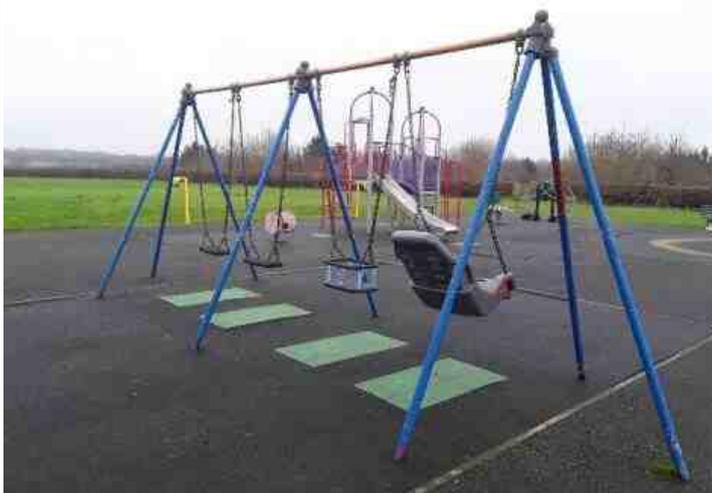
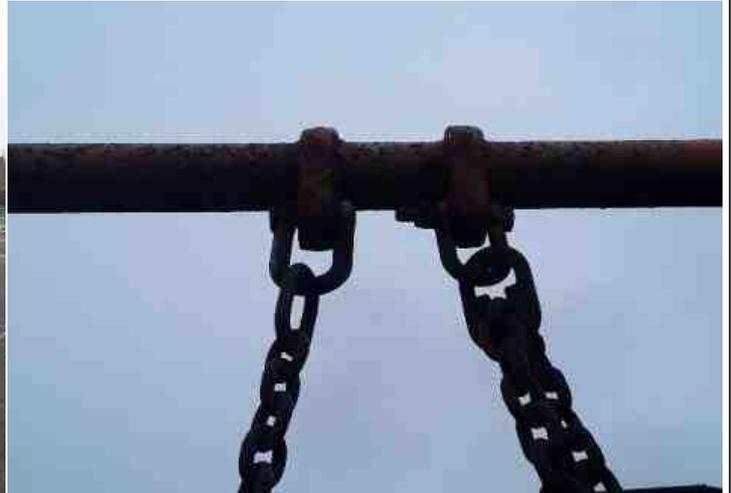
Finding: The bush / bushes is / are worn or missing

Action: Replace worn or missing bushes

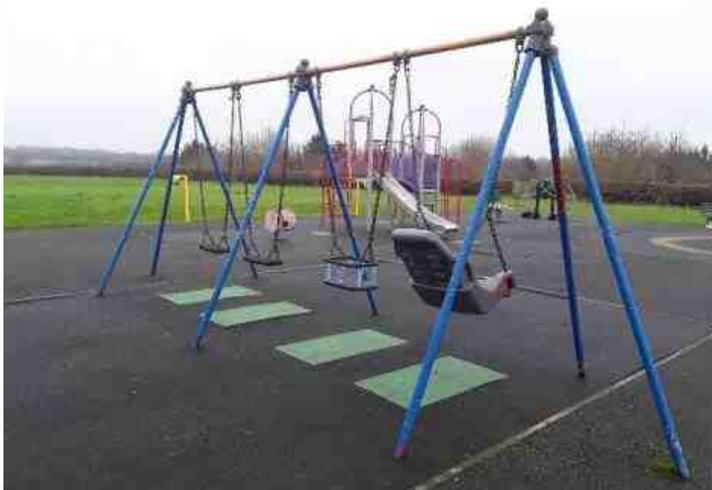
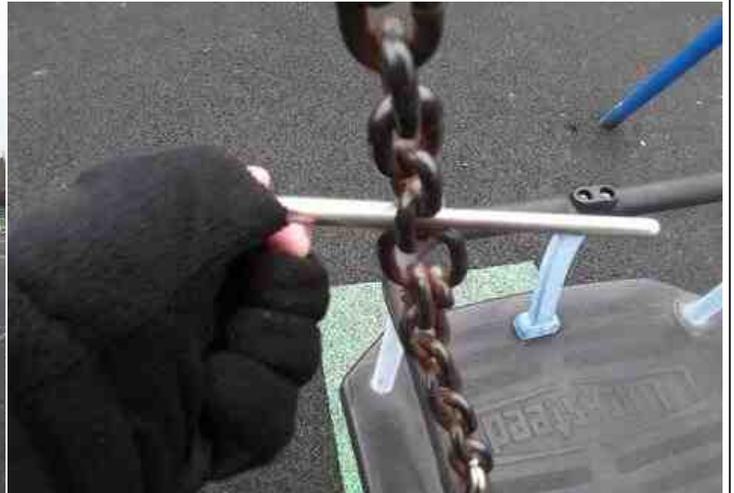
Finding: The chain openings are in excess of the 8.6mm as recommended by BS EN 1176
Action: Monitor - No action given the risk assessment

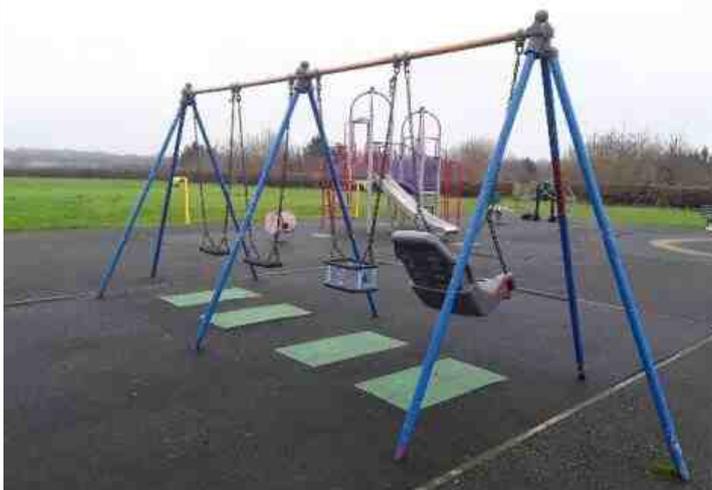
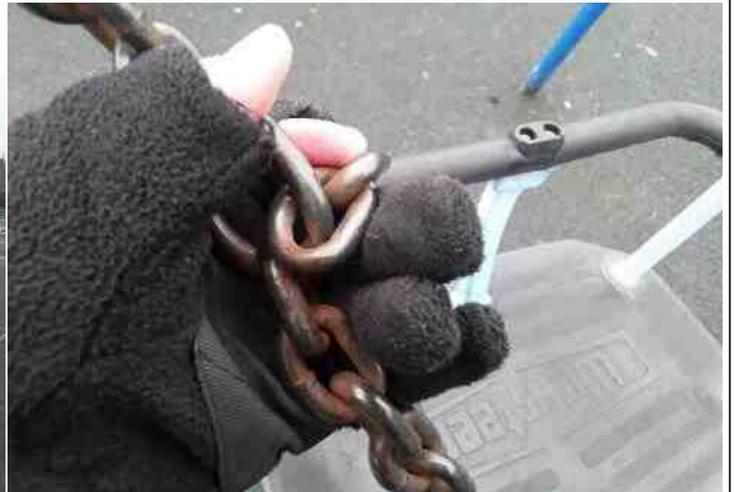
Finding: There is some notable evidence of chain wear
Action: Monitor for any further deterioration and replace when 40% worn

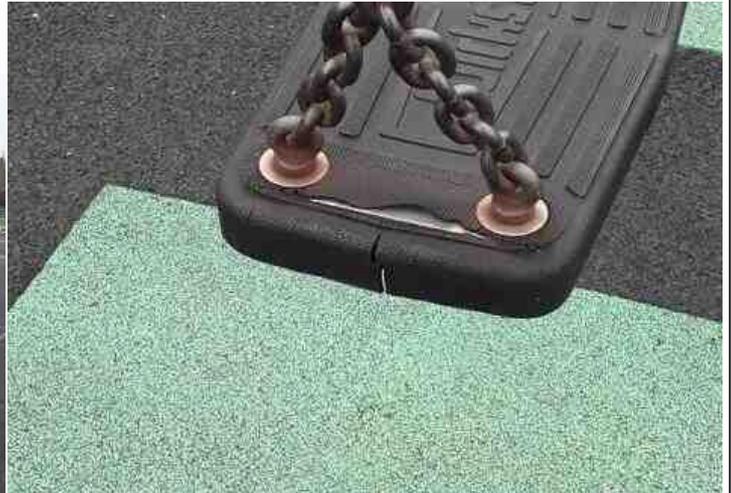
Finding: The seat is damaged and requires replacing

Action: Replace damaged seat

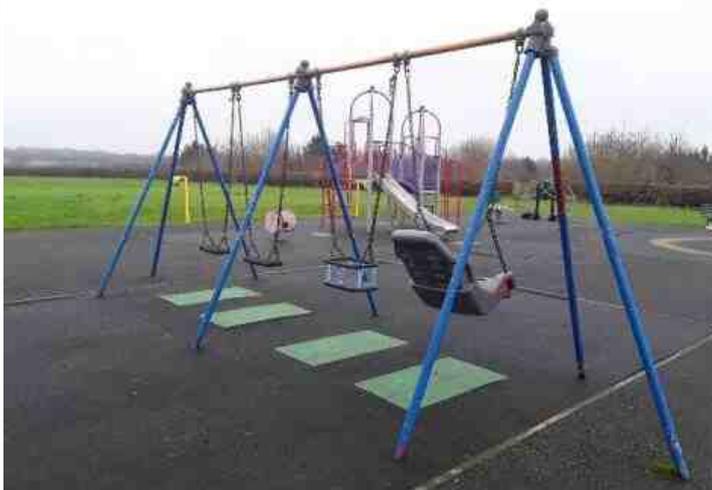
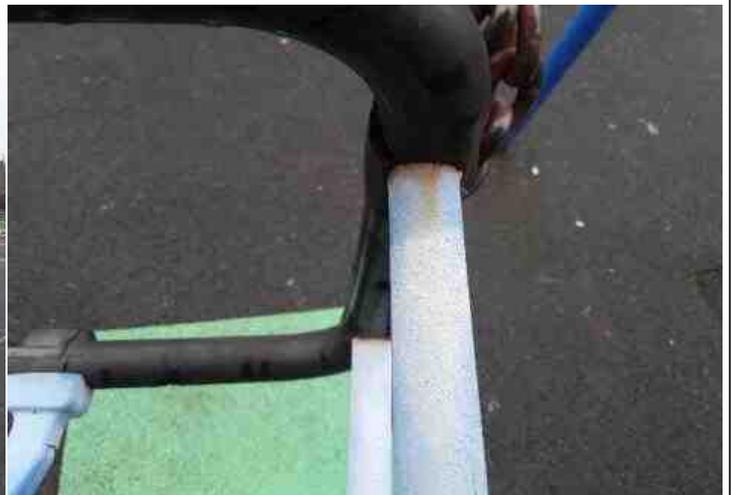
Finding: The swing seat frames are corroding

Action: Monitor for any further deterioration and replace as required

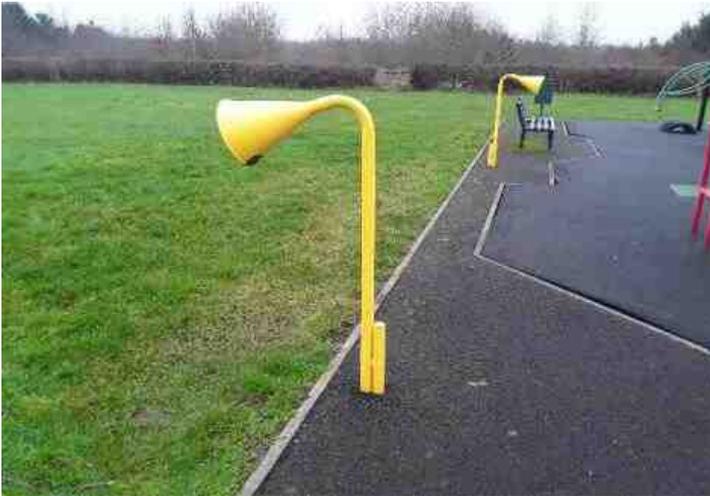
Finding: The paintwork on this item has been damaged or worn exposing the metal underneath which is rusting / corroding

Action: Treat affected areas and repaint

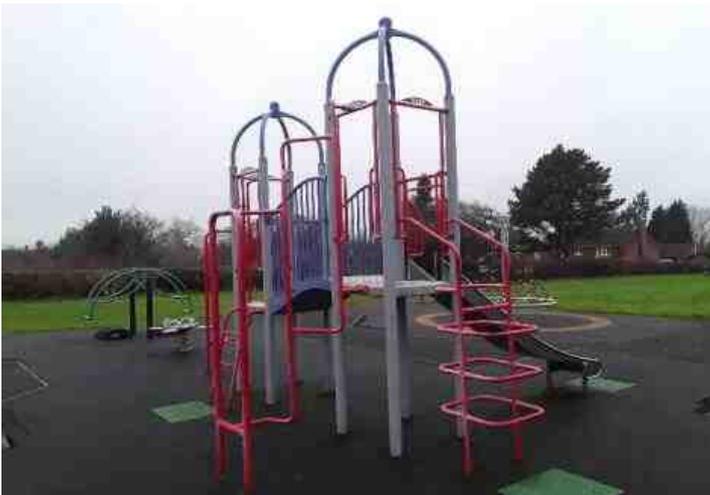
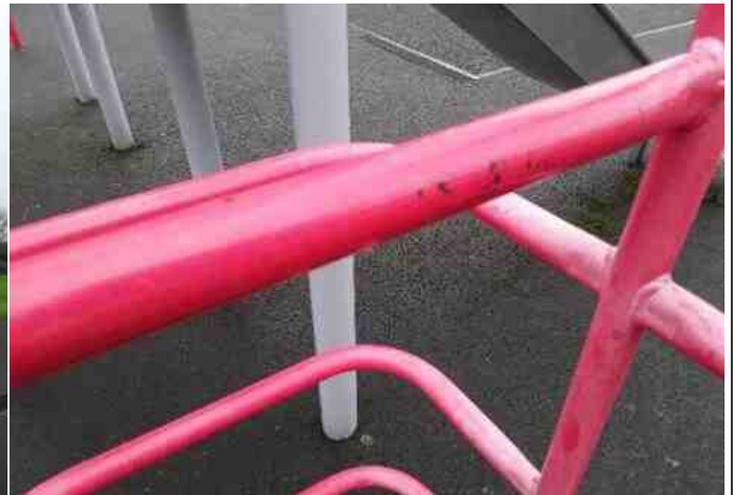
Finding: The paintwork on this item has been damaged or worn exposing the metal underneath which is rusting / corroding

Action: Treat affected areas and repaint

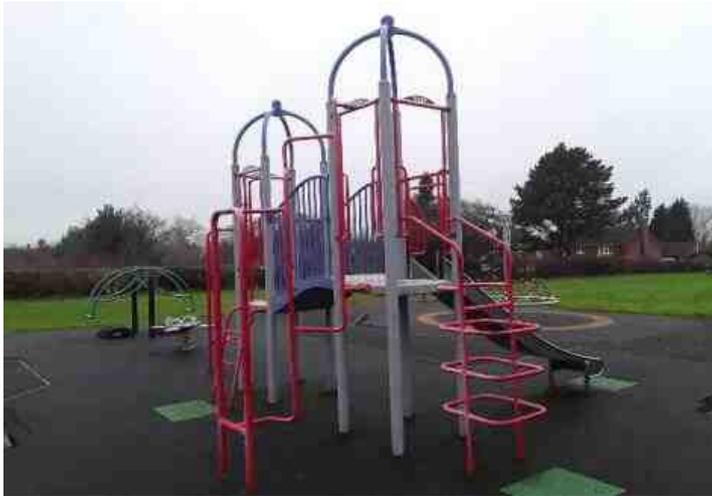
Finding: There are a number of dents in the slide surface

Action: Monitor for any further deterioration and repair as required

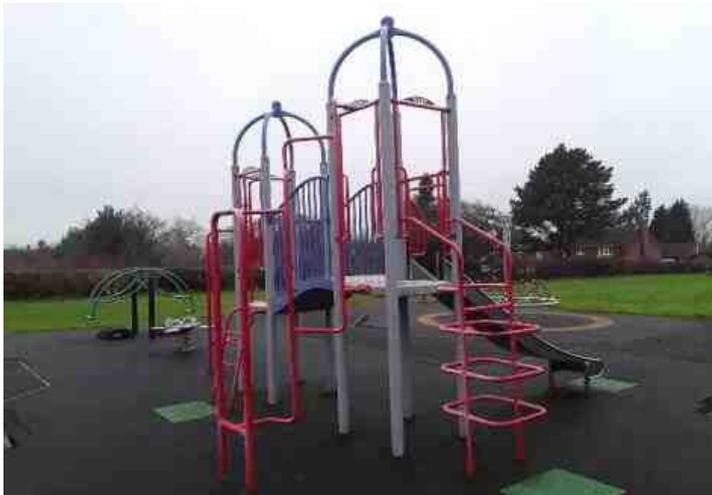
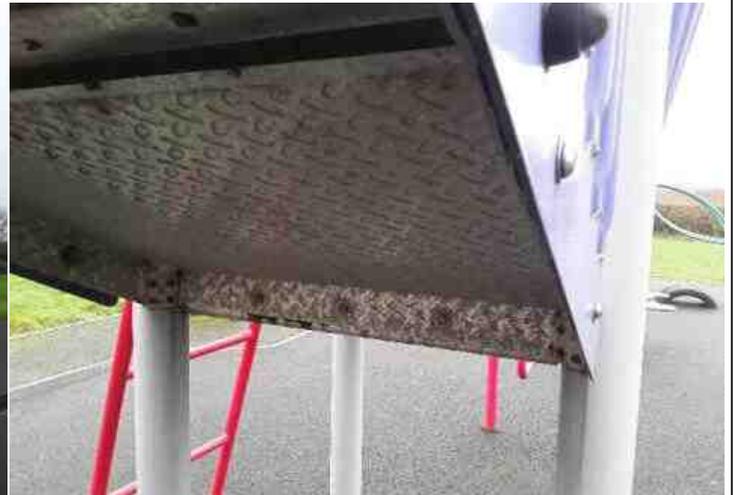
Item: Activity Equipment - Multi Play (Junior)
Manufacturer: Hags

Finding: The item has exposed edges and corners that are sharp, or with a radius of less than 3mm, and does not meet the requirements of BS EN 1176 Part 1 - 4.2.5

Action: Provide a 3mm radius to all exposed edges and corners, or remove sharp edge

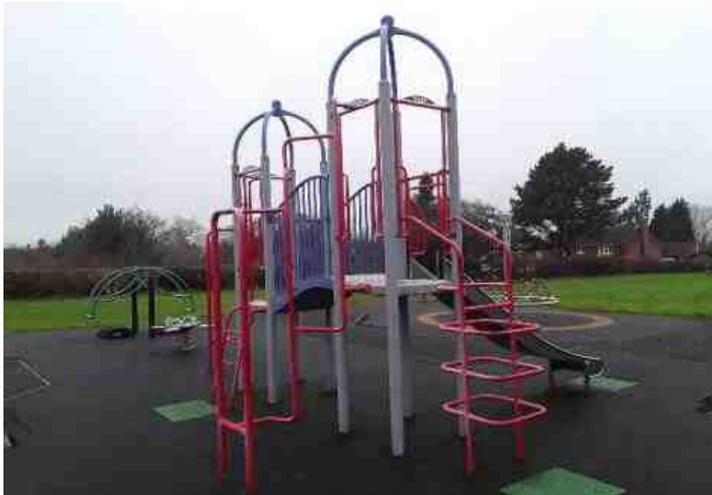
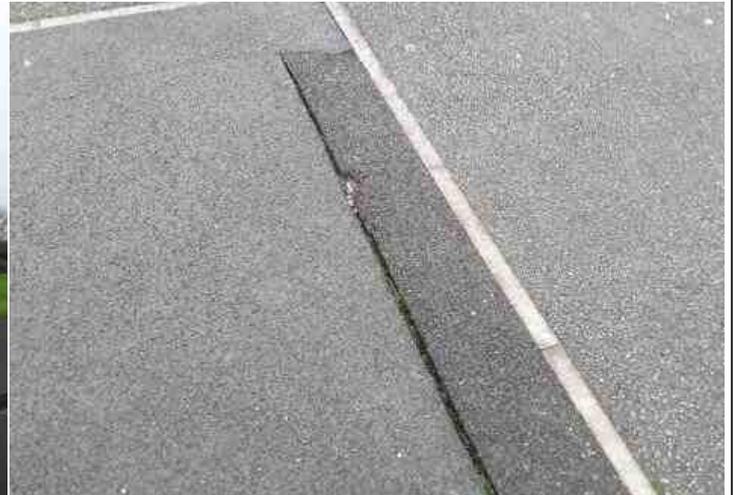
Item: Activity Equipment - Multi Play (Junior)
Manufacturer: Hags

Finding: The surfacing is damaged

Action: Repair damaged areas of surfacing

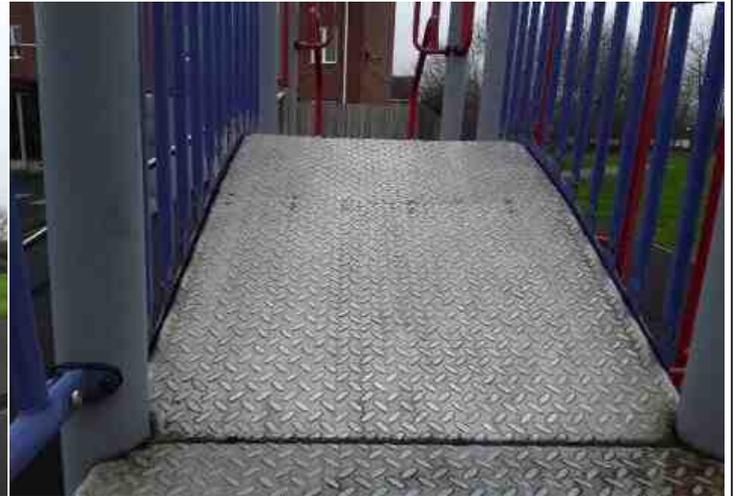
Item: Activity Equipment - Multi Play (Junior)
Manufacturer: Hags

Finding: The bridge buckles / distorts under load

Action: Monitor and provide bracing if required

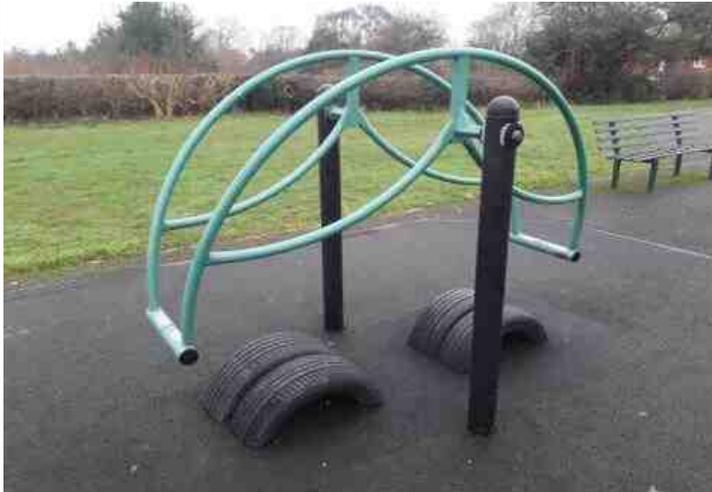
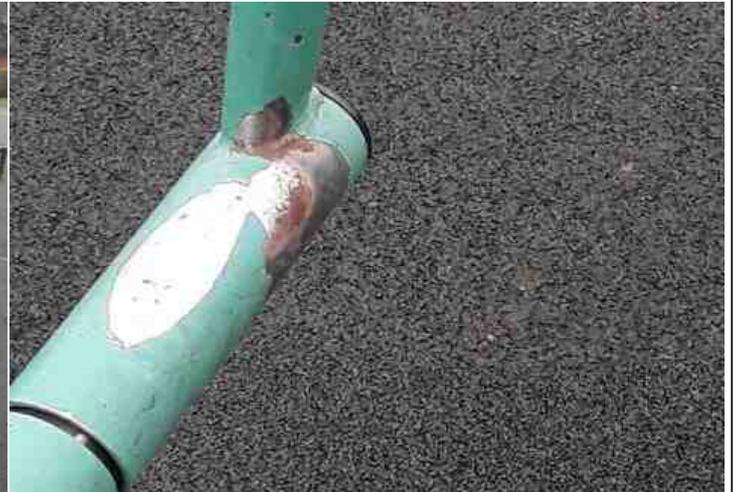
Item: Rocking Equipment - Stand up SeeSaw
Manufacturer: Hags

Finding: The paintwork on this item has been damaged or worn exposing the metal underneath which is rusting / corroding

Action: Treat affected areas and repaint

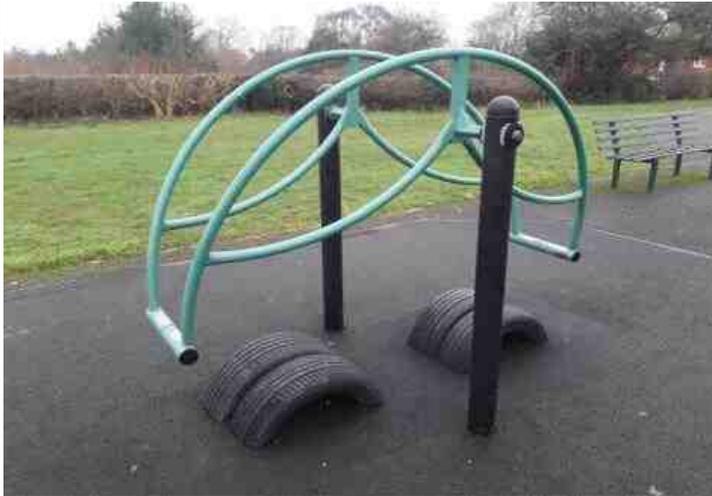
Item: Rocking Equipment - Stand up SeeSaw
Manufacturer: Hags

Finding: The tyre buffers are showing signs of wear

Action: Monitor and replace if required

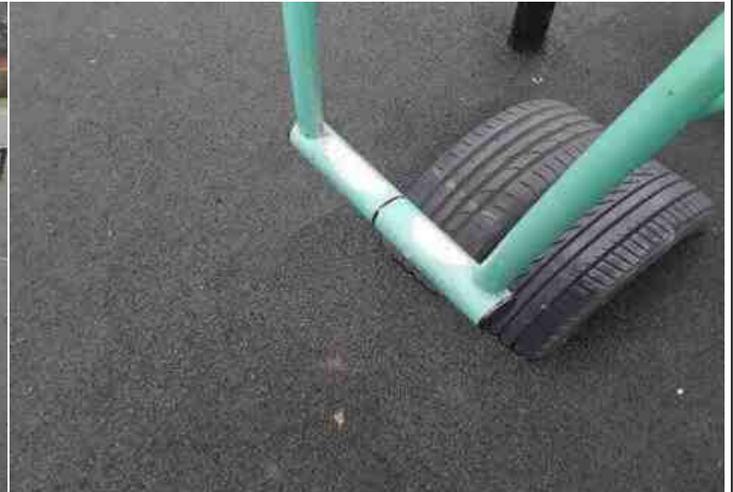
Item: Rocking Equipment - Stand up SeeSaw
Manufacturer: Hags

Finding: The foot treads have been removed

Action: Replace the missing components

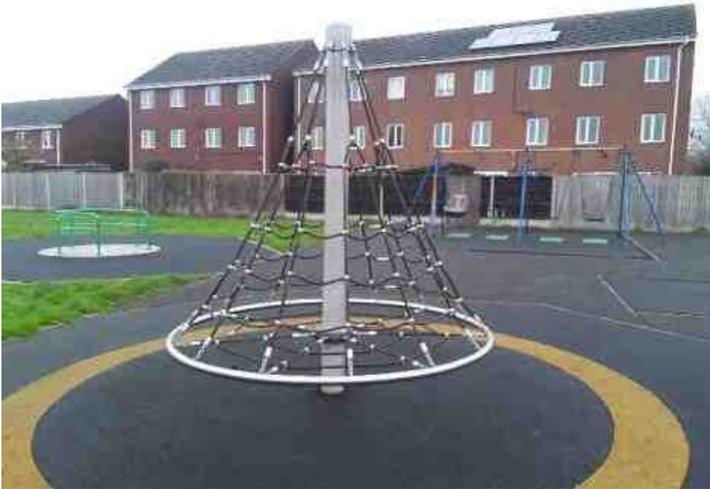
Item: Rotor Play - Cone Climber
Manufacturer: Tayplay Ltd

Finding: The ropes/nets are worn/damaged in places

Action: Monitor for any further deterioration and repair or replace as required

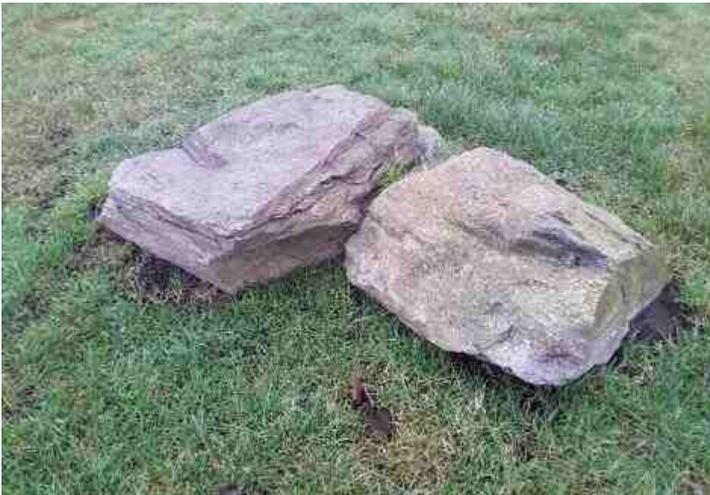
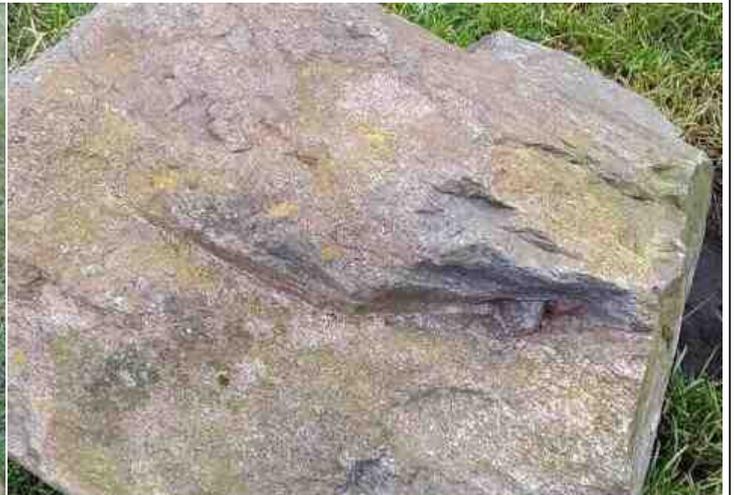
Item: Other - Boulders
Manufacturer: Natural Feature

Finding: The rocks and/or boulders have moss/algae growth apparent

Action: Clean and maintain

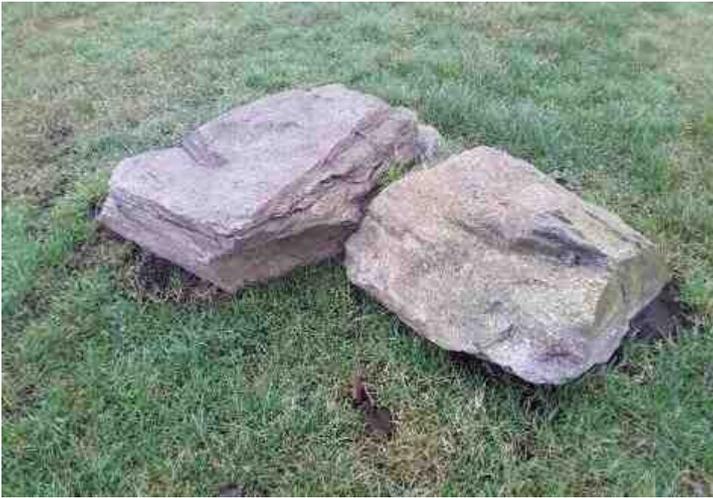
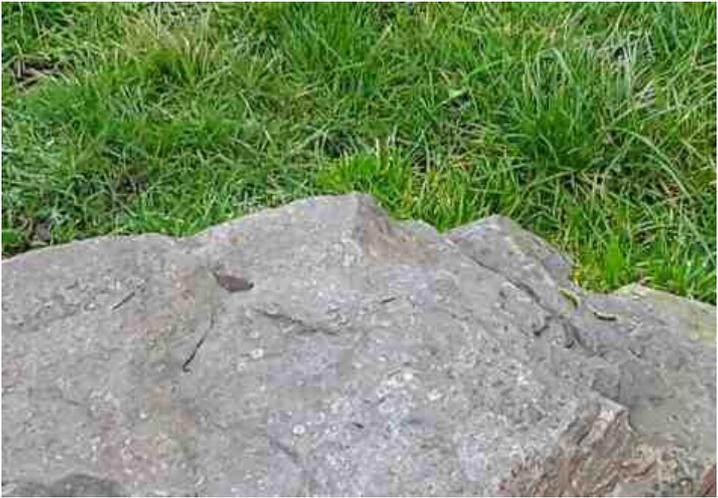
Item:	Other - Boulders	Risk Level:	L - Low Risk
Manufacturer:	Natural Feature	Surface:	Grass

Finding: The rocks and/or boulders have sharp edges that are exposed to the user

Action: Remove all sharp edges

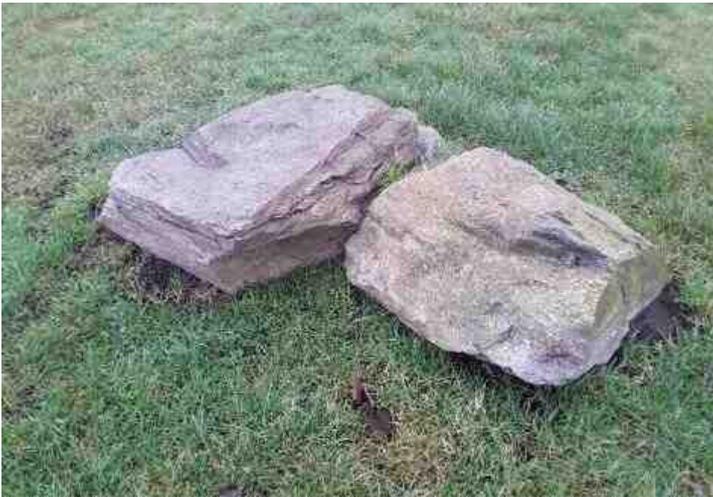
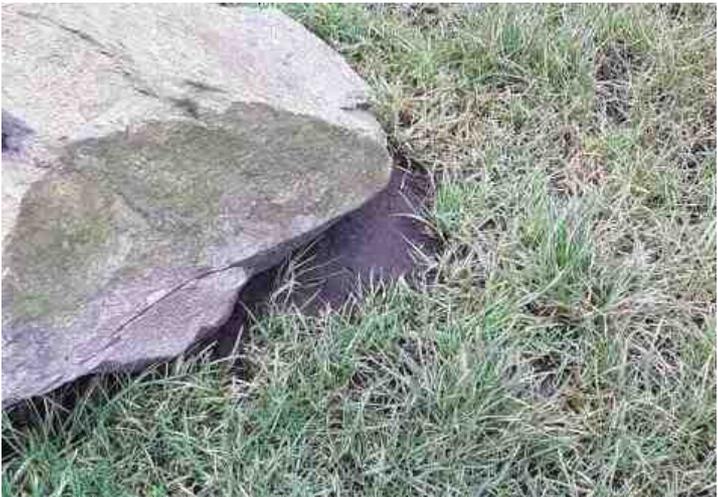
Item:	Other - Boulders	Risk Level:	L - Low Risk
Manufacturer:	Natural Feature	Surface:	Grass

Finding: The area around the item has eroded and may become slippery

Action: Reinstate eroded area

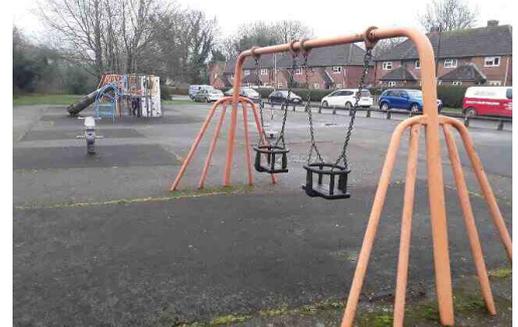
Item: Site General
Manufacturer: Owner/Operator
Surface Type: N/A
Item Quantity: 1
Equipment Compliance: N/A
Surface Area Compliance: N/A

There is algae, silt or moss growth on the bitmac and safety surfaces resulting in slippery conditions - Clean and treat appropriately

Equipment has been removed which has created trip hazards due to the redundant foundations - Reinstate surrounding surfaces to level to remove the trip points

The bitmac surfacing is uneven creating trip hazards over the edges - Remove the trip hazards

The bitmac surfacing is damaged - Repair damaged areas of surfacing

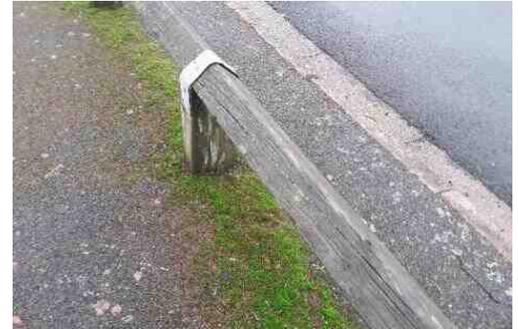
Item: Fencing - Post & Rail
Manufacturer: Not Identified
Surface Type: Bitmac
Item Quantity: 1
Equipment Compliance: N/A
Surface Area Compliance: N/A

There are parts of the timber that have rotted - Replace all affected timbers

A number of straps are damaged exposing sharp edges - Replace the damaged straps

There is or are fixings missing on the item - Replace all missing fixings

The timber has a number of splits/shakes or air cracks and this may affect the stability or allow water ingress which will accelerate the rotting process. Timber splits may also create rough / splintering edges. - Monitor, sand down any rough edges and ensure the splits do not cross through fixing points of the structure and/or cause any instability

There is surface corrosion / rust present on the item - Consider treating the item

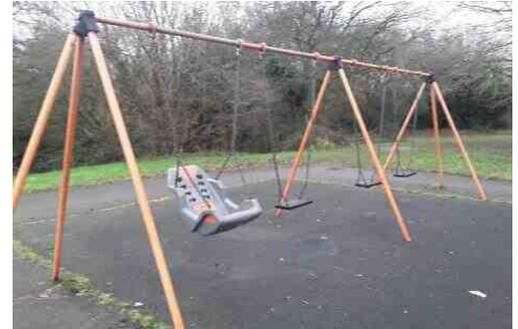
Item: 2 Bay 4 Seat Swing
Manufacturer: Wicksteed Playgrounds
Surface Type: Wet Pour
Item Quantity: 1
Equipment Compliance: No
Surface Area Compliance: No
Life Expectancy: >10 Years
Total Findings: 4

Finding 1
 The safety surface is beginning to wear - Monitor for any further deterioration and repair as required

Finding 2
 The surfacing width under the seat/s is / are less than 875mm when measured from the centre of the seat outwards, and fail the requirements of BS EN 1176 Part 2 - Monitor - No action given the risk assessment

Finding 3
 The chain openings are in excess of the 8.6mm as recommended by BS EN 1176 - Monitor - No action given the risk assessment

Finding 4
 There is surface corrosion / rust present on the item - Consider treating the item

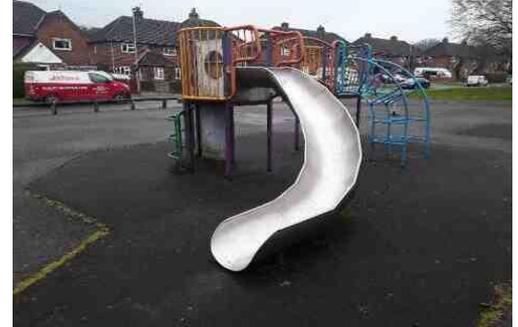
Item: Multi Play (Junior)
Manufacturer: Wicksteed Playgrounds
Surface Type: Wet Pour
Item Quantity: 1
Equipment Compliance: No
Surface Area Compliance: Yes
Life Expectancy: >10 Years
Total Findings: 11

There are a number of dents in the slide surface - Monitor for any further deterioration and repair as required

The item fails to meet the requirements of BS EN 1176 Part 1 4.2.7.2 head and neck entrapment in the barriers and/or steps - Monitor - No action given the risk assessment

There is/are inserts missing creating finger entrapment/s in the redundant bolt holes and the item fails to meet the requirements of BS EN 1176 Part 1 4.2.7.6 Entrapment of fingers - Provide inserts

The paintwork on this item has been damaged or worn exposing the metal underneath which is rusting / corroding - Treat affected areas and repaint

There is/are inserts missing - Replace missing inserts

The fixings have corroded - Replace all corroded fixings

There is / are post or end caps missing / damaged on the item - Replace missing / damaged post or end caps

The climbing wall panel is damaged - Remove the sharp edges and monitor

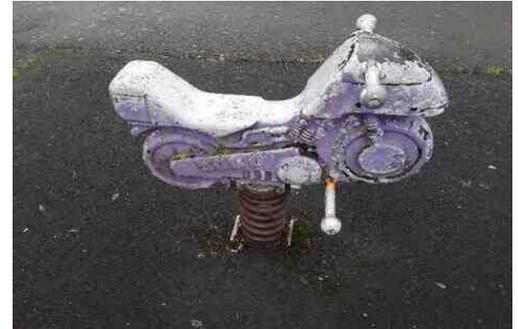
Item: Spring Bike
Manufacturer: Wicksteed Playgrounds
Surface Type: Wet Pour
Item Quantity: 1
Equipment Compliance: Yes
Surface Area Compliance: Yes
Life Expectancy: 5 -10 Years
Total Findings: 3

The spring cover is damaged, split or missing - Replace the cover

There is surface corrosion / rust present on the item - Consider treating the item

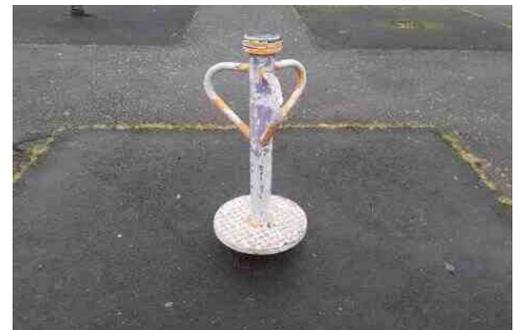
Item: Low Rotator
Manufacturer: Wicksteed Playgrounds
Surface Type: Wet Pour
Item Quantity: 1
Equipment Compliance: Yes
Surface Area Compliance: No
Life Expectancy: 3 - 5 Years
Total Findings: 3

The surfacing dimensions are short and do not meet with the requirements of the current applicable standard - Monitor - No action given the risk assessment

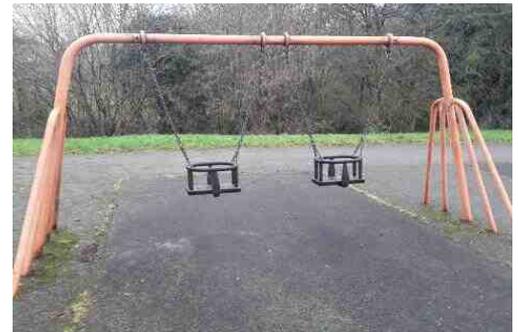
Item: 1 Bay 2 Seat (Cradle)
Manufacturer: Wicksteed Playgrounds
Surface Type: Wet Pour
Item Quantity: 1
Equipment Compliance: No
Surface Area Compliance: Yes
Life Expectancy: >10 Years
Total Findings: 5

The bushes are showing signs of wear - Monitor for any further deterioration and replace as required

The paintwork on this item has been damaged or worn exposing the metal underneath which is rusting / corroding - Treat affected areas and repaint

The chain openings are in excess of the 8.6mm as recommended by BS EN 1176 - Monitor - No action given the risk assessment

The Anti Wrap bearings are dry / worn - Replace the anti wrap bearings

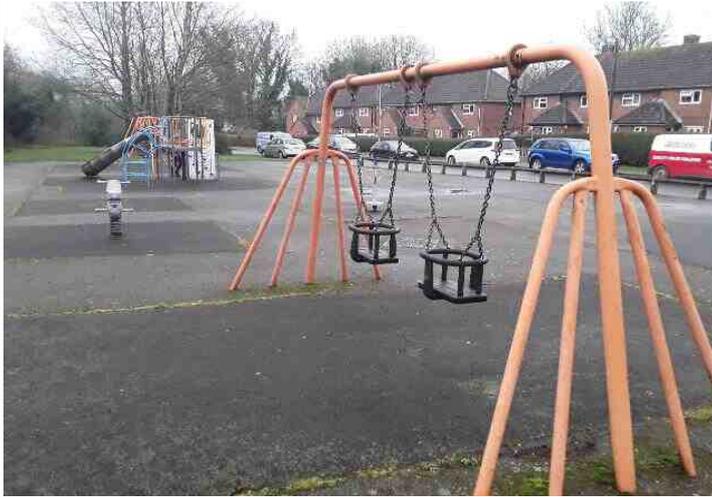
Item: Ancillary Items - Site General
Manufacturer: Owner/Operator

Finding: There is algae, silt or moss growth on the bitmac and safety surfaces resulting in slippery conditions

Action: Clean and treat appropriately

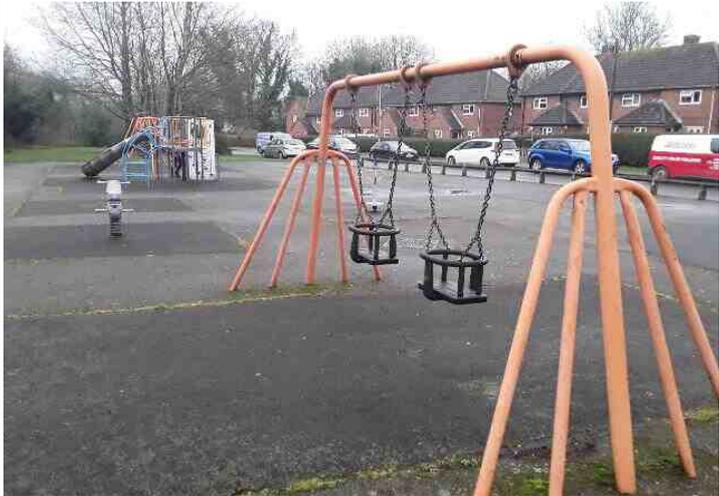
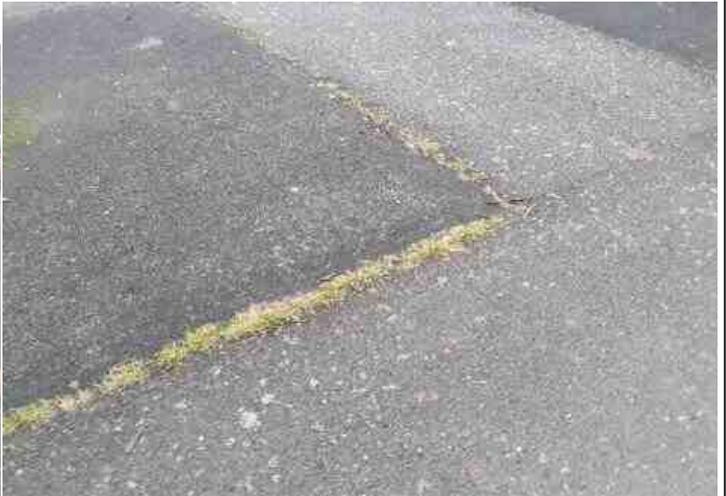
Item: Ancillary Items - Site General
Manufacturer: Owner/Operator

Finding: There is weed / vegetation growth on and around the surface
Action: Remove weed / vegetation growth

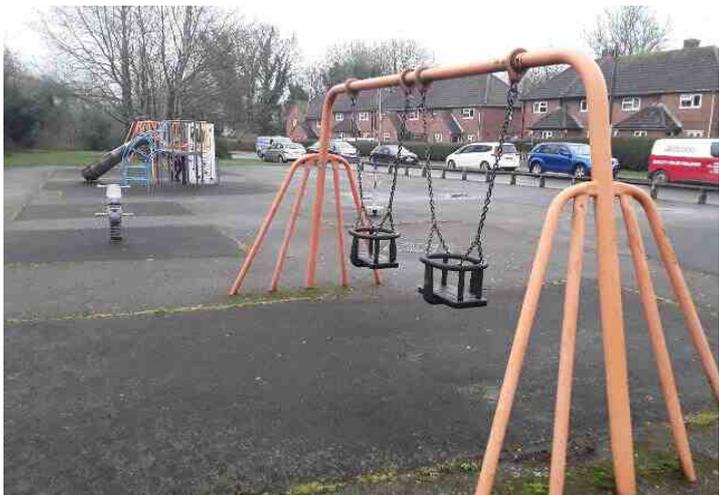
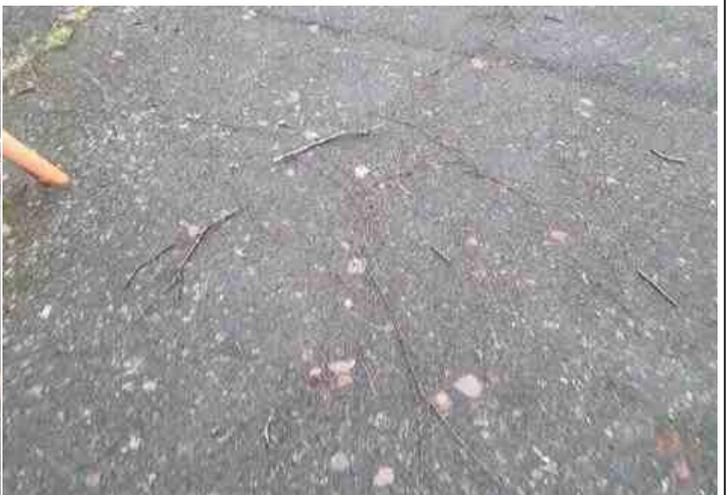
Item: Ancillary Items - Site General
Manufacturer: Owner/Operator

Finding: There is some tree debris present
Action: Remove and maintain

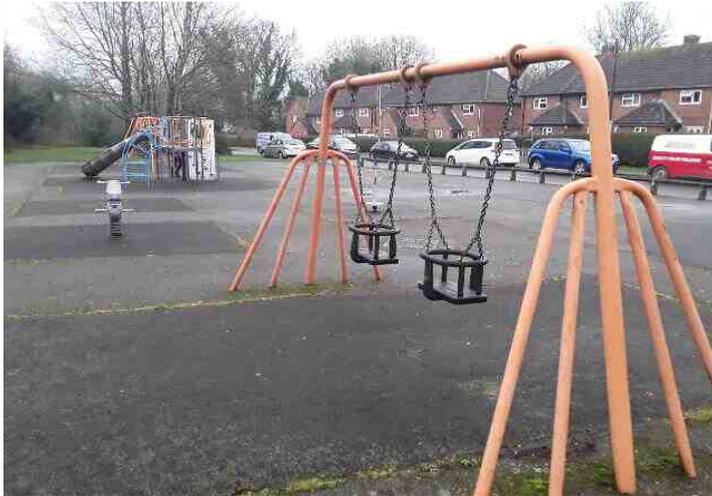
Item: Ancillary Items - Site General
Manufacturer: Owner/Operator

Finding: Equipment has been removed which has created trip hazards due to the redundant foundations

Action: Reinstate surrounding surfaces to level to remove the trip points

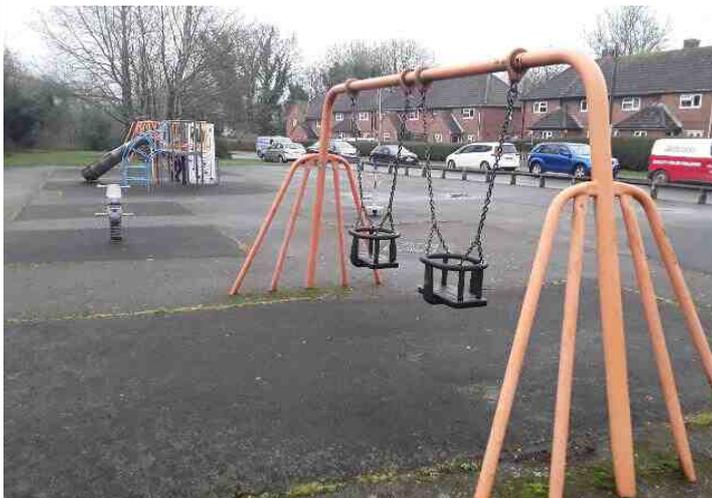
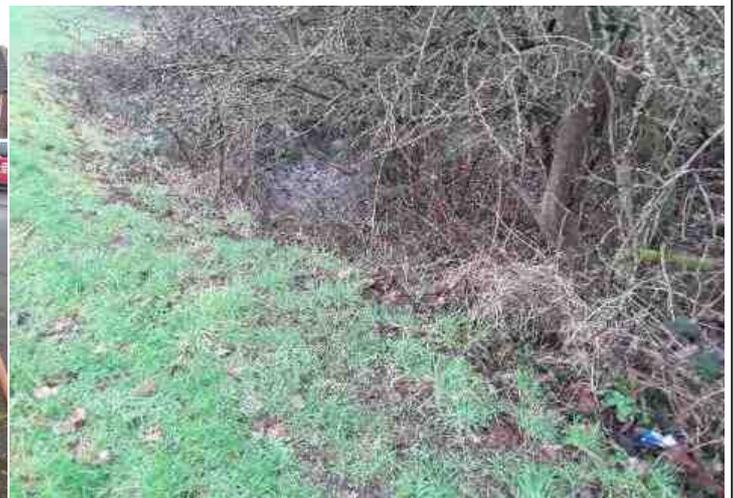
Item: Ancillary Items - Site General
Manufacturer: Owner/Operator

Finding: NOTE - There is a body of water or a water basin in close proximity to the playground. Risk assessment of this is a specialist field and outside the scope of our inspection.

Action: Contact our official water safety partner the RLSS (Royal Life Saving Society) at www.rlss.org.uk and / or ensure that the appropriate risk assessment is in place

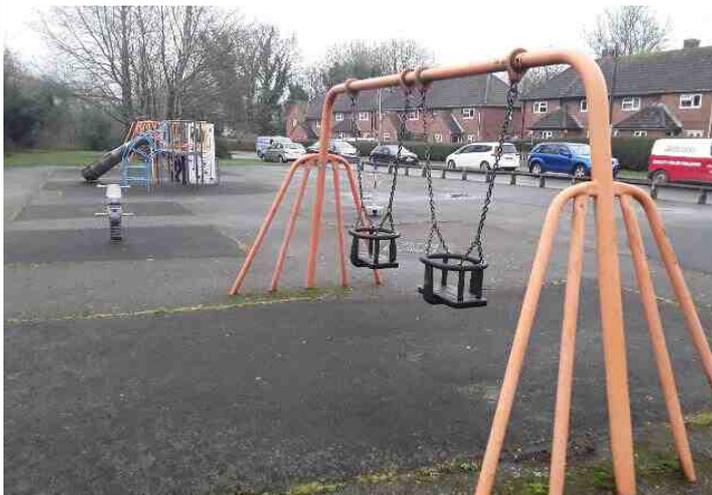
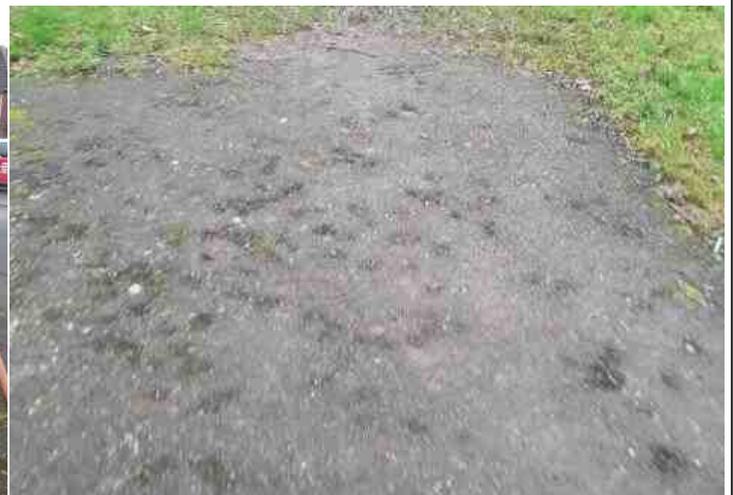
Item: Ancillary Items - Site General
Manufacturer: Owner/Operator

Finding: The bitmac surfacing is damaged

Action: Repair damaged areas of surfacing

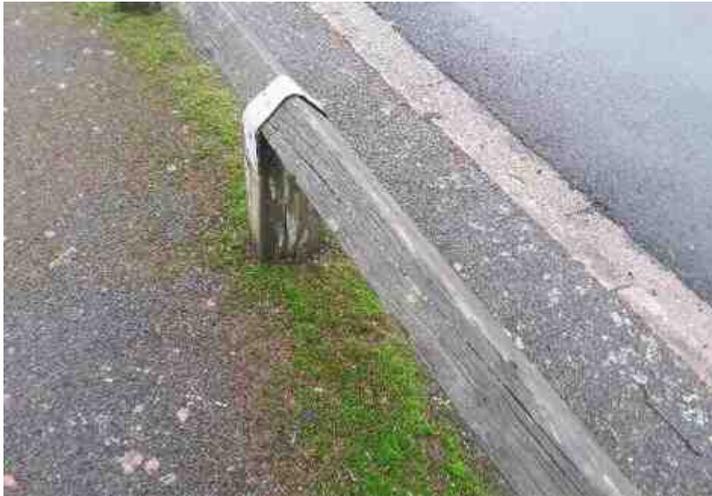
Item: Fences - Fencing - Post & Rail
Manufacturer: Not Identified

Finding: There are parts of the timber that have rotted

Action: Replace all affected timbers
