NOTICE OF PROPERTY MANAGEMENT AND GENERAL PURPOSES COMMITTEE MEETING

Thursday 5th March 2026 7pm

AGENDA

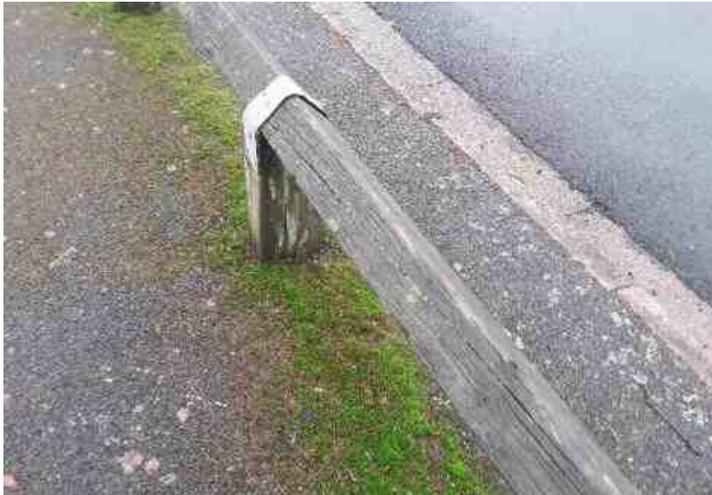
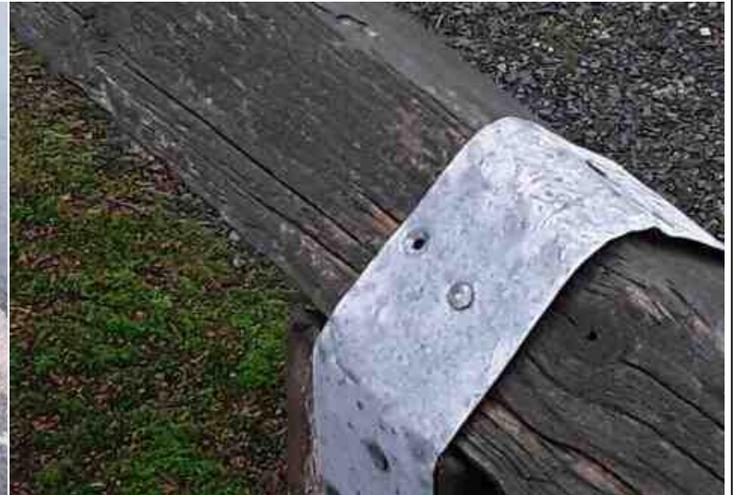
Item: Fences - Fencing - Post & Rail
Manufacturer: Not Identified

Finding: There is or are fixings missing on the item

Action: Replace all missing fixings

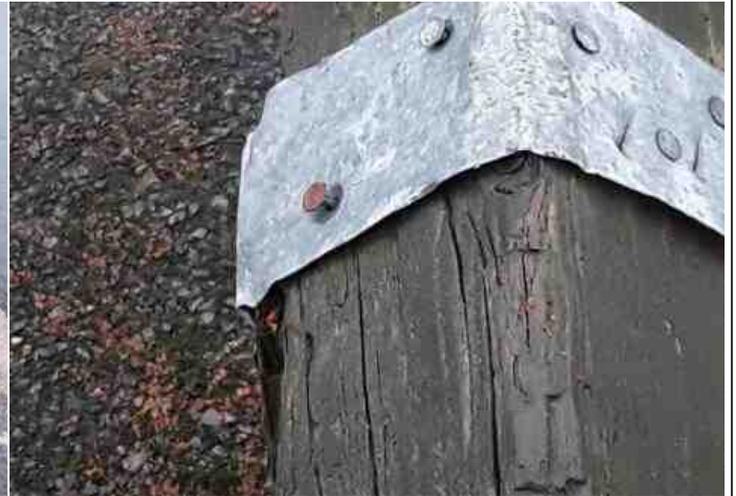
Item: Fences - Fencing - Post & Rail
Manufacturer: Not Identified

Finding: There are projecting nail ends present

Action: Knock the nails in flush

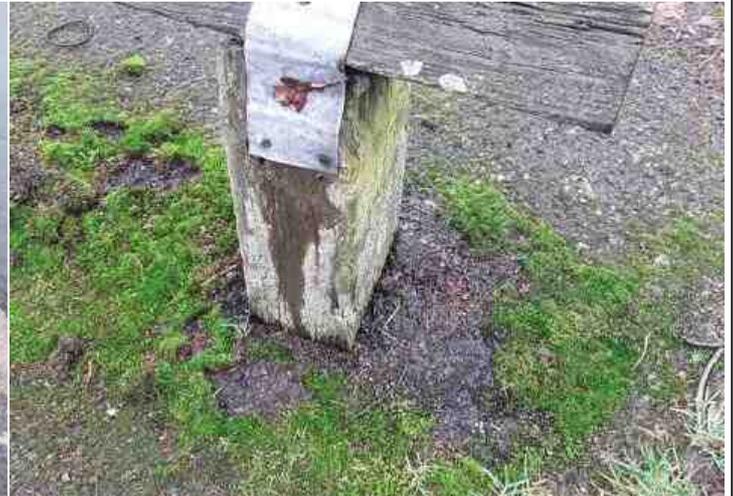
Item: Fences - Fencing - Post & Rail
Manufacturer: Not Identified

Finding: Parts of the timber are rough or splintered

Action: Remove all rough or sharp edges

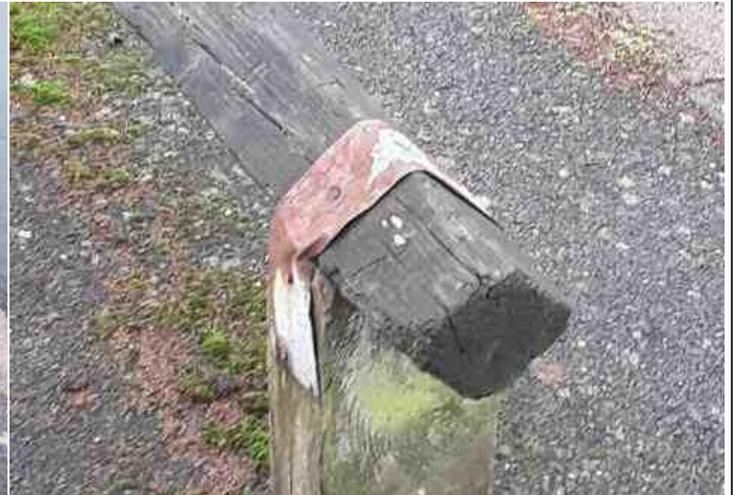
Item: Fences - Fencing - Post & Rail
Manufacturer: Not Identified

Finding: There is surface corrosion / rust present on the item

Action: Consider treating the item

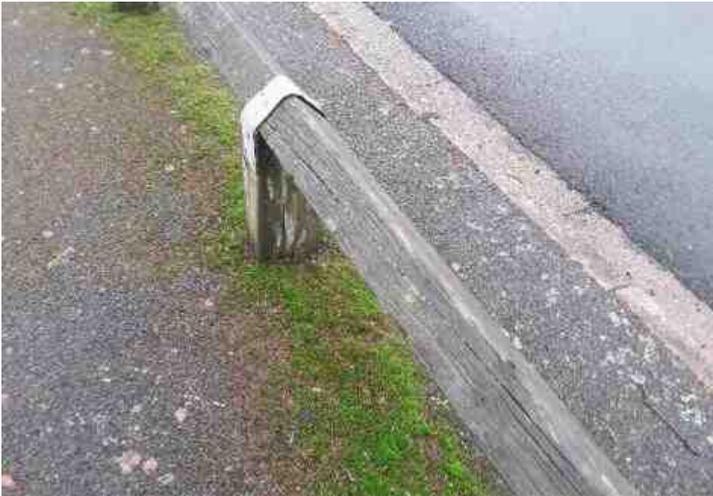
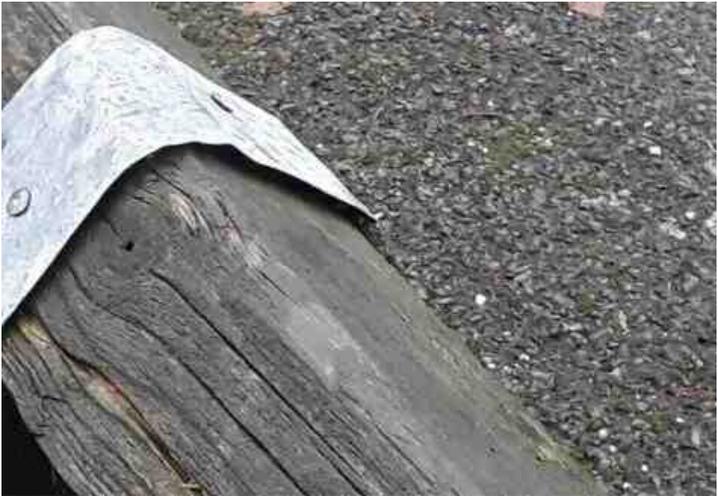
Item:	Fences - Fencing - Post & Rail	Risk Level:	L - Low Risk
Manufacturer:	Not Identified	Surface:	Bitmac

Finding: A number of straps are damaged exposing sharp edges

Action: Replace the damaged straps

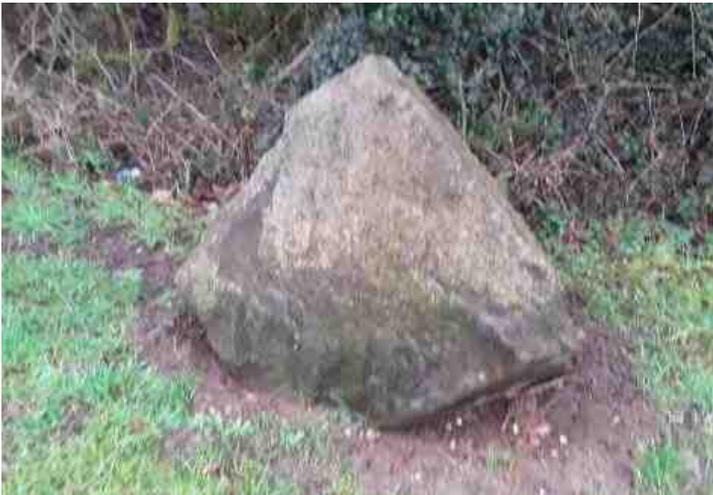
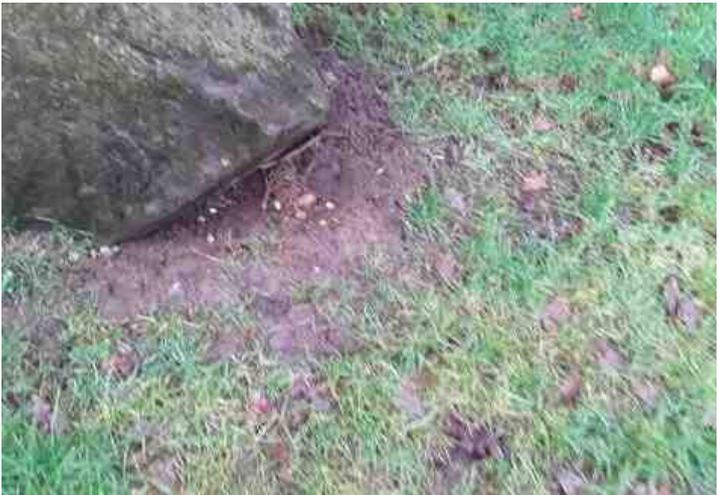
Item:	Other - Boulders	Risk Level:	L - Low Risk
Manufacturer:	Natural Feature	Surface:	Grass

Finding: The area around the item has eroded and may become slippery

Action: Reinstate eroded area

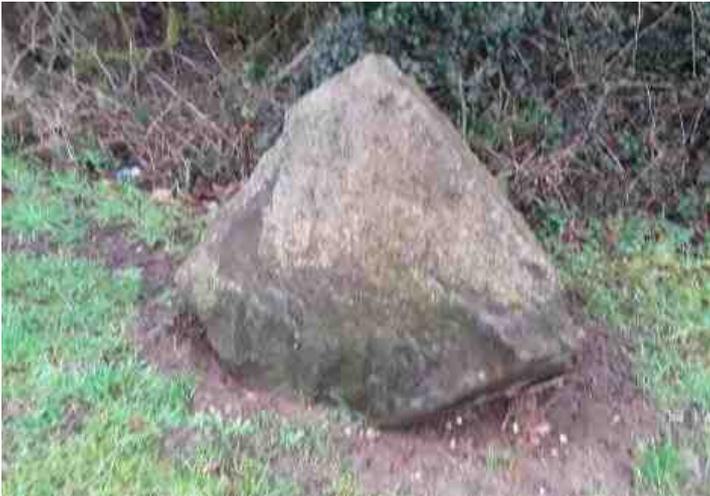
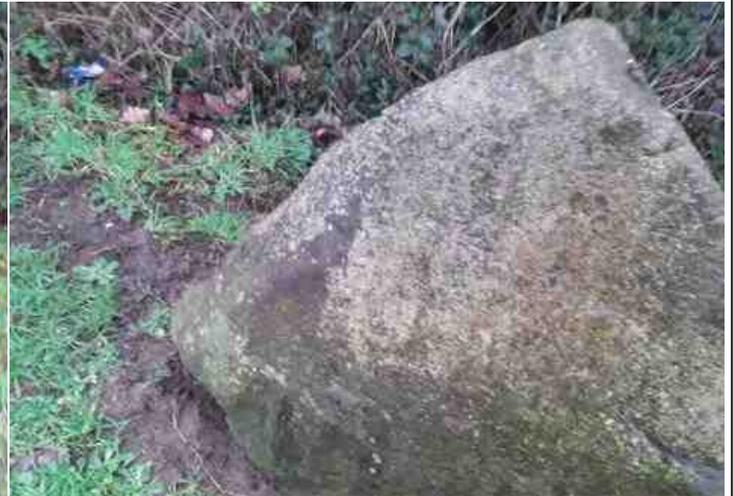
Item: Other - Boulders
Manufacturer: Natural Feature

Finding: The rocks and/or boulders have moss/algae growth apparent

Action: Clean and maintain

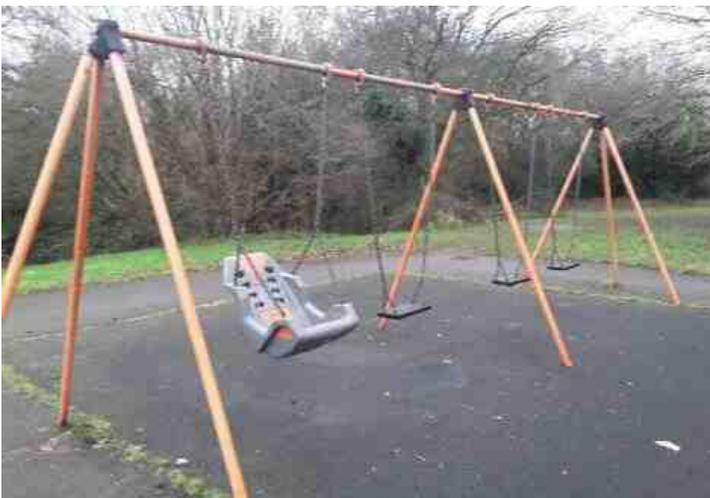
Item: Swings - 2 Bay 4 Seat Swing
Manufacturer: Wicksteed Playgrounds

Finding: The safety surface is beginning to wear

Action: Monitor for any further deterioration and repair as required

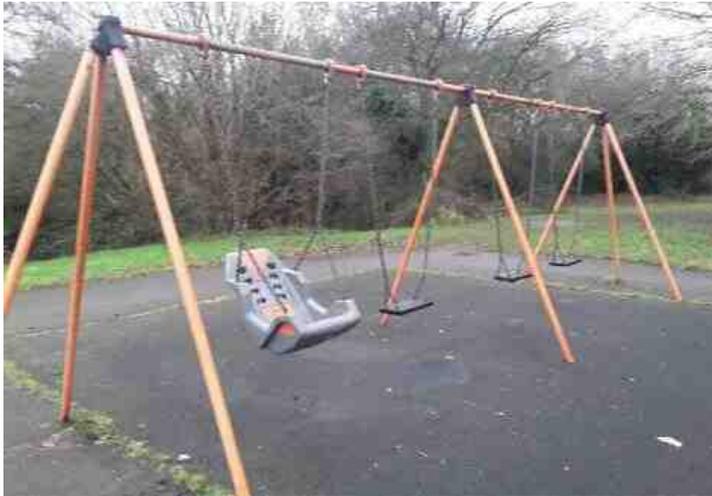
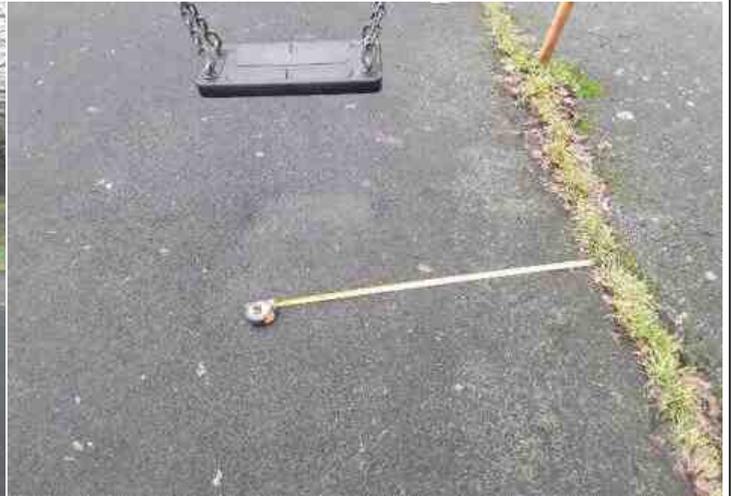
Item: Swings - 2 Bay 4 Seat Swing
Manufacturer: Wicksteed Playgrounds

Finding: The surfacing width under the seat/s is / are less than 875mm when measured from the centre of the seat outwards, and fail the requirements of BS EN 1176 Part 2

Action: Monitor - No action given the risk assessment

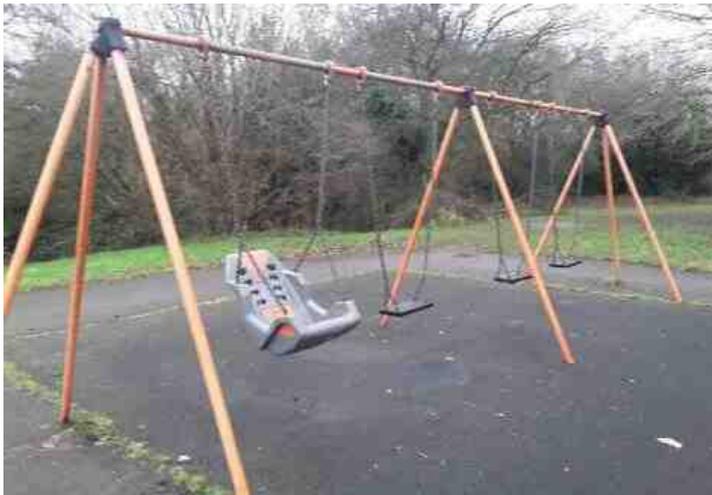
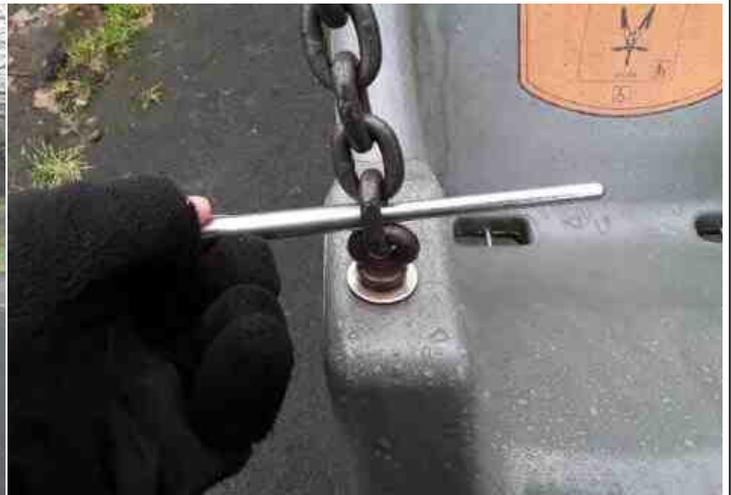
Item: Swings - 2 Bay 4 Seat Swing
Manufacturer: Wicksteed Playgrounds

Finding: The chain openings are in excess of the 8.6mm as recommended by BS EN 1176

Action: Monitor - No action given the risk assessment

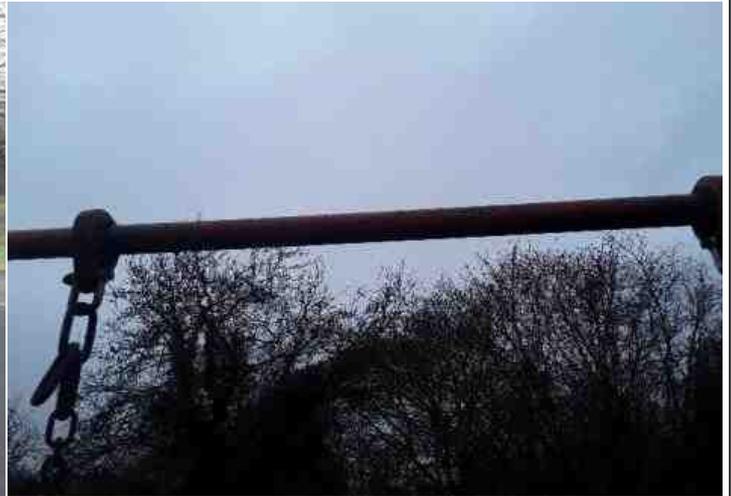
Item: Swings - 2 Bay 4 Seat Swing
Manufacturer: Wicksteed Playgrounds

Finding: There is surface corrosion / rust present on the item

Action: Consider treating the item

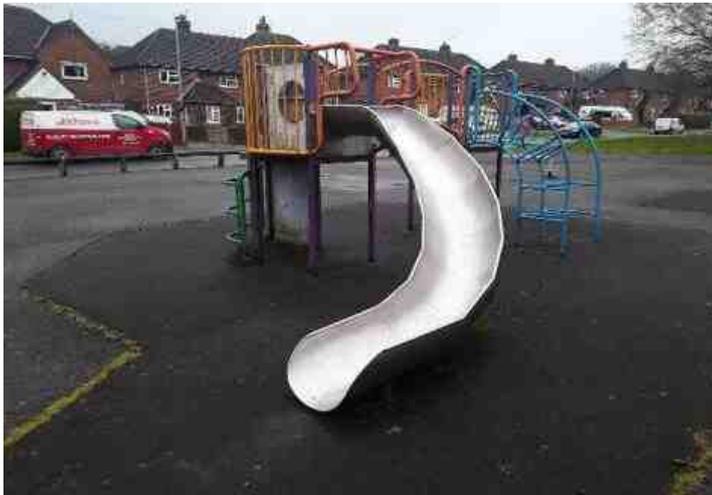
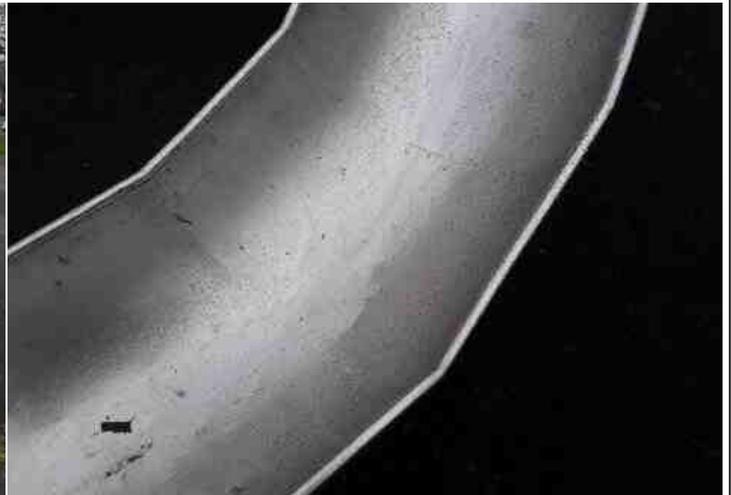
Item: Activity Equipment - Multi Play (Junior)
Manufacturer: Wicksteed Playgrounds

Finding: There are a number of dents in the slide surface

Action: Monitor for any further deterioration and repair as required

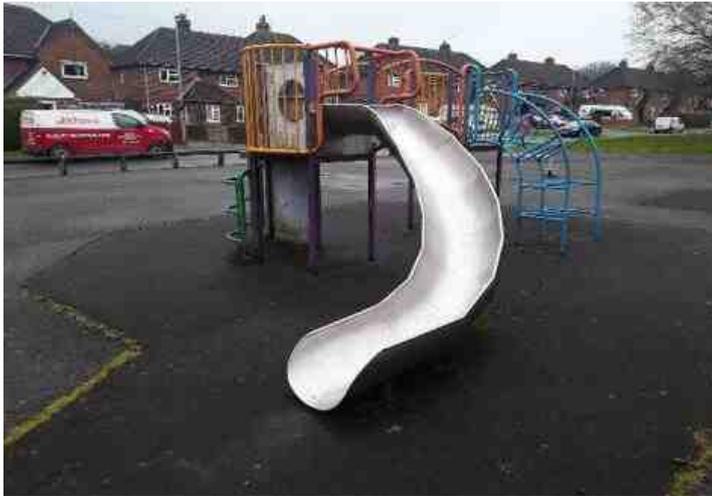
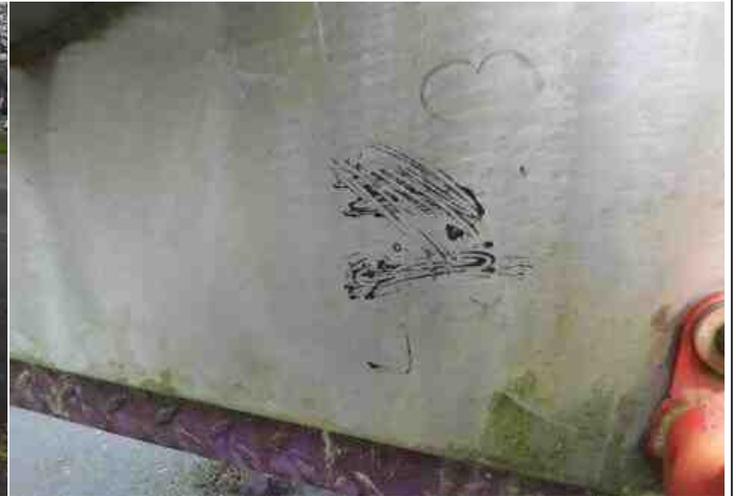
Item: Activity Equipment - Multi Play (Junior)
Manufacturer: Wicksteed Playgrounds

Finding: There is some graffiti present

Action: Remove the graffiti

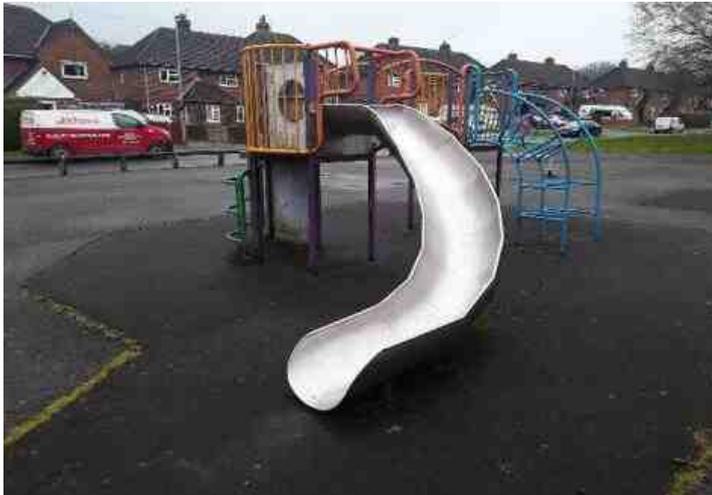
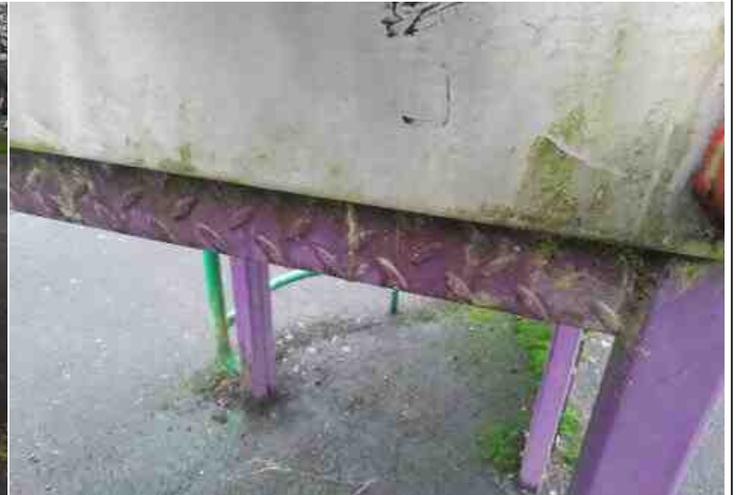
Item: Activity Equipment - Multi Play (Junior)
Manufacturer: Wicksteed Playgrounds

Finding: There is algae or moss on the equipment

Action: Clean and treat appropriately

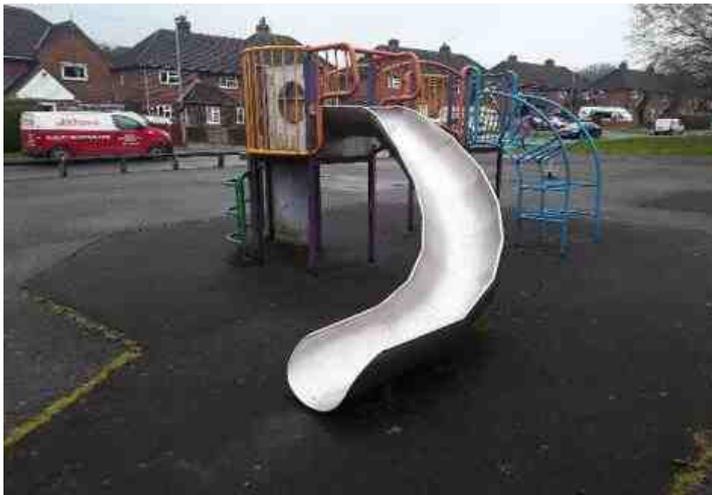
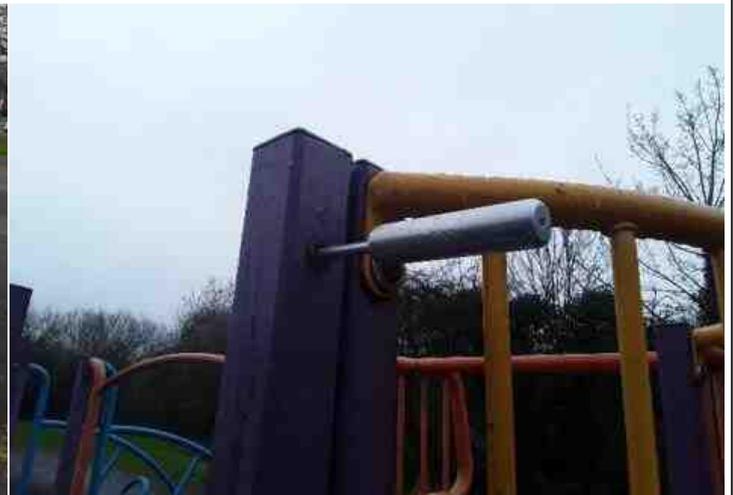
Item: Activity Equipment - Multi Play (Junior)
Manufacturer: Wicksteed Playgrounds

Finding: There is/are inserts missing creating finger entrapment/s in the redundant bolt holes and the item fails to meet the requirements of BS EN 1176 Part 1 4.2.7.6 Entrapment of fingers
Action: Provide inserts

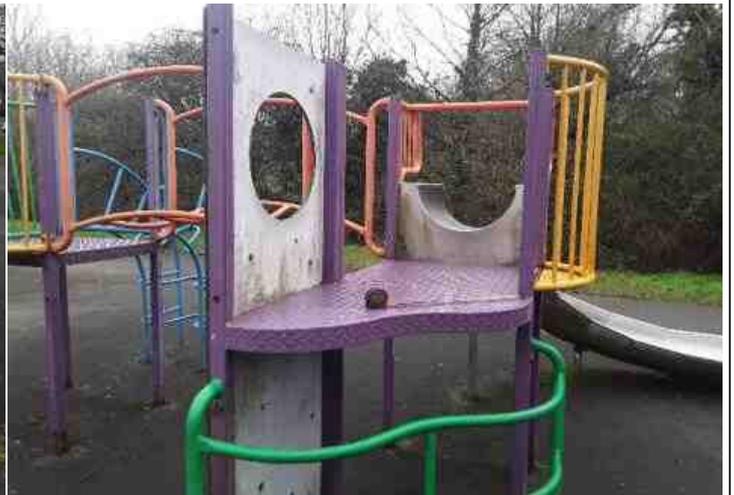
Item: Activity Equipment - Multi Play (Junior)
Manufacturer: Wicksteed Playgrounds

Finding: There is an opening in the barriers exceeding the width allowed (500mm) in BS EN 1176 Part 1, and no guardrail has been provided

Action: Monitor - No action given the risk assessment

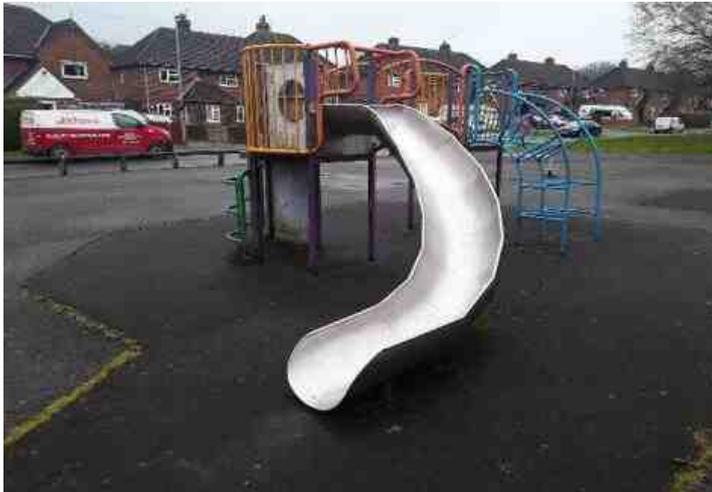
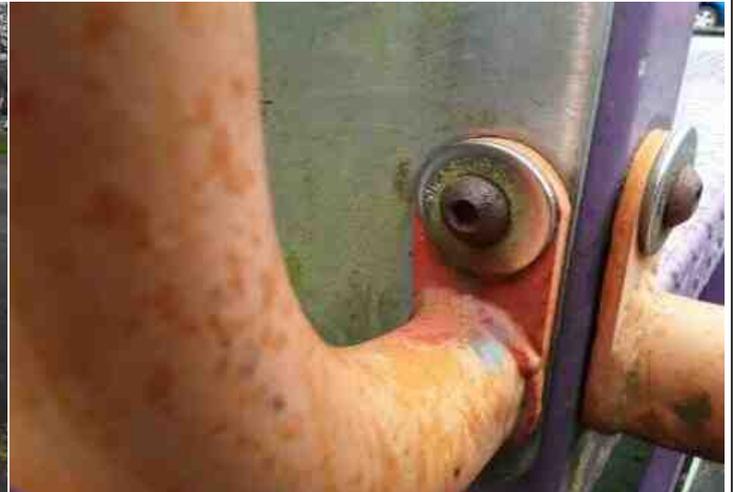
Item: Activity Equipment - Multi Play (Junior)
Manufacturer: Wicksteed Playgrounds

The fixings have corroded - Replace all corroded fixings

Finding: The fixings have corroded

Action: Replace all corroded fixings

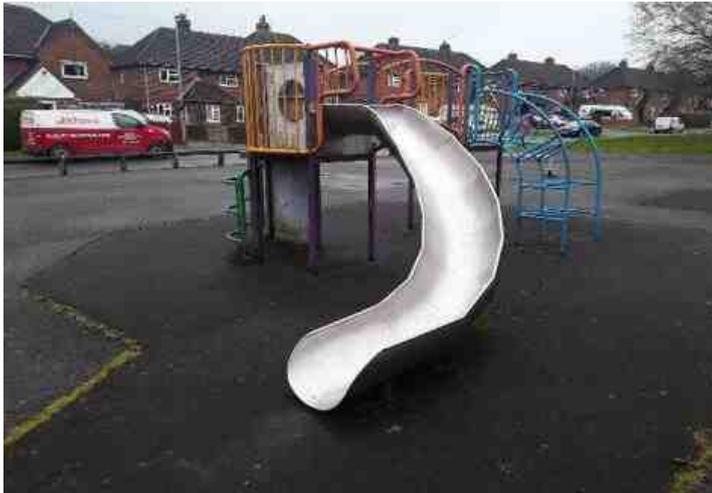
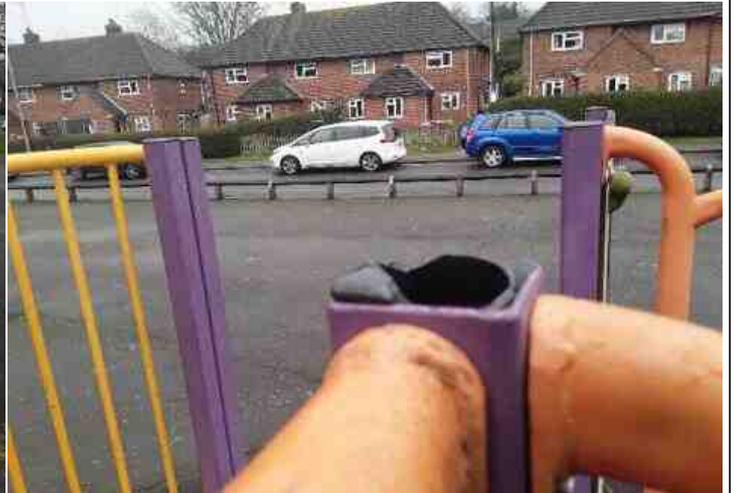
Item: Activity Equipment - Multi Play (Junior)
Manufacturer: Wicksteed Playgrounds

There is / are post or end caps missing / damaged on the item - Replace missing / damaged post or end caps

Finding: There is / are post or end caps missing / damaged
Action: Replace missing / damaged post or end caps on the item

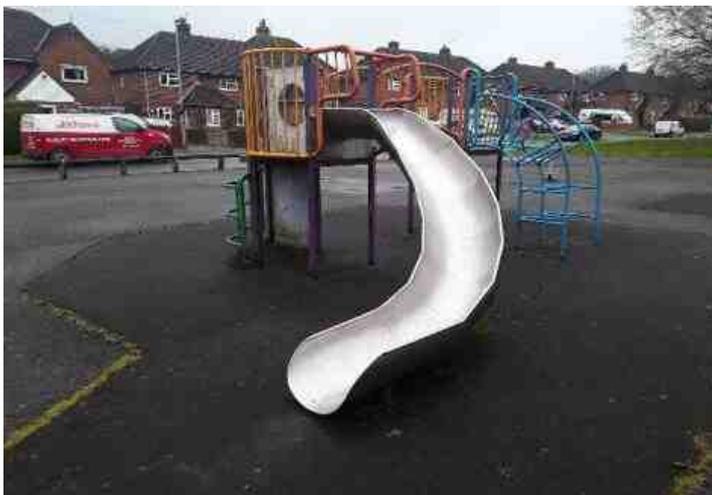
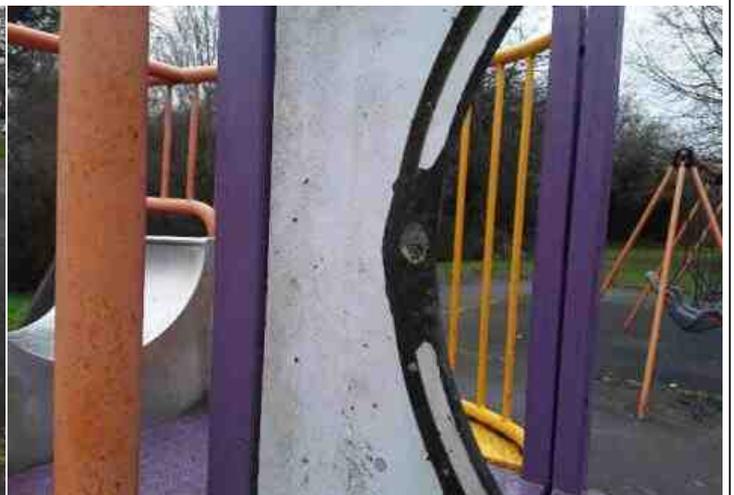
Item: Activity Equipment - Multi Play (Junior)
Manufacturer: Wicksteed Playgrounds

The climbing wall panel is damaged - Remove the sharp edges and monitor

Finding: The climbing wall panel is damaged
Action: Remove the sharp edges and monitor

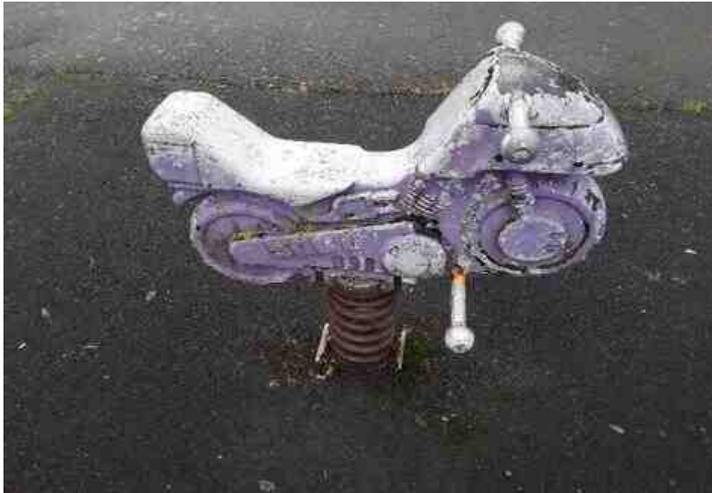
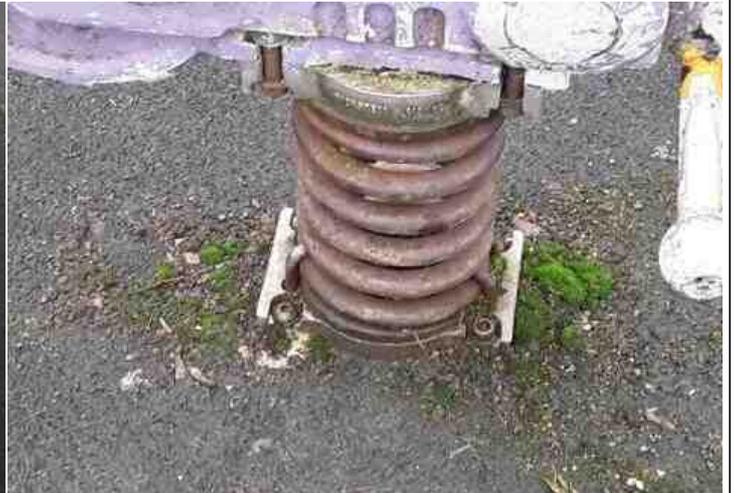
Item: Rocking Equipment - Spring Bike
Manufacturer: Wicksteed Playgrounds

The spring cover is damaged, split or missing - Replace the cover

Finding: The spring cover is damaged, split or missing

Action: Replace the cover

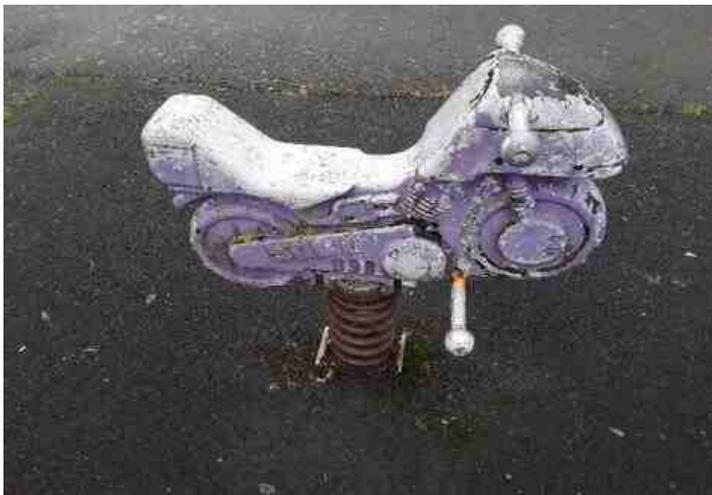
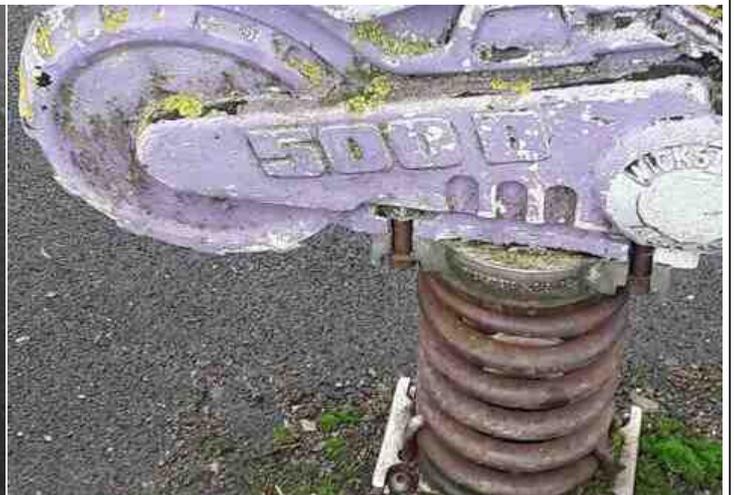
Item: Rocking Equipment - Spring Bike
Manufacturer: Wicksteed Playgrounds

Finding: There is surface corrosion / rust present on the item

Action: Consider treating the item

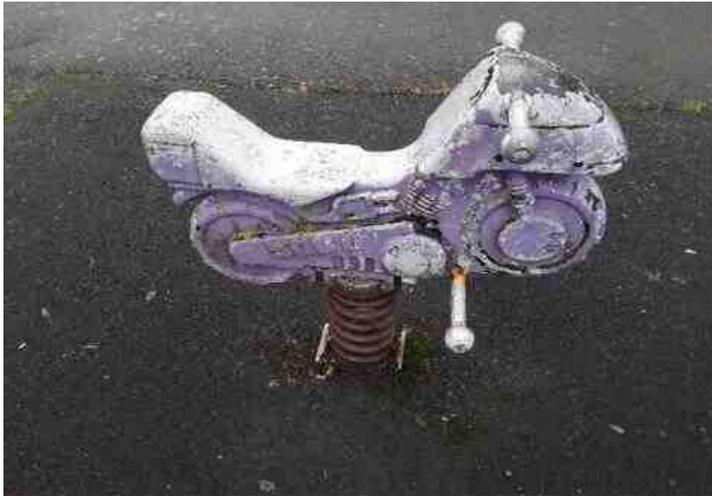
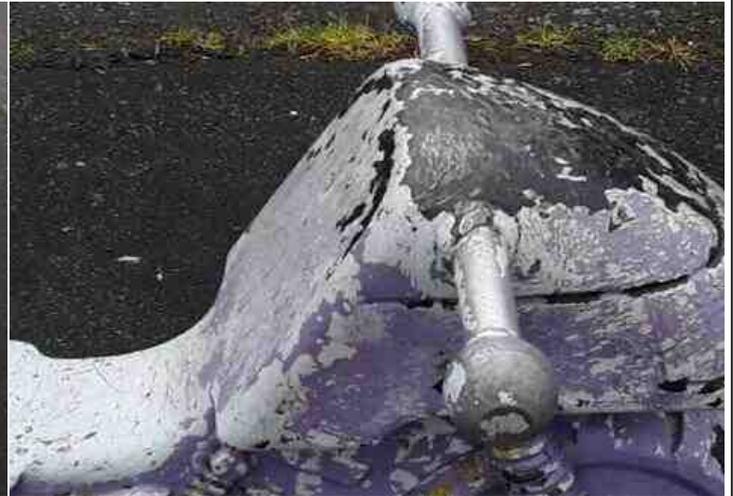
Item: Rocking Equipment - Spring Bike
Manufacturer: Wicksteed Playgrounds

Finding: The paint is flaking off the metalwork

Action: Rub down and re-paint

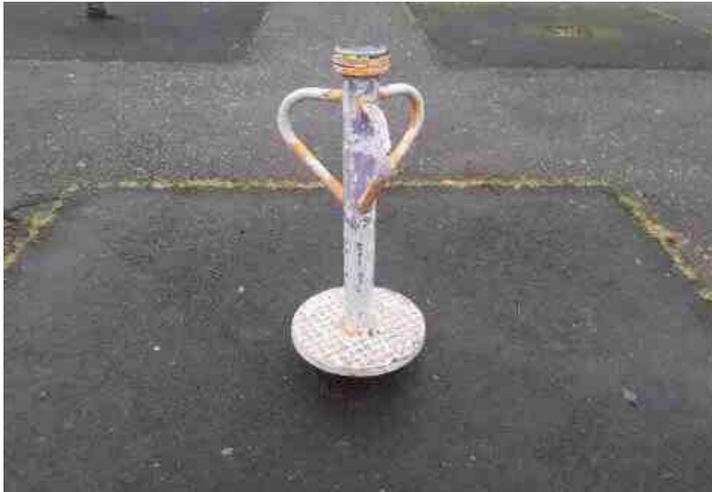
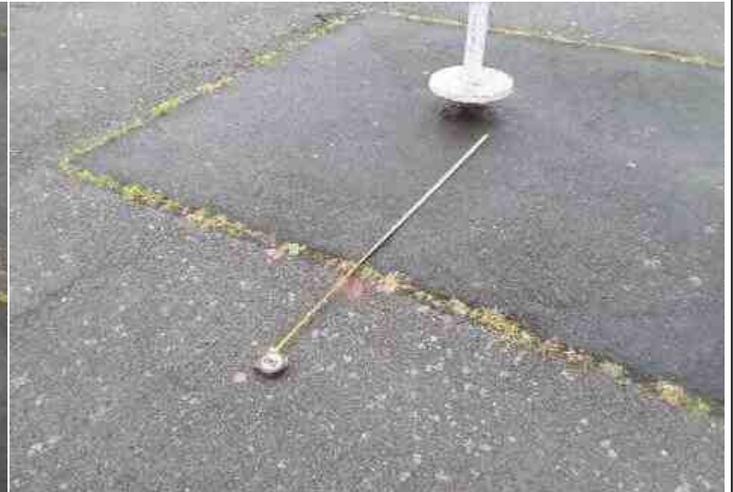
Item: Rotor Play - Low Rotator
Manufacturer: Wicksteed Playgrounds

Finding: The surfacing dimensions are short and do not meet with the requirements of the current applicable standard

Action: Monitor - No action given the risk assessment

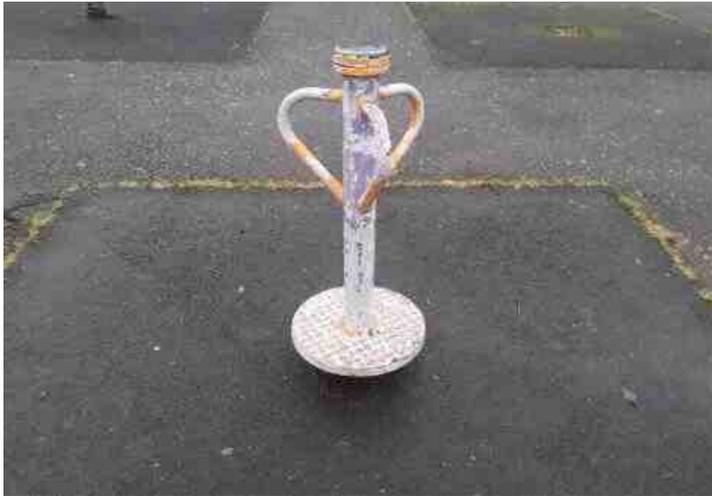
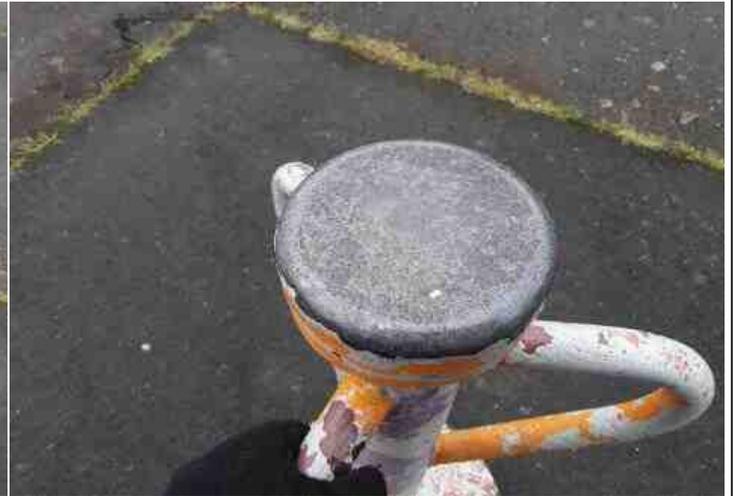
Item: Rotor Play - Low Rotator
Manufacturer: Wicksteed Playgrounds

Finding: The paint is flaking off the metalwork

Action: Rub down and re-paint

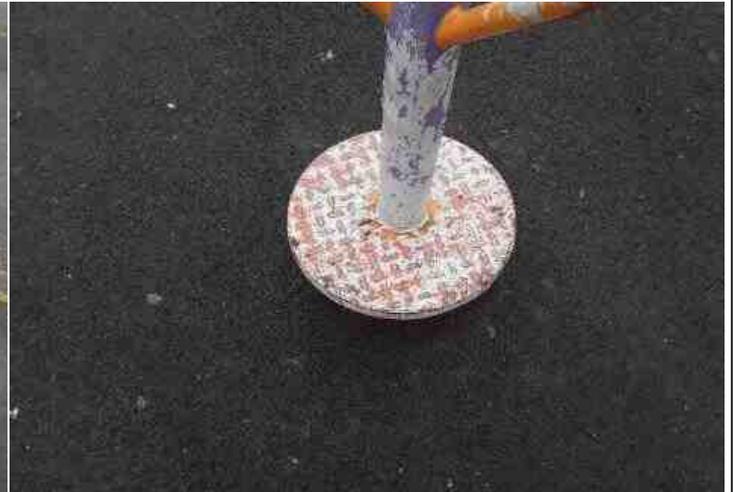
Item: Rotor Play - Low Rotator
Manufacturer: Wicksteed Playgrounds

Finding: The bearing on the unit is dry

Action: Service and lubricate the bearing(s)

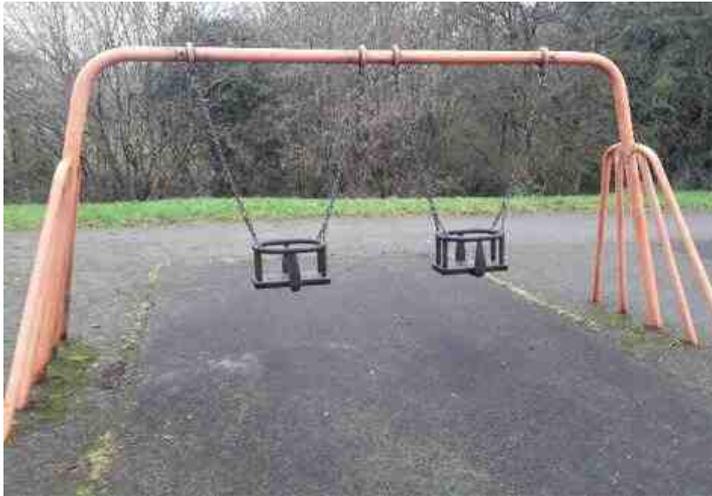
Item: Swings - 1 Bay 2 Seat (Cradle)
Manufacturer: Wicksteed Playgrounds

Finding: The bushes are showing signs of wear

Action: Monitor for any further deterioration and replace as required

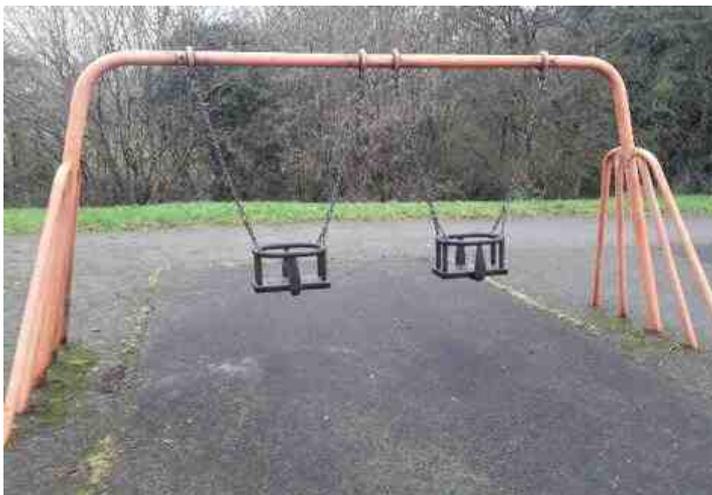
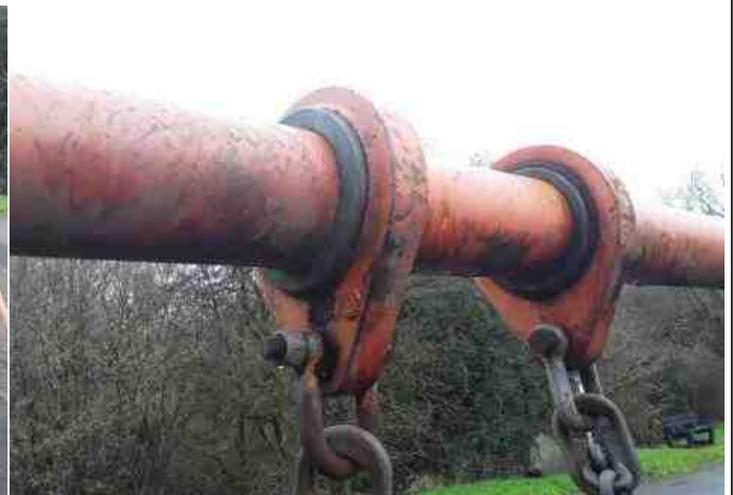
Item: Swings - 1 Bay 2 Seat (Cradle)
Manufacturer: Wicksteed Playgrounds

Finding: The Anti Wrap bearings are dry / worn

Action: Replace the anti wrap bearings

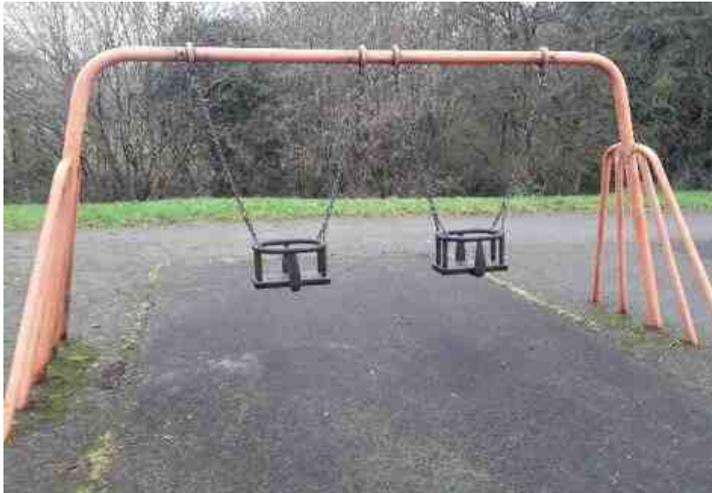
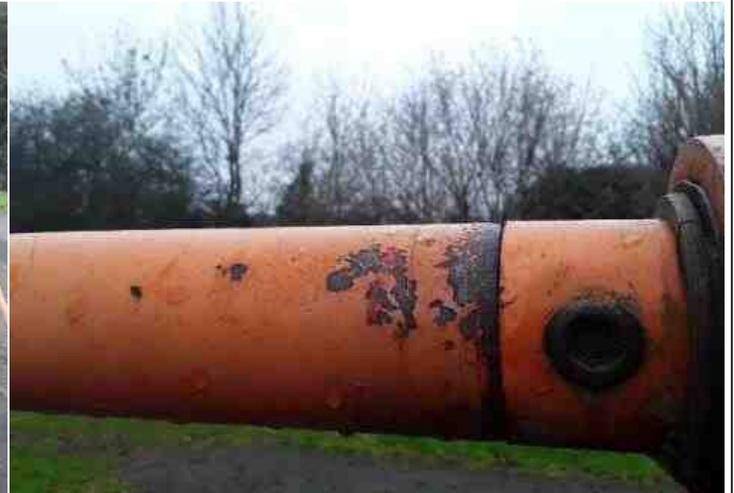
Item: Swings - 1 Bay 2 Seat (Cradle)
Manufacturer: Wicksteed Playgrounds

Finding: The paintwork on this item has been damaged or worn exposing the metal underneath which is rusting / corroding

Action: Treat affected areas and repaint

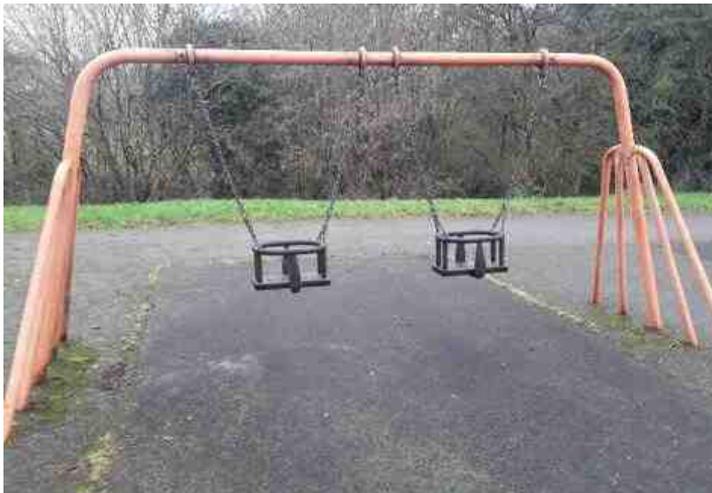
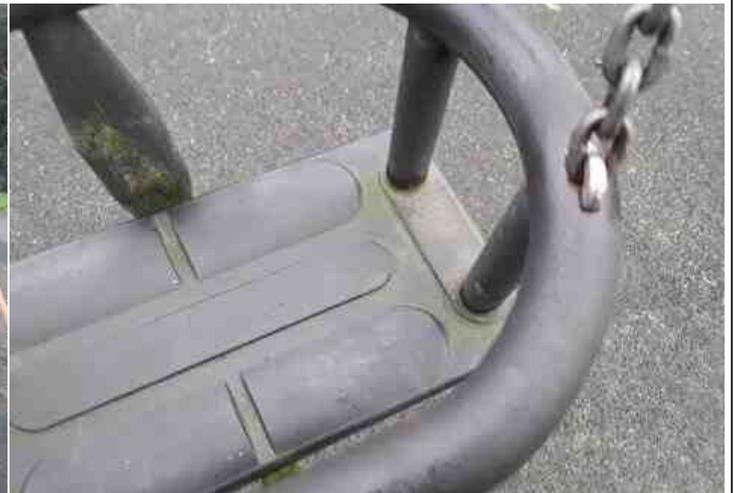
Item: Swings - 1 Bay 2 Seat (Cradle)
Manufacturer: Wicksteed Playgrounds

Finding: There is algae or moss on the equipment

Action: Clean and treat appropriately

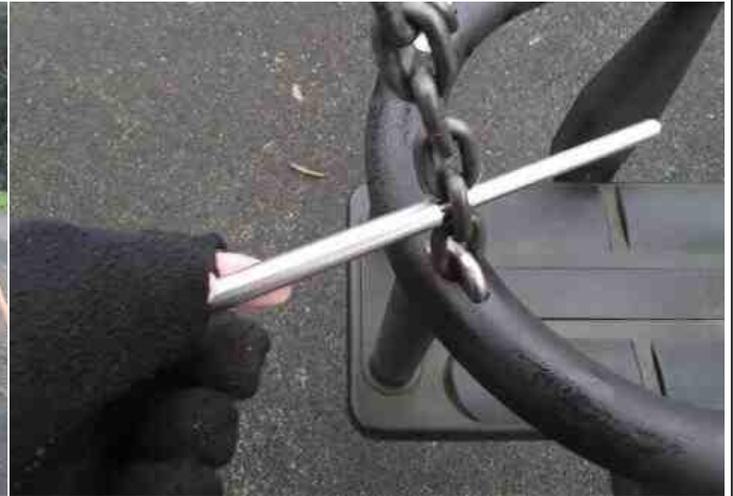
Item: Swings - 1 Bay 2 Seat (Cradle)
Manufacturer: Wicksteed Playgrounds

Finding: The chain openings are in excess of the 8.6mm as recommended by BS EN 1176 **Action:** Monitor - No action given the risk assessment

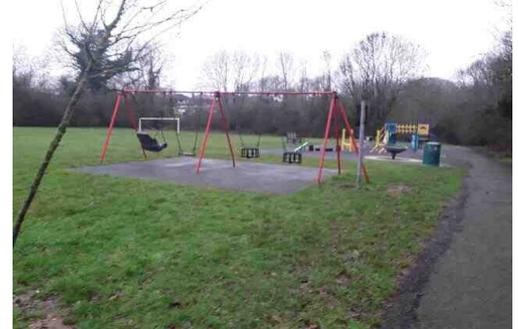
Item: Site General
Manufacturer: Owner/Operator
Surface Type: N/A
Item Quantity: 1
Equipment Compliance: N/A
Surface Area Compliance: N/A

The footpath is worn / damaged which has created trip hazards - Remove the trip hazards

The wet pour safety surface is lifting at the edges and creating trip points - Repair perimeter of surfacing to remove trip points

There is algae, silt or moss growth on the bitmac surface resulting in slippery conditions - Clean and treat appropriately

There are a number of molehills within the area and these may present unforeseen hazards for users - Remove moles by appropriate means, reinstate surfaces to level and maintain the area

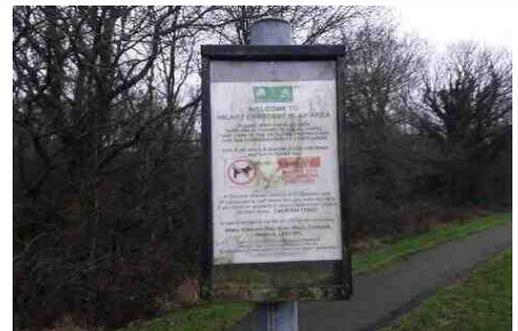
Item: Sign
Manufacturer: Not Identified
Surface Type: Grass
Item Quantity: 1
Equipment Compliance: N/A
Surface Area Compliance: N/A

There is surface corrosion / rust present on the item - Consider treating the item

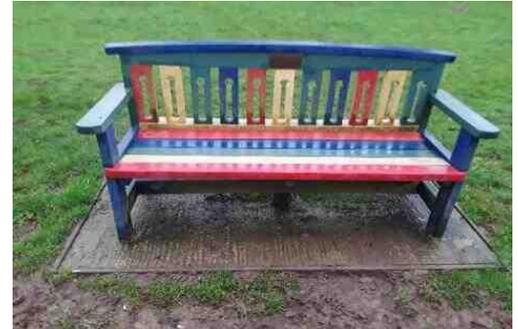
Item: Bench
Manufacturer: Not Identified
Surface Type: Concrete
Item Quantity: 1
Equipment Compliance: N/A
Surface Area Compliance: N/A

The area around the item has eroded creating trip hazards and may become slippery when wet - Reinstate eroded area

There are gaps opening between the concrete and the edging surround - Monitor for any further deterioration and repair as required

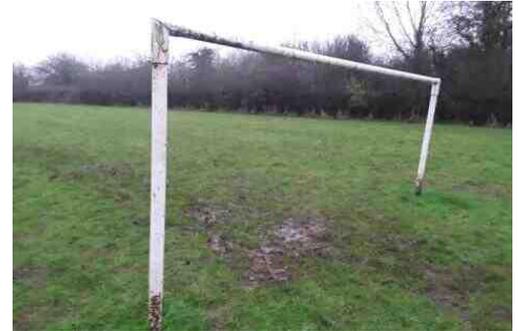
Item: 5 a side Goals
Manufacturer: Not Identified
Surface Type: Grass
Item Quantity: 1
Equipment Compliance: N/A
Surface Area Compliance: N/A
Life Expectancy: 5 -10 Years
Total Findings: 5

NB: We have undertaken a maintenance inspection only of the football goal(s); full load testing falls outside the scope of our inspection. - Implement load testing as required

The paintwork on this item has been damaged or worn exposing the metal underneath which is rusting / corroding - Treat affected areas and repaint

The item is slightly loose in its foundations - Monitor for any further deterioration and repair as required

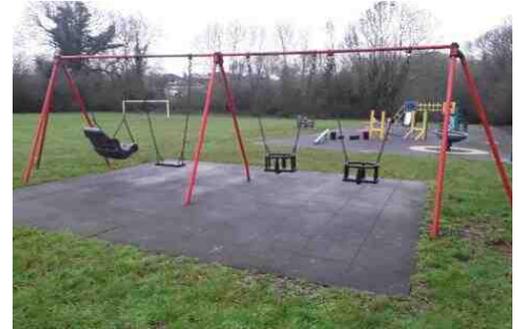
Item: 2 Bay Swing
Manufacturer: Wicksteed Playgrounds
Surface Type: Mixed Surface
Item Quantity: 1
Equipment Compliance: No
Surface Area Compliance: Yes
Life Expectancy: >10 Years
Total Findings: 8

There are trip hazards at the edges of the tiled surface - Remove trip hazard

The chain openings are in excess of the 8.6mm as recommended by BS EN 1176 - Monitor - No action given the risk assessment

The seat is damaged and requires replacing - Replace damaged seat

The paintwork on this item has been damaged or worn exposing the metal underneath which is rusting / corroding - Treat affected areas and repaint

There is some evidence of fire damage to the surfacing - Monitor for any further deterioration and repair as required

There are gaps opening in between the tiles - Monitor for any further deterioration and repair as required

The bush / bushes is / are worn or missing - Replace worn or missing bushes

There is minor distortion damage to the frame - Monitor and repair if required

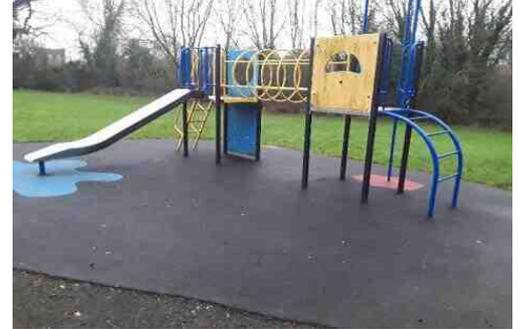
Item: Multi Play (Junior)
Manufacturer: Action Play and Leisure
Surface Type: Wet Pour
Item Quantity: 1
Equipment Compliance: Yes
Surface Area Compliance: Yes
Life Expectancy: >10 Years
Total Findings: 3

The slide is predominately south facing and will catch the majority of the sun's heat during the day. Slide surfaces can become very warm during periods of sustained sunny weather - Monitor - No action given the risk assessment

There are a number of dents in the slide surface - Monitor for any further deterioration and repair as required

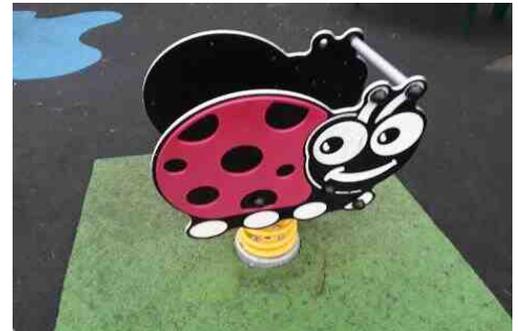
Item: Spring Ladybird
Manufacturer: Action Play and Leisure
Surface Type: Wet Pour
Item Quantity: 1
Equipment Compliance: Yes
Surface Area Compliance: Yes
Life Expectancy: 5 -10 Years
Total Findings: 1

The Handgrips/Footrests rotate and may cause an unexpected movement for the user - Secure Handgrips/Footrests to prevent rotation.

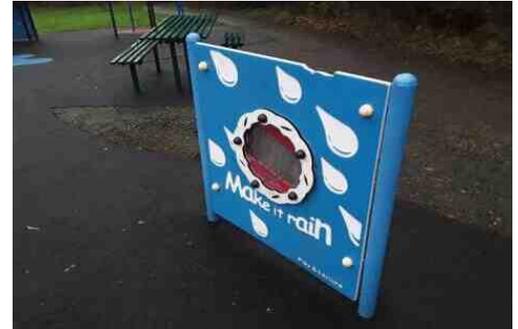
Item: Play Panel
Manufacturer: Action Play and Leisure
Surface Type: Wet Pour
Item Quantity: 1
Equipment Compliance: Yes
Surface Area Compliance: N/A
Life Expectancy: >10 Years
Total Findings: 2

The centre piece doesn't rotate / has seized - Replace the panel

There is vandalism damage to the panel exposing sharp edges - Replace the panel

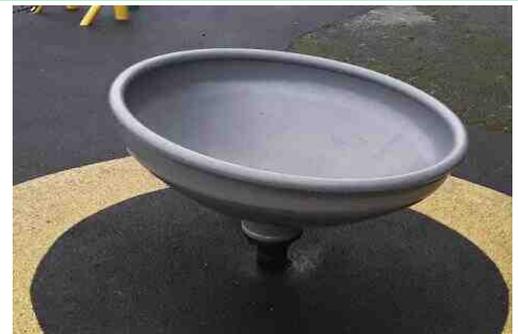
Item: Dish Roundabout
Manufacturer: Action Play and Leisure
Surface Type: Wet Pour
Item Quantity: 1
Equipment Compliance: Yes
Surface Area Compliance: Yes
Life Expectancy: 5 -10 Years
Total Findings: 3

There is some graffiti present - Remove the graffiti

The bearing is noisy / showing signs of wear - Monitor for any further deterioration and replace as required

There are a number of dents in the bowl surface - Monitor for any further deterioration and repair as required
