NOTICE OF PROPERTY MANAGEMENT AND GENERAL PURPOSES COMMITTEE MEETING

Thursday 5th March 2026 7pm

AGENDA

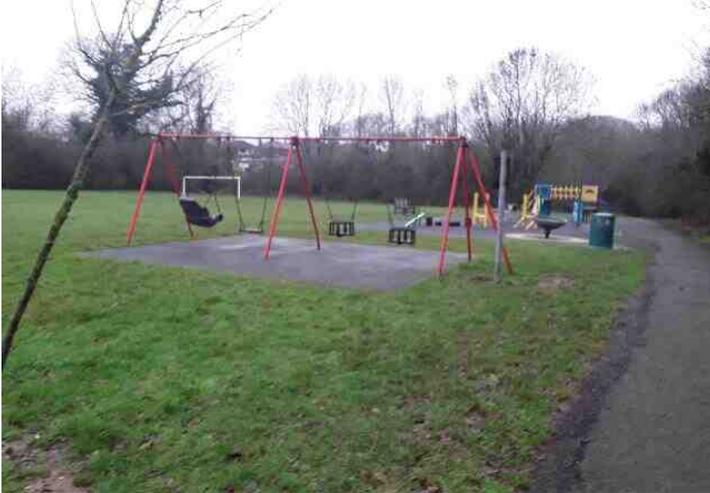
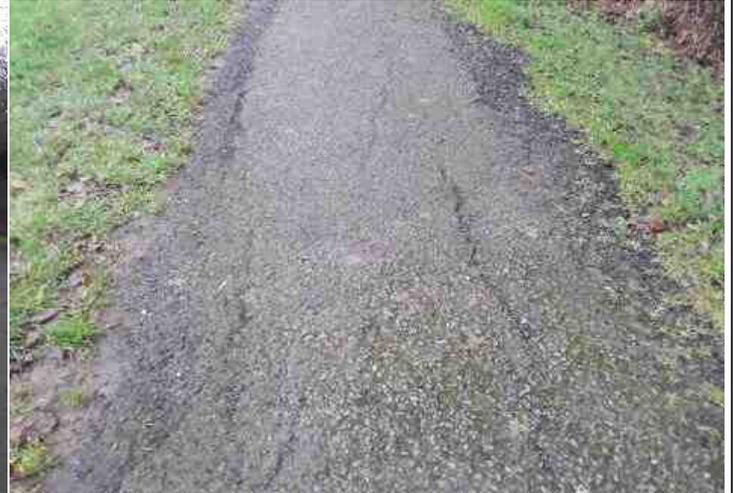
Item: Ancillary Items - Site General
Manufacturer: Owner/Operator

Finding: The footpath is worn / damaged which has created trip hazards
Action: Remove the trip hazards

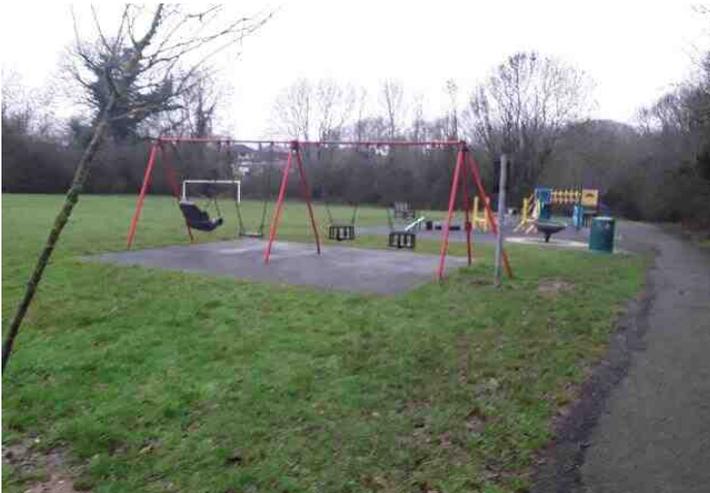
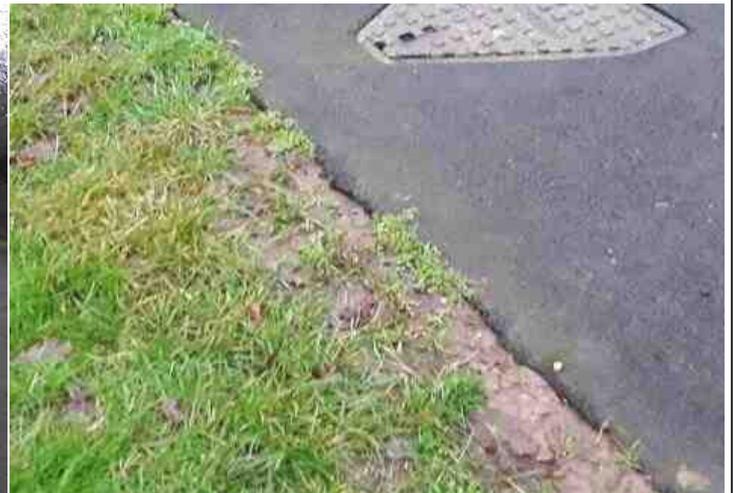
Item: Ancillary Items - Site General
Manufacturer: Owner/Operator

Finding: The wet pour safety surface is lifting at the edges and creating trip points
Action: Repair perimeter of surfacing to remove trip points

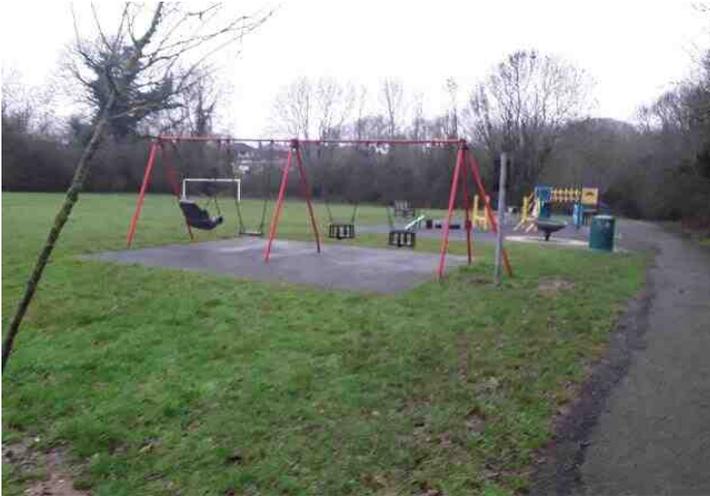
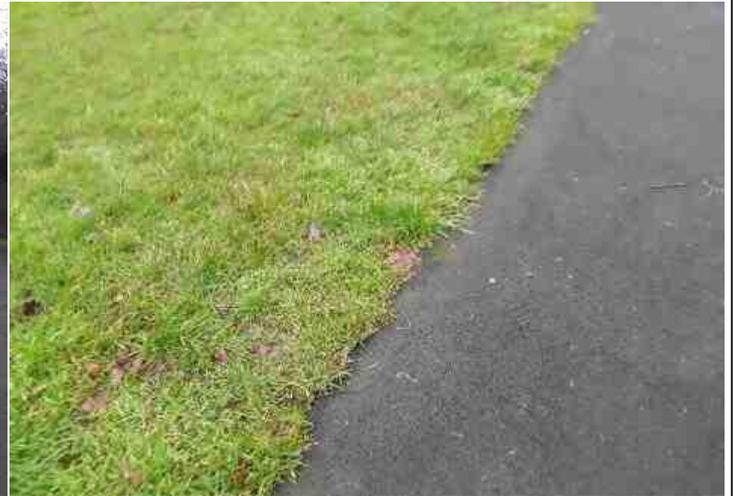
Item: Ancillary Items - Site General
Manufacturer: Owner/Operator

Finding: There is weed / vegetation growth on and around the surface

Action: Remove weed / vegetation growth

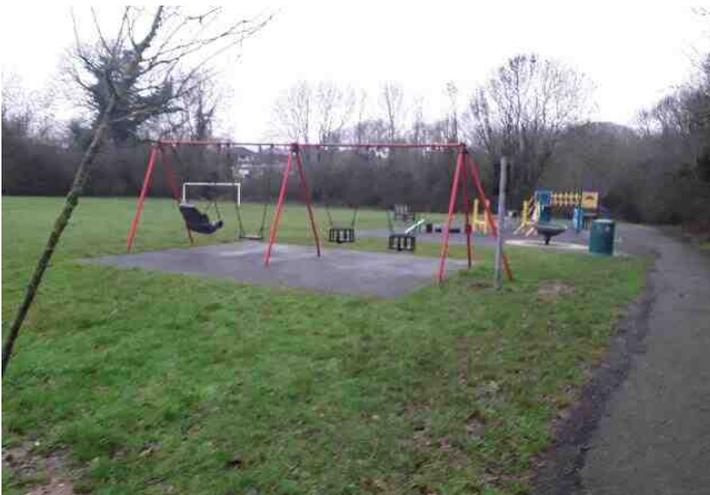
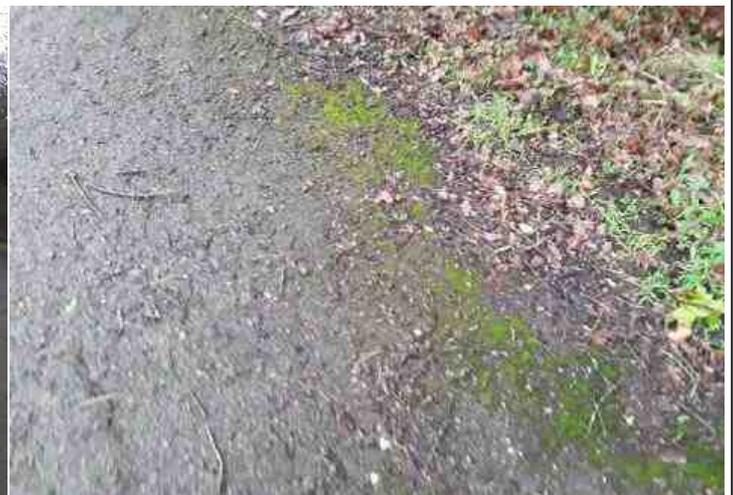
Item: Ancillary Items - Site General
Manufacturer: Owner/Operator

Finding: There is algae, silt or moss growth on the bitmac surface resulting in slippery conditions

Action: Clean and treat appropriately

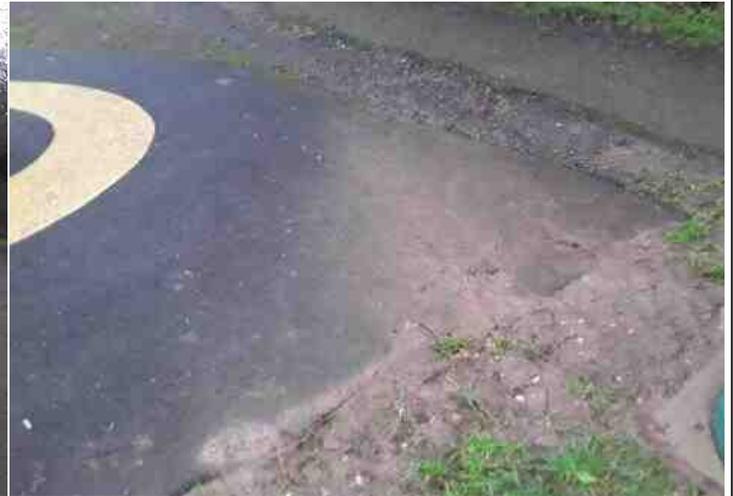
Item: Ancillary Items - Site General
Manufacturer: Owner/Operator

Finding: Soil has migrated onto the wet pour safety surface **Action:** Remove the soil

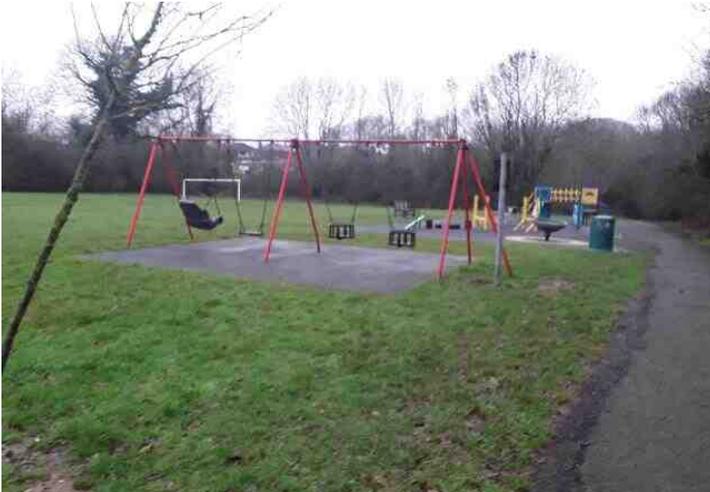
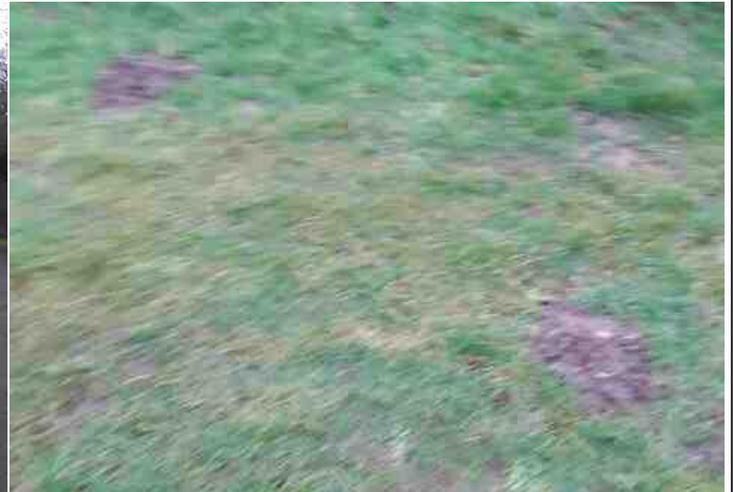
Item: Ancillary Items - Site General
Manufacturer: Owner/Operator

Finding: There are a number of molehills within the area and these may present unforeseen hazards for users **Action:** Remove moles by appropriate means, reinstate surfaces to level and maintain the area

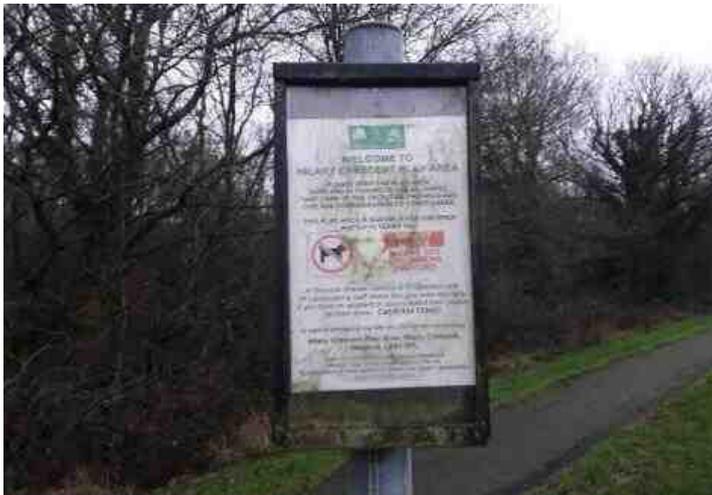
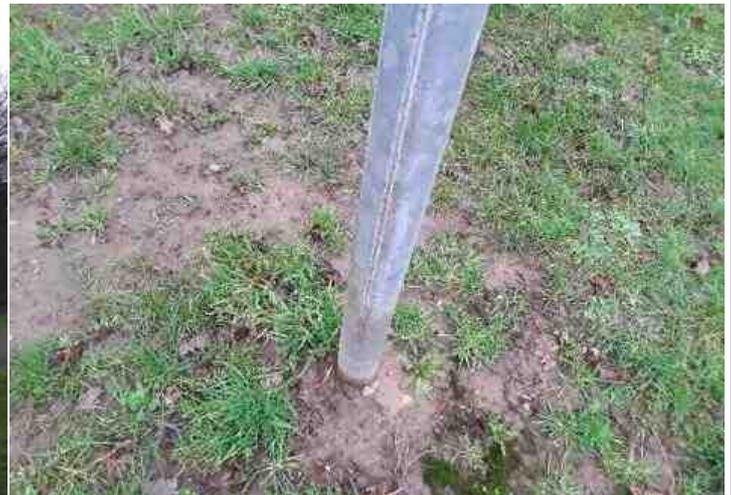
Item: Ancillary Items - Sign
Manufacturer: Not Identified
Risk Level: L - Low Risk
Surface: Grass

Finding: There is surface corrosion / rust present on the item
Action: Consider treating the item

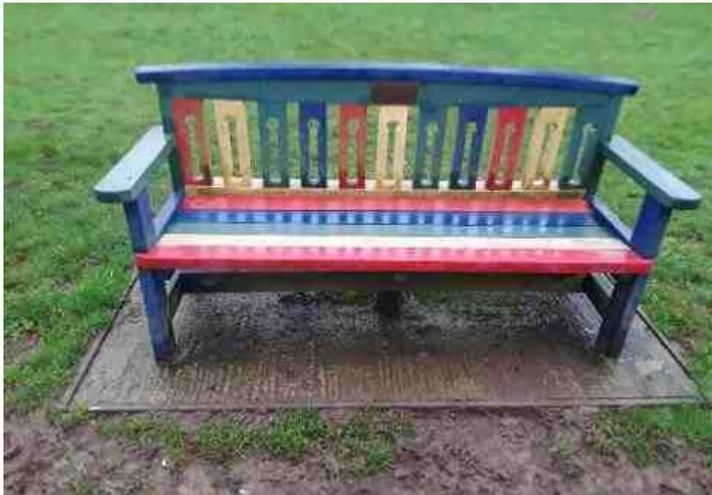
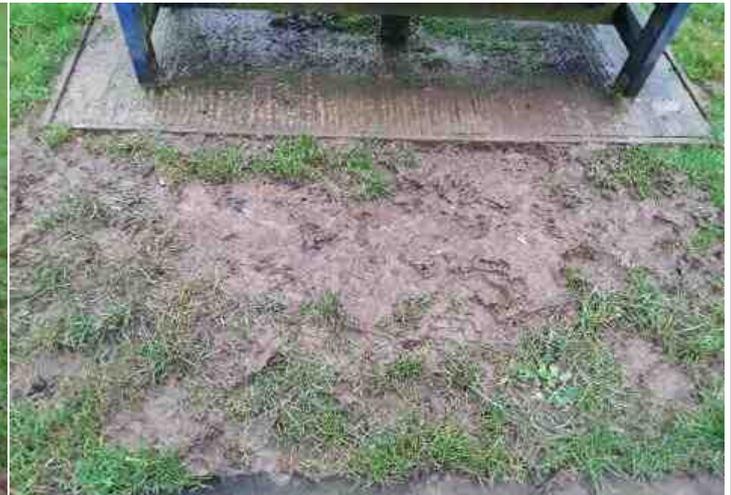
8 - Low Risk (Finding 1)

Item: Ancillary Items - Bench
Manufacturer: Not Identified
Risk Level: L - Low Risk
Surface: Concrete

Finding: The area around the item has eroded creating trip hazards and may become slippery when wet
Action: Reinstate eroded area

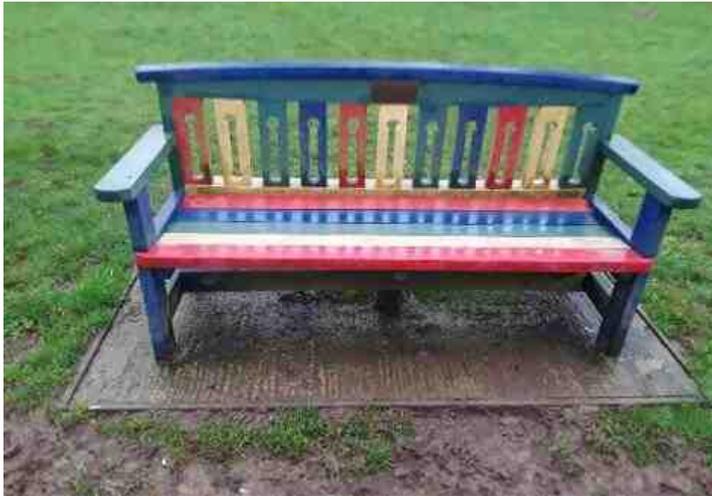
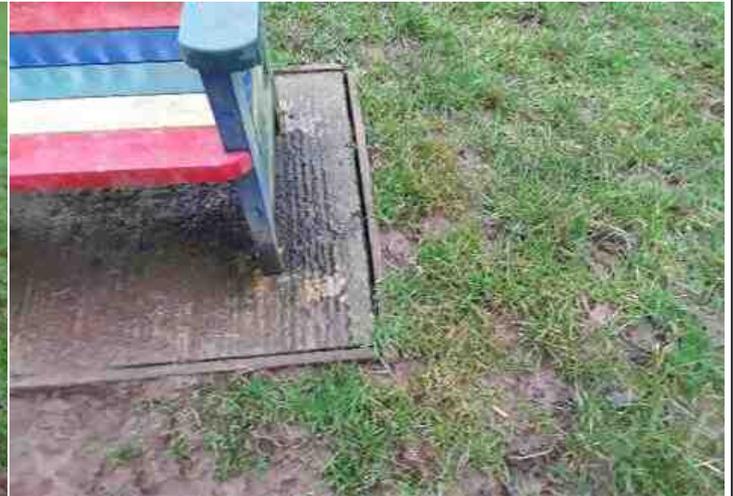
6 - Low Risk (Finding 2)

Item: Ancillary Items - Bench
Manufacturer: Not Identified

Finding: There are gaps opening between the concrete and the edging surround
Action: Monitor for any further deterioration and repair as required

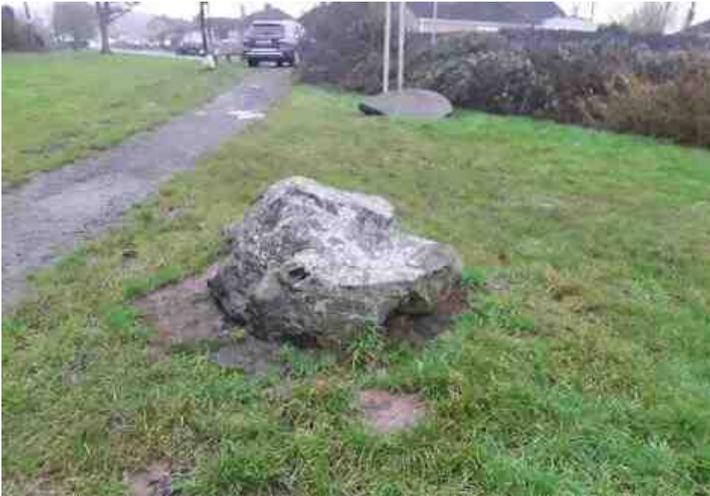
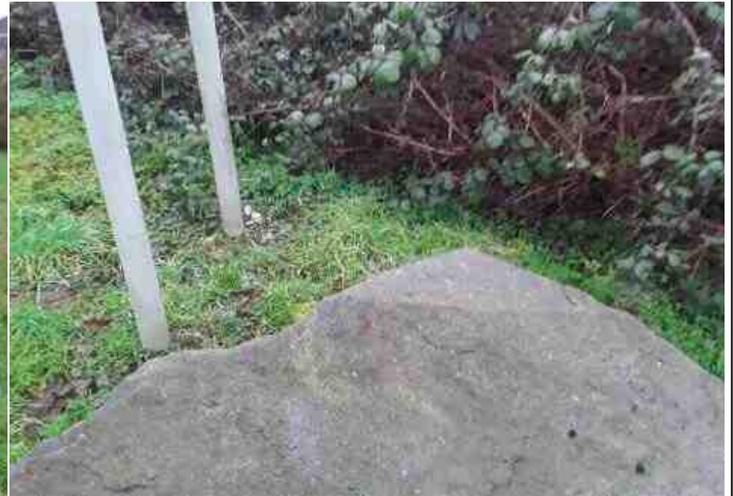
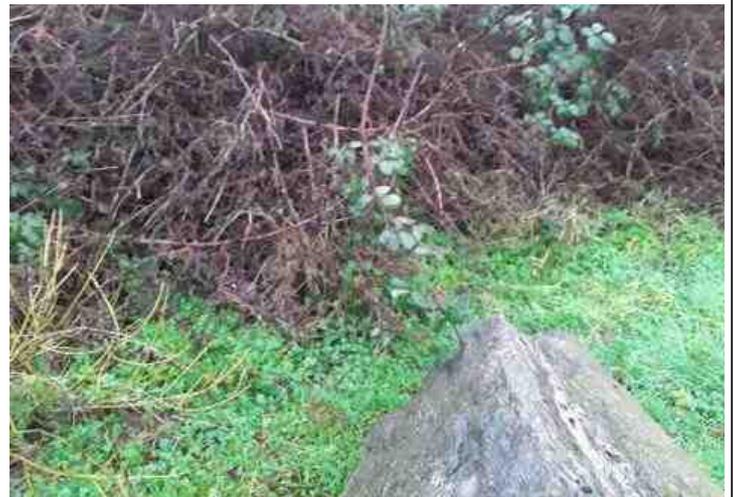
i 5 - Very Low Risk (Finding 1)

Item: Other - Boulders
Manufacturer: Natural Feature

Finding: The adjacent foliage and post form projecting obstacles / hard objects within the falling space of the equipment, in contravention of the requirements of BS EN 1176 Part 1

Action: Monitor - No action given the risk assessment

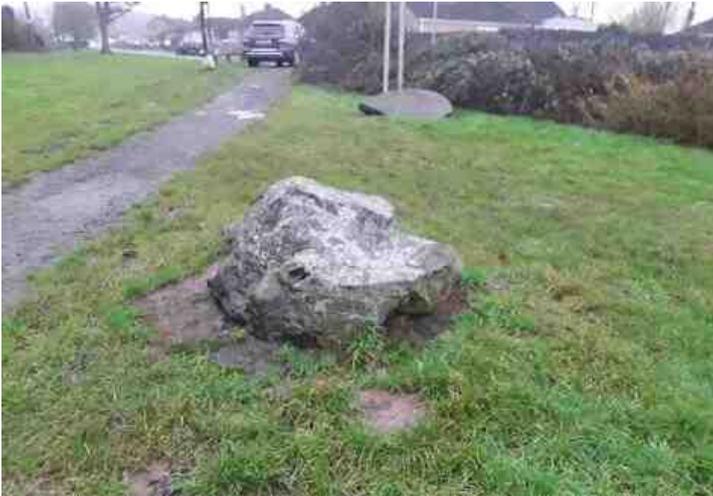
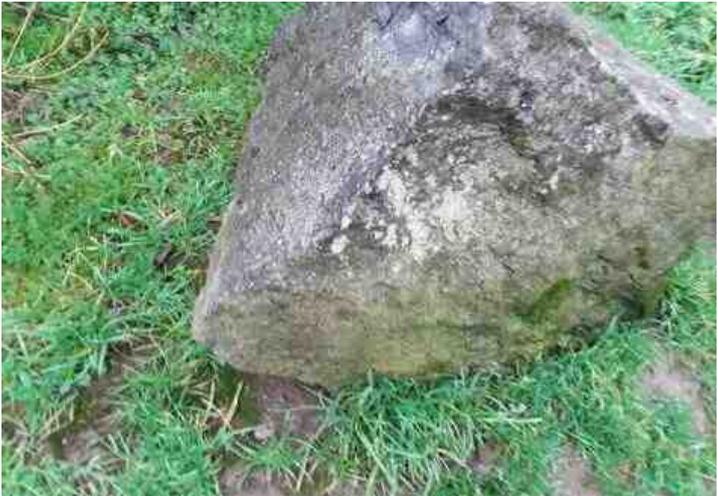
8 - Low Risk (Finding 2)

Item:	Other - Boulders	Risk Level:	L - Low Risk
Manufacturer:	Natural Feature	Surface:	Grass

Finding: The rocks and/or boulders have moss/algae growth apparent

Action: Clean and maintain

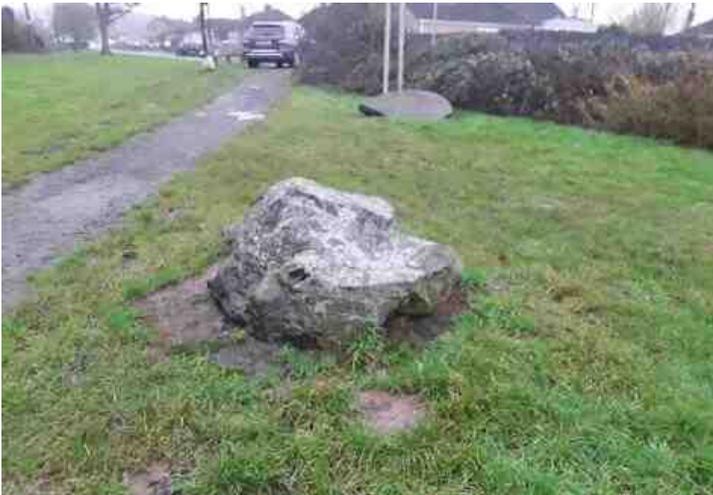
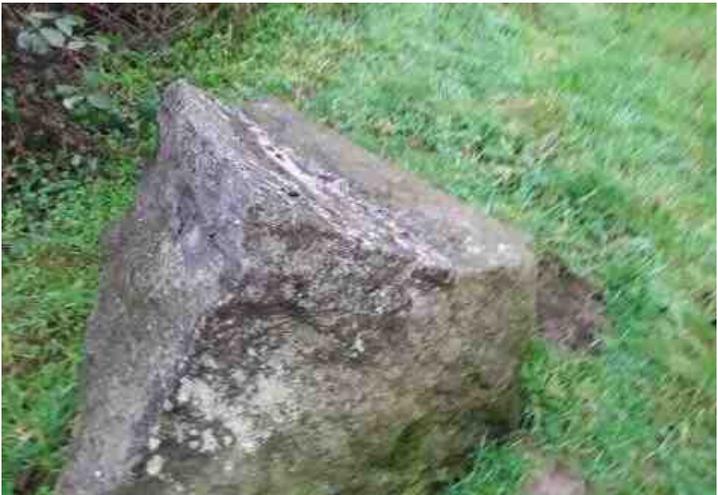
8 - Low Risk (Finding 3)

Item:	Other - Boulders	Risk Level:	L - Low Risk
Manufacturer:	Natural Feature	Surface:	Grass

Finding: The rocks and/or boulders have sharp edges that are exposed to the user

Action: Remove all sharp edges

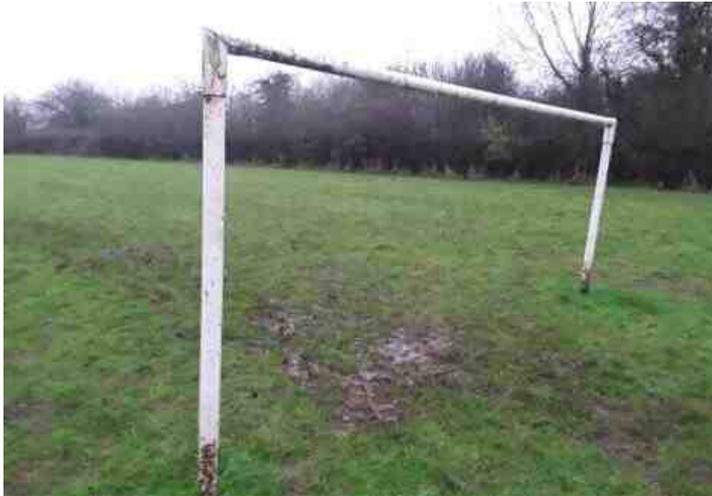
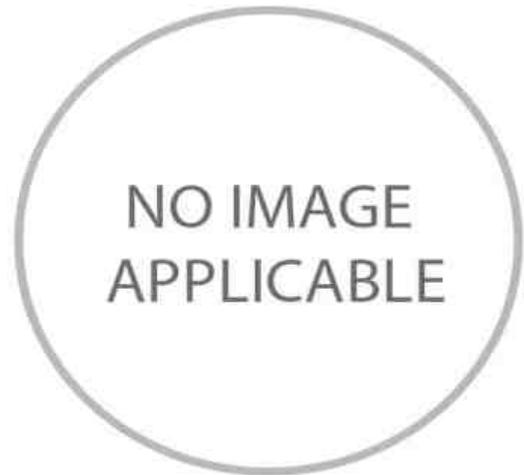
Item: Multi Use Games Area - 5 a side Goals
Manufacturer: Not Identified

Finding: NB: We have undertaken a maintenance inspection only of the football goal(s); full load testing falls outside the scope of our inspection.

Action: Implement load testing as required

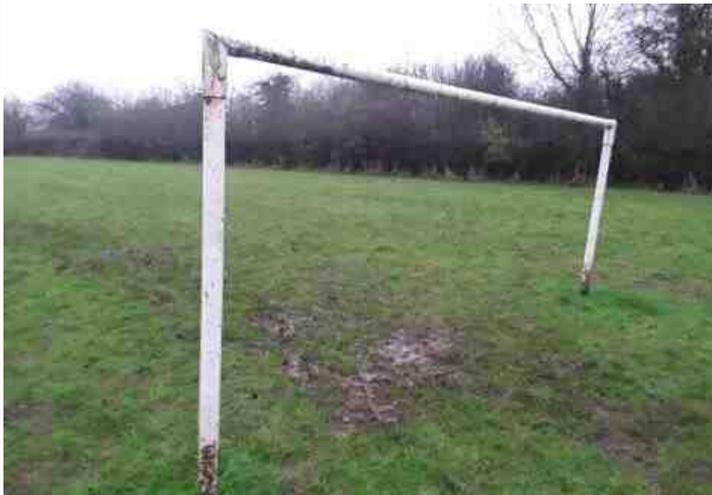
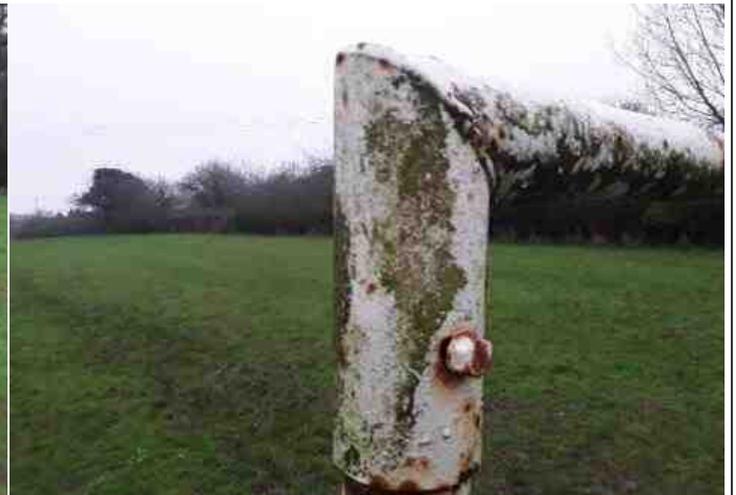
Item: Multi Use Games Area - 5 a side Goals
Manufacturer: Not Identified

Finding: There is algae or moss on the equipment

Action: Clean and treat appropriately

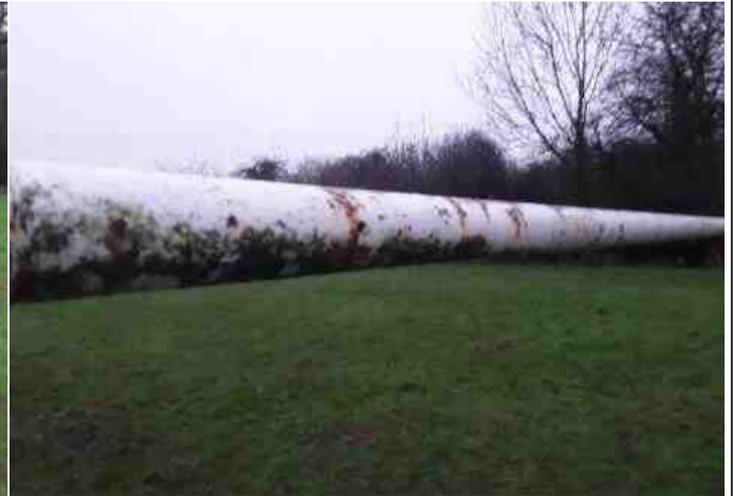
Item: Multi Use Games Area - 5 a side Goals
Manufacturer: Not Identified

Finding: The paintwork on this item has been damaged or worn exposing the metal underneath which is rusting / corroding

Action: Treat affected areas and repaint

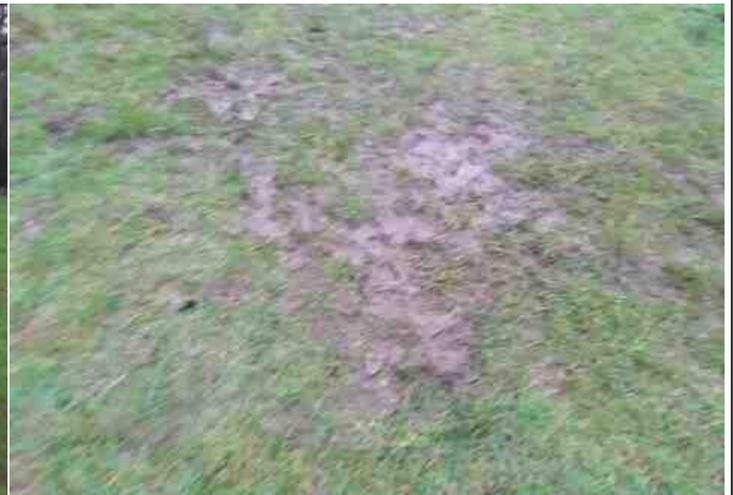
Item: Multi Use Games Area - 5 a side Goals
Manufacturer: Not Identified

Finding: The area around the item has eroded and may become slippery

Action: Reinststate eroded area

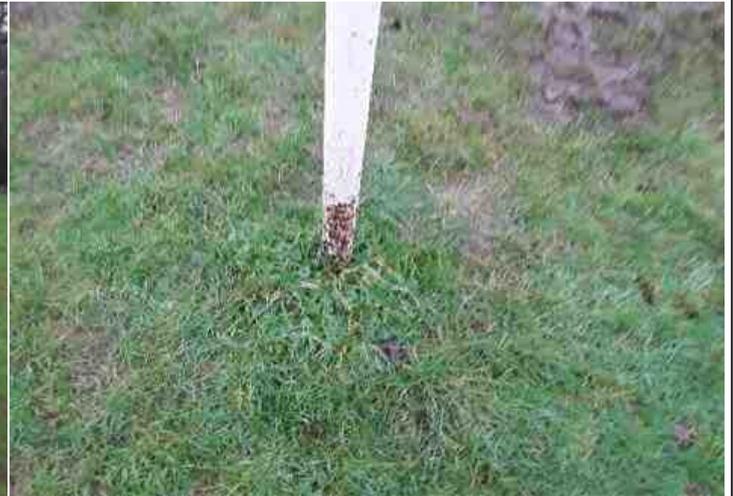
Item: Multi Use Games Area - 5 a side Goals
Manufacturer: Not Identified

Finding: The item is slightly loose in its foundations

Action: Monitor for any further deterioration and repair as required

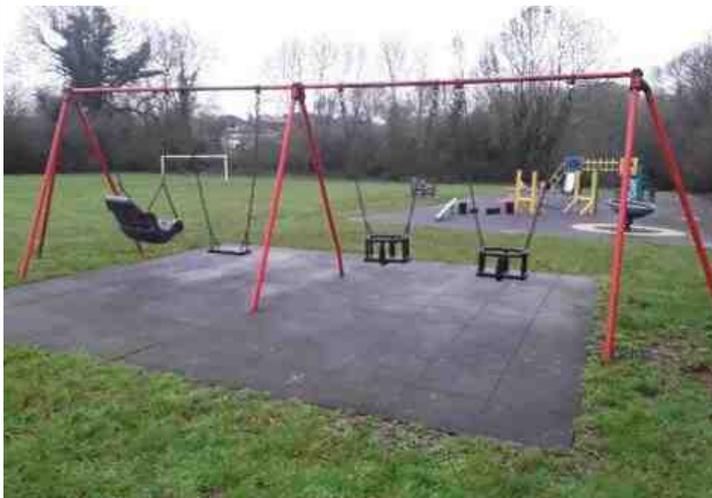
Item: Swings - 2 Bay Swing
Manufacturer: Wicksteed Playgrounds

Finding: There are trip hazards at the edges of the tiled surface

Action: Remove trip hazard

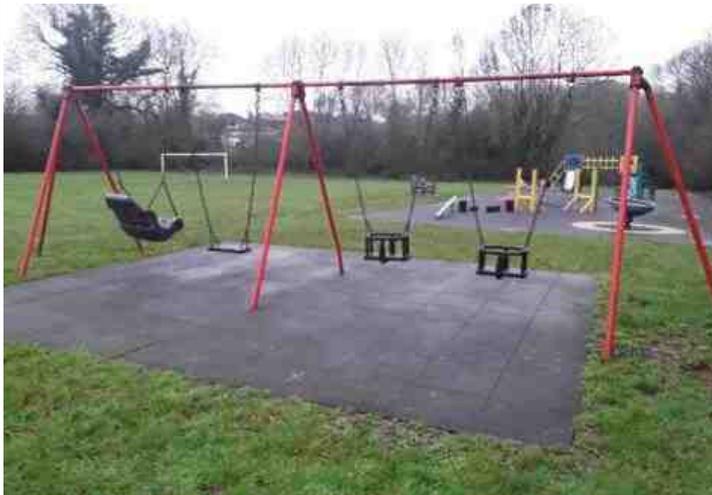
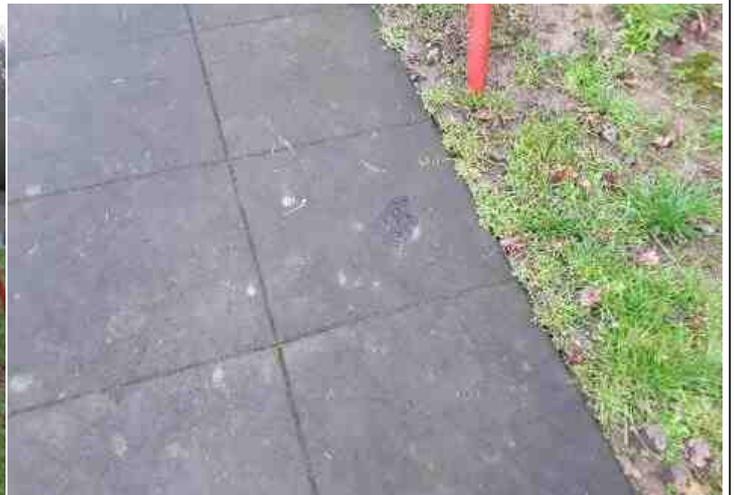
Item: Swings - 2 Bay Swing
Manufacturer: Wicksteed Playgrounds

Finding: There is some evidence of fire damage to the surfacing

Action: Monitor for any further deterioration and repair as required

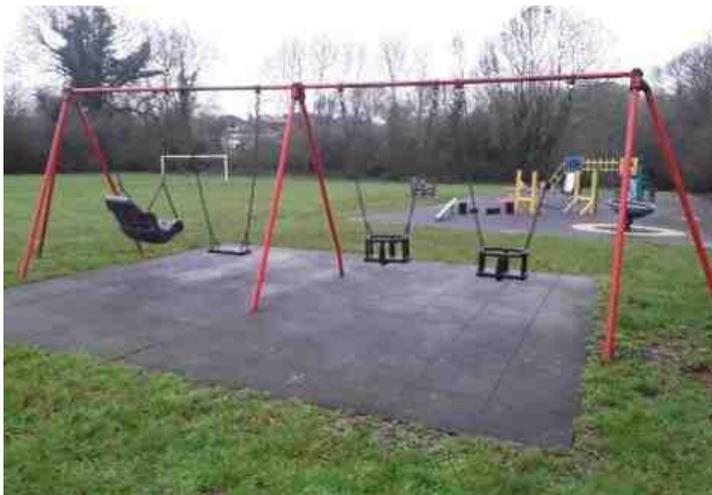
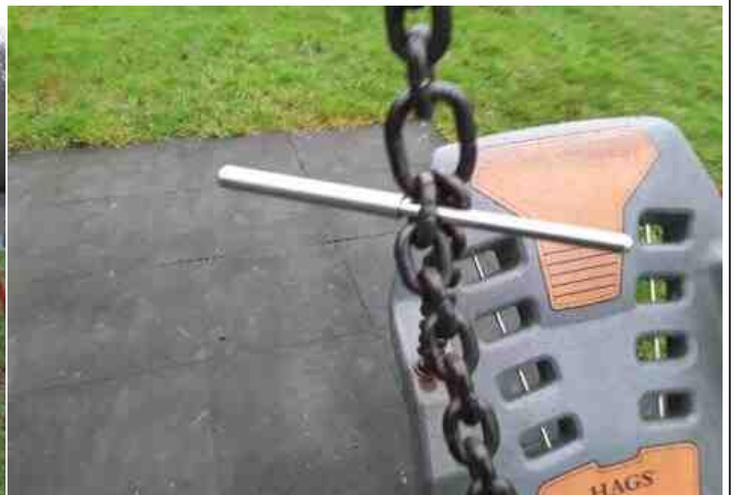
Item: Swings - 2 Bay Swing
Manufacturer: Wicksteed Playgrounds

Finding: The chain openings are in excess of the 8.6mm as recommended by BS EN 1176

Action: Monitor - No action given the risk assessment

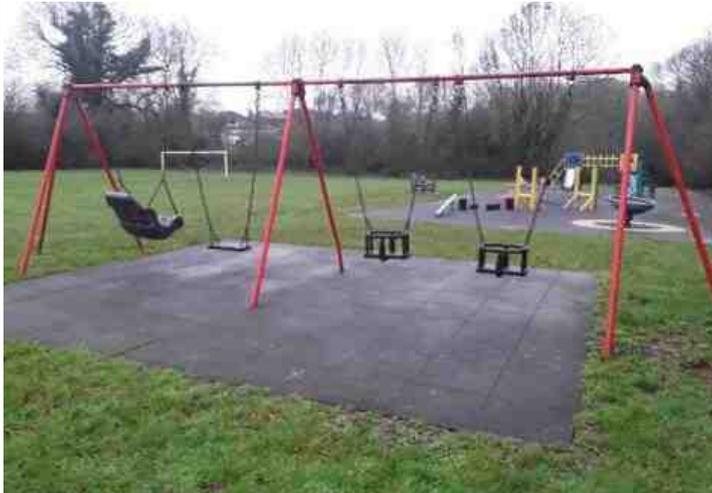
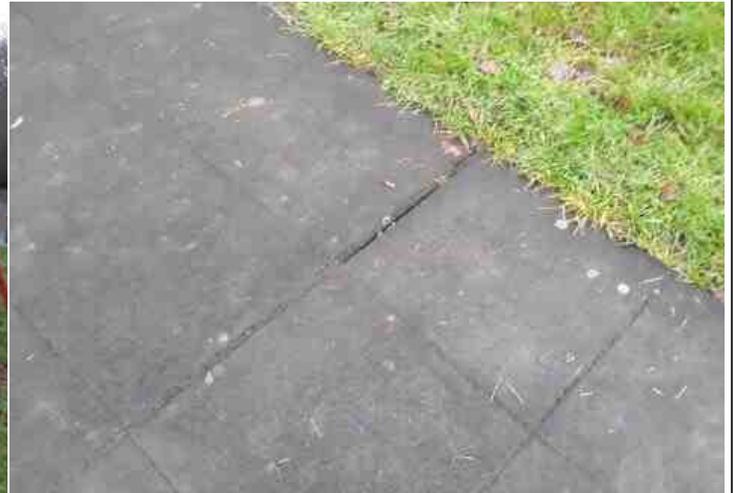
Item: Swings - 2 Bay Swing
Manufacturer: Wicksteed Playgrounds

Finding: There are gaps opening in between the tiles

Action: Monitor for any further deterioration and repair as required

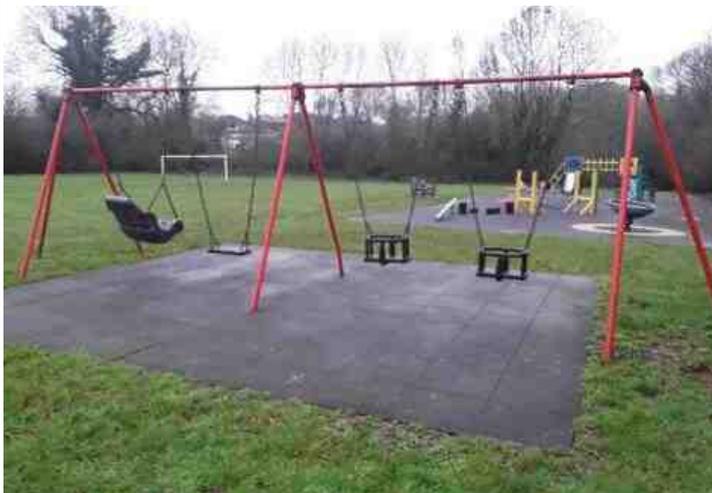
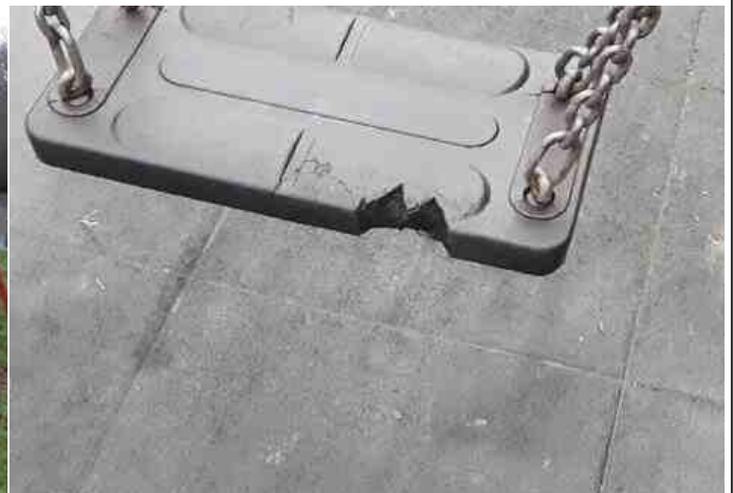
Item: Swings - 2 Bay Swing
Manufacturer: Wicksteed Playgrounds

Finding: The seat is damaged and requires replacing

Action: Replace damaged seat

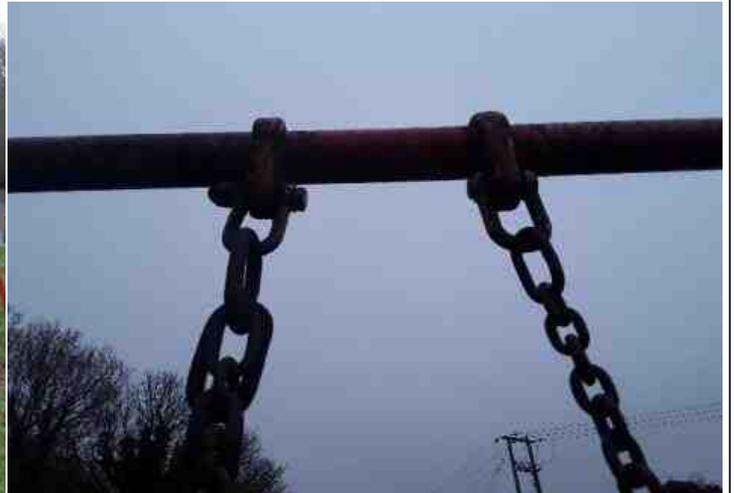
Item: Swings - 2 Bay Swing
Manufacturer: Wicksteed Playgrounds

Finding: The bush / bushes is / are worn or missing

Action: Replace worn or missing bushes

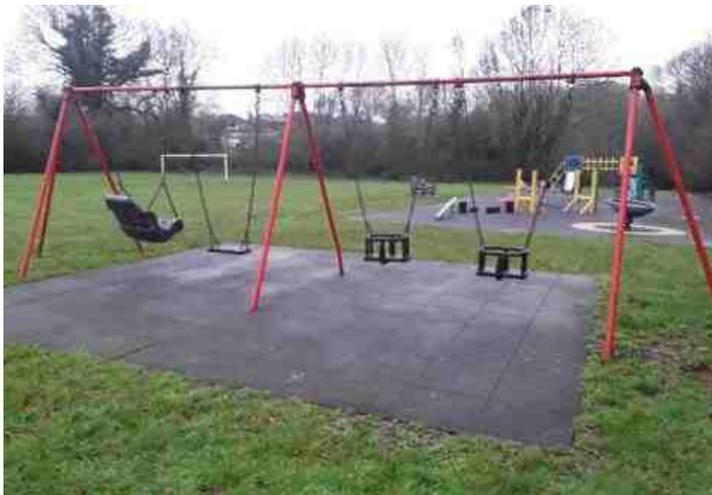
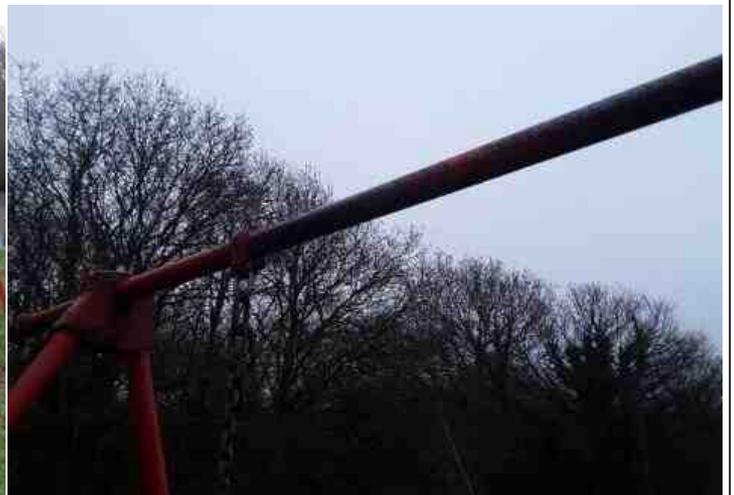
Item: Swings - 2 Bay Swing
Manufacturer: Wicksteed Playgrounds

Finding: The paintwork on this item has been damaged or worn exposing the metal underneath which is rusting / corroding

Action: Treat affected areas and repaint

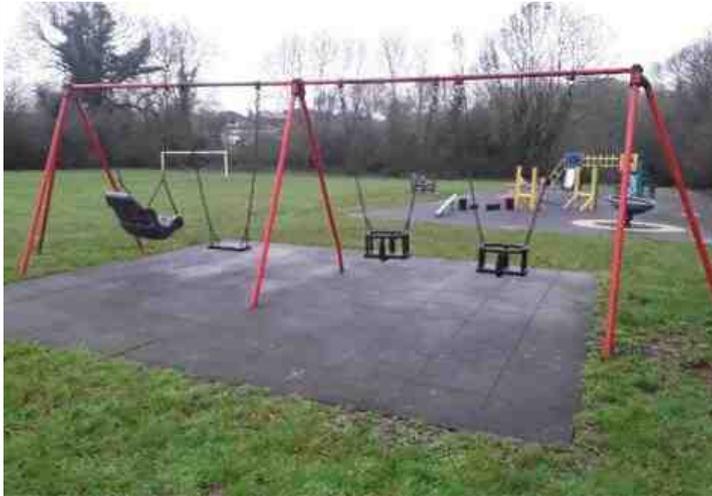
Item: Swings - 2 Bay Swing
Manufacturer: Wicksteed Playgrounds

Finding: There is minor distortion damage to the frame

Action: Monitor and repair if required

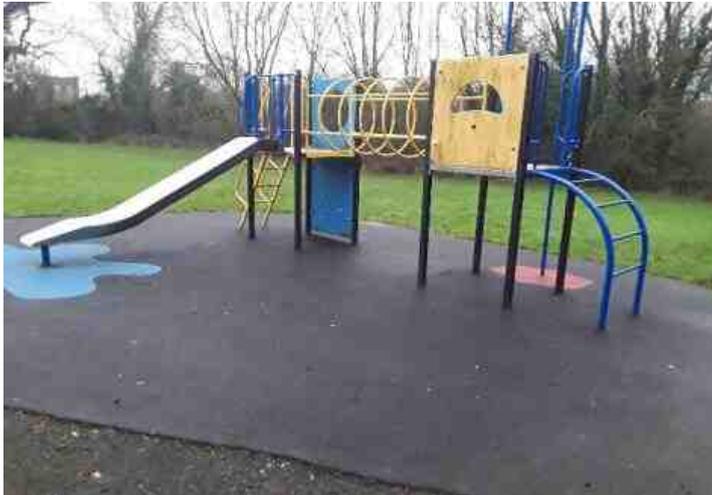
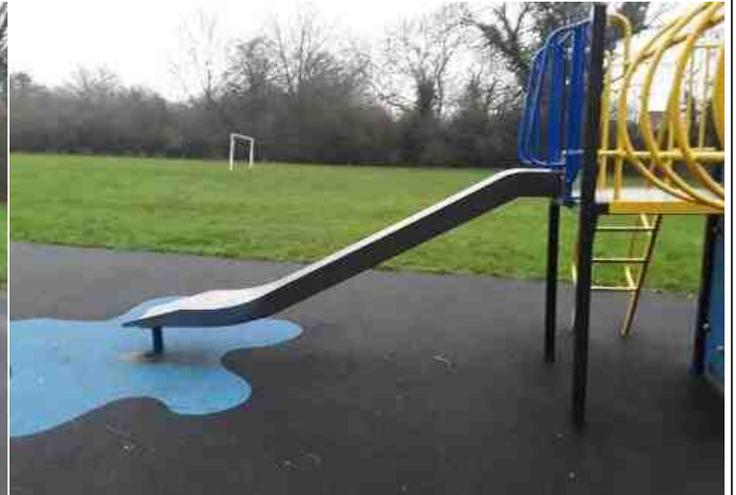
Item: Activity Equipment - Multi Play (Junior)
Manufacturer: Action Play and Leisure

Finding: The slide is predominately south facing and will catch the majority of the sun's heat during the day. Slide surfaces can become very warm during periods of sustained sunny weather

Action: Monitor - No action given the risk assessment

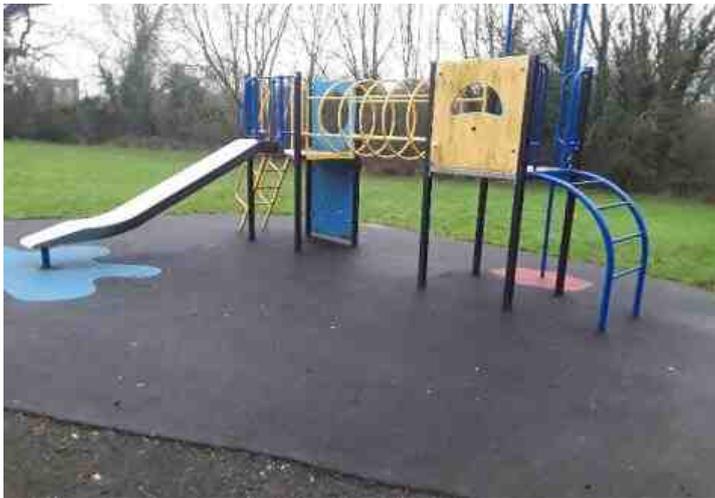
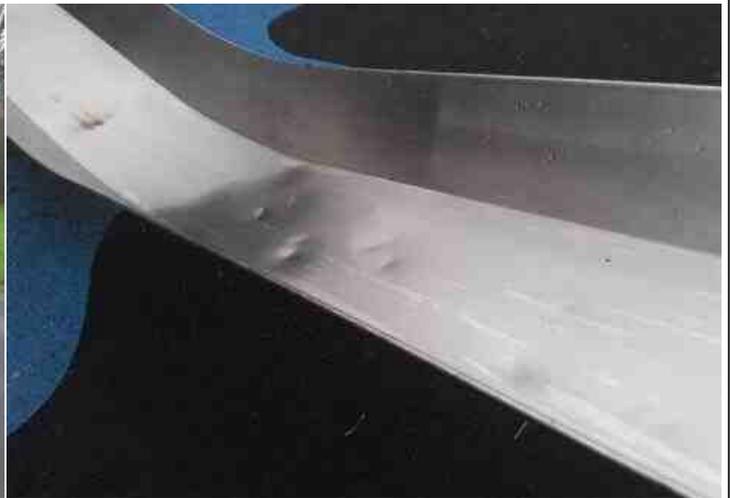
4 - Very Low Risk (Finding 2)

There are a number of dents in the slide surface - Monitor for any further deterioration and repair as required

Item: Activity Equipment - Multi Play (Junior) **Risk Level:** V - Very Low Risk
Manufacturer: Action Play and Leisure **Surface:** Wet Pour

Finding: There are a number of dents in the slide surface **Action:** Monitor for any further deterioration and repair as required

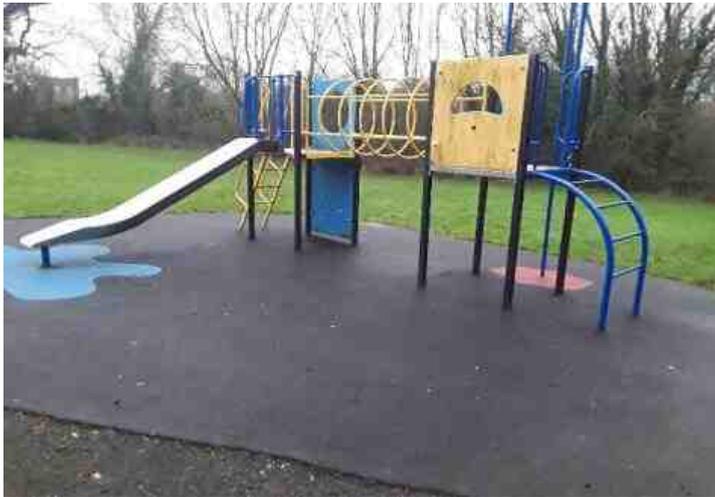
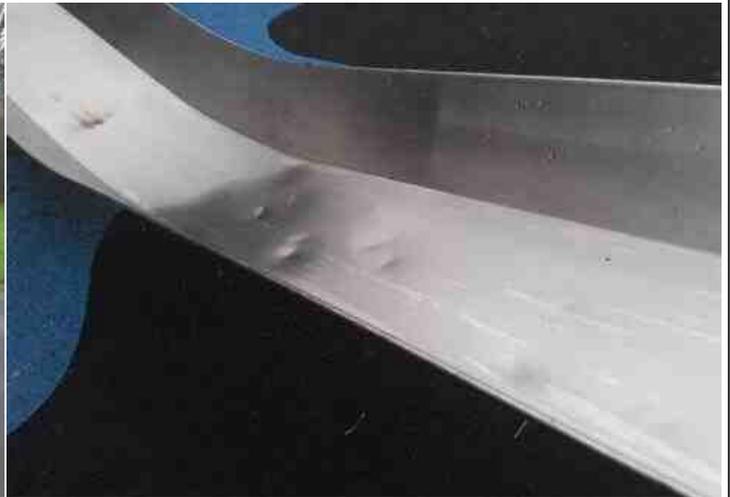
6 - Low Risk (Finding 3)

Item: Activity Equipment - Multi Play (Junior) **Risk Level:** L - Low Risk
Manufacturer: Action Play and Leisure **Surface:** Wet Pour

Finding: There is algae or moss on the equipment **Action:** Clean and treat appropriately

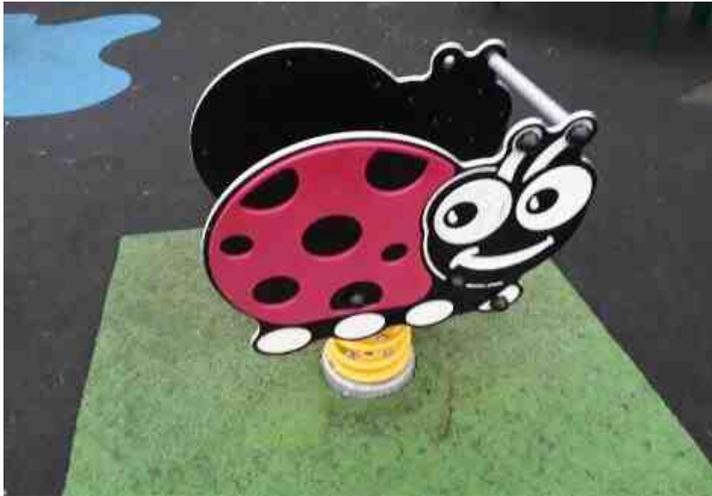
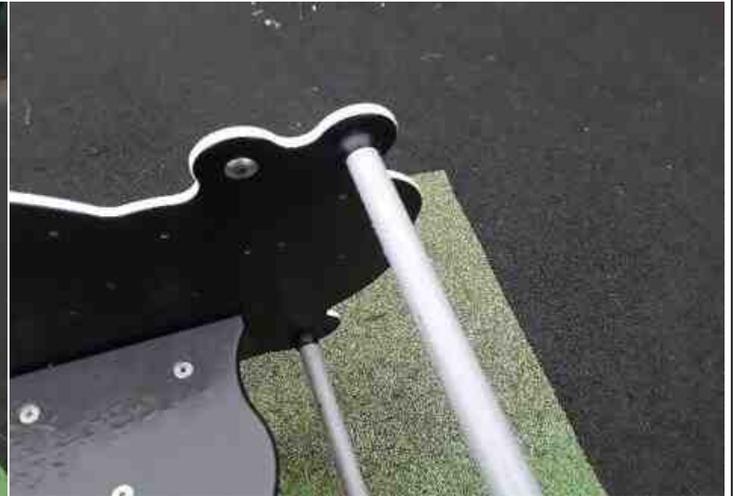
6 - Low Risk (Finding 1)

The Handgrips/Footrests rotate and may cause an unexpected movement for the user - Secure Handgrips/Footrests to prevent rotation.

Item: Rocking Equipment - Spring Ladybird
Manufacturer: Action Play and Leisure

Finding: The Handgrips/Footrests rotate and may cause an unexpected movement for the user
Action: Secure Handgrips/Footrests to prevent rotation.

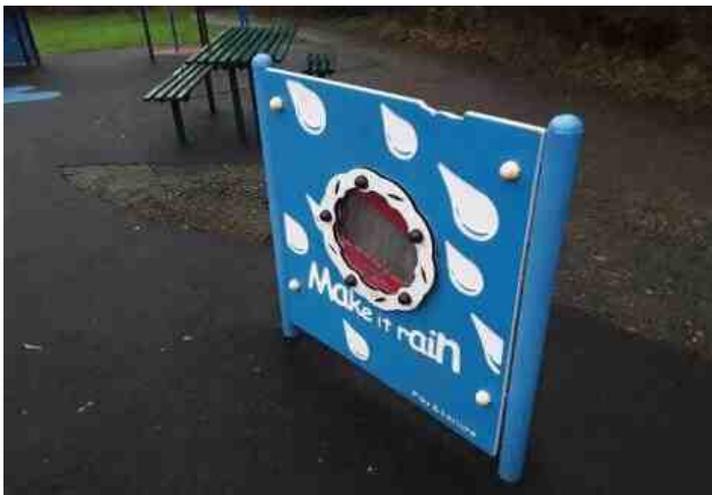
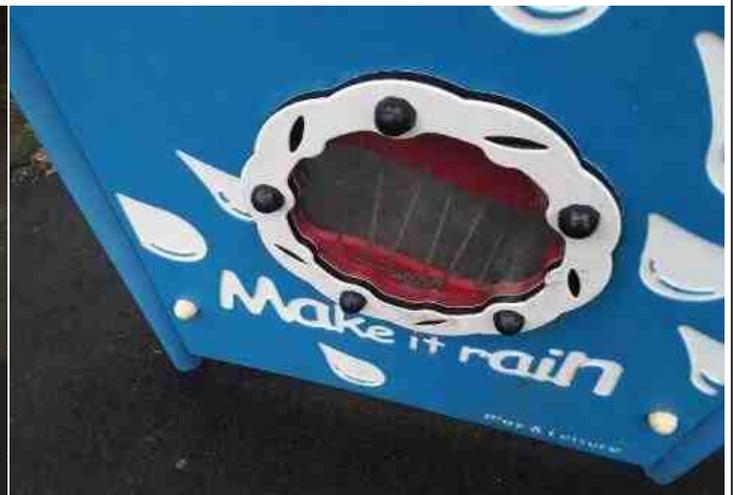
Item: Activity Equipment - Play Panel
Manufacturer: Action Play and Leisure

Risk Level: L - Low Risk
Surface: Wet Pour

Finding: The centre piece doesn't rotate / has seized
Action: Replace the panel

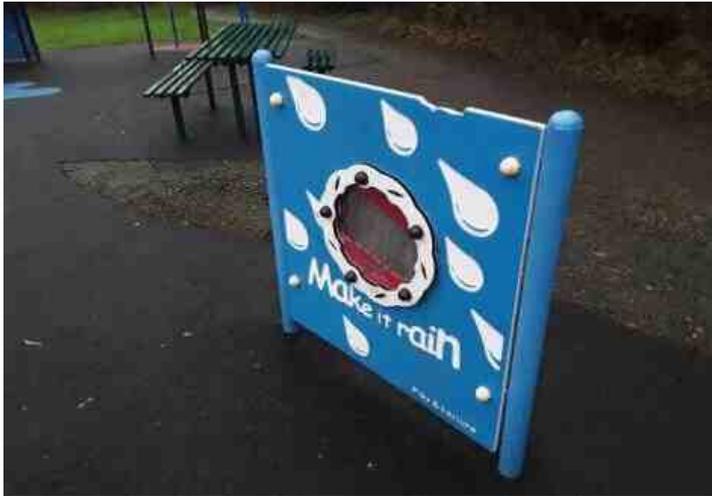
6 - Low Risk (Finding 2)

Item: Activity Equipment - Play Panel
Manufacturer: Action Play and Leisure

Risk Level: L - Low Risk
Surface: Wet Pour

Finding: There is vandalism damage to the panel exposing sharp edges

Action: Replace the panel

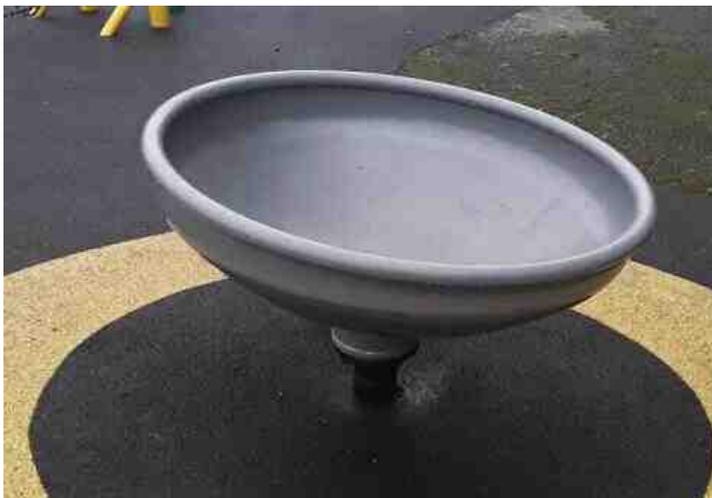
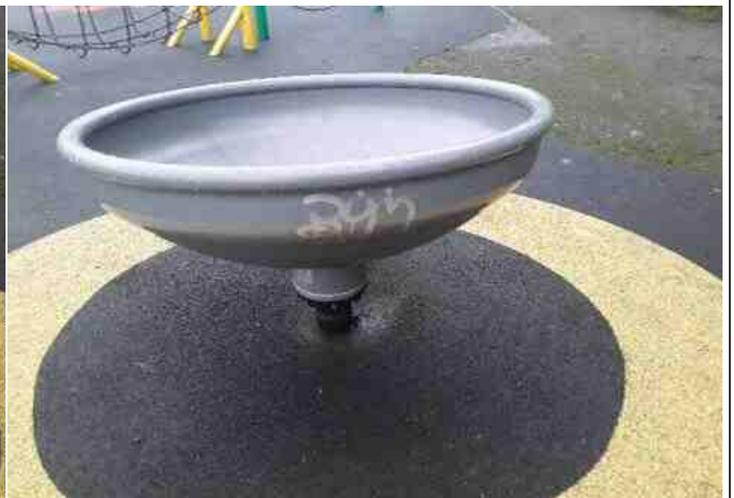
Item: Rotor Play - Dish Roundabout
Manufacturer: Action Play and Leisure

Risk Level: N - Risk Assessment not Undertaken
Surface: Wet Pour

Finding: There is some graffiti present

Action: Remove the graffiti

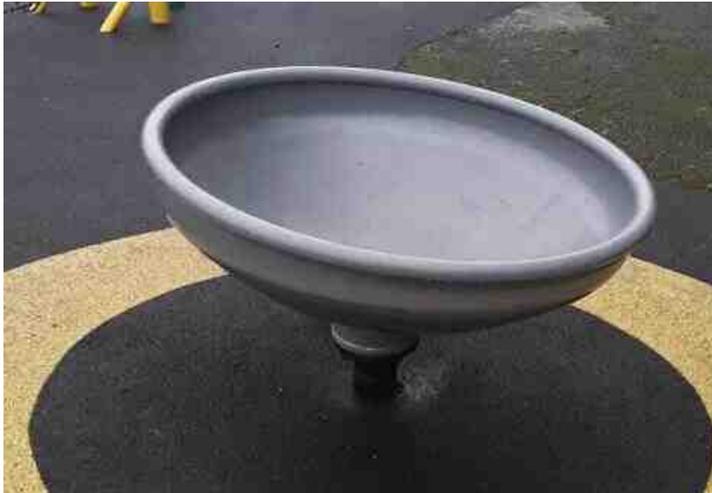
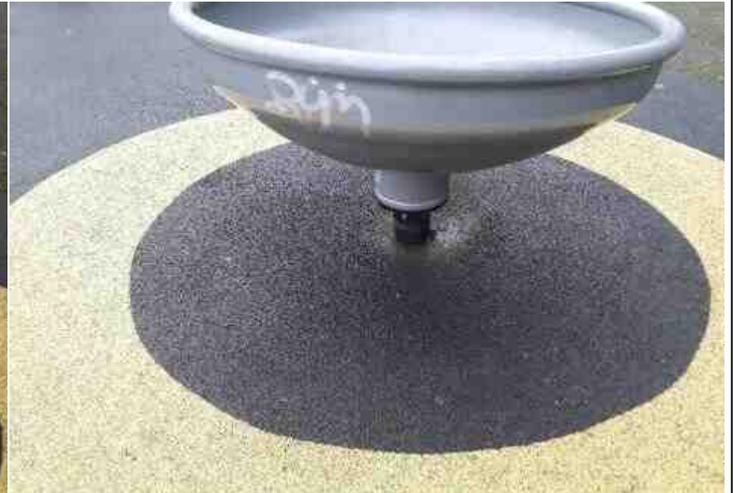
Item: Rotor Play - Dish Roundabout
Manufacturer: Action Play and Leisure

Risk Level: L - Low Risk
Surface: Wet Pour

Finding: The bearing is noisy / showing signs of wear

Action: Monitor for any further deterioration and replace as required
