NOTICE OF PROPERTY MANAGEMENT AND GENERAL PURPOSES COMMITTEE MEETING

Thursday 5th March 2026 7pm

AGENDA

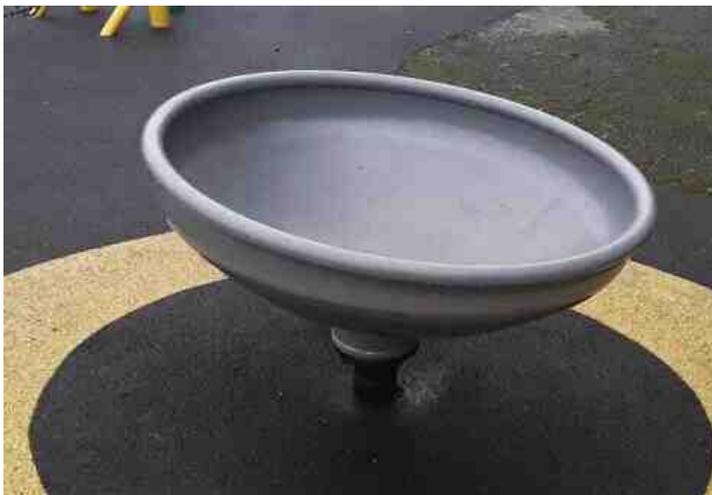
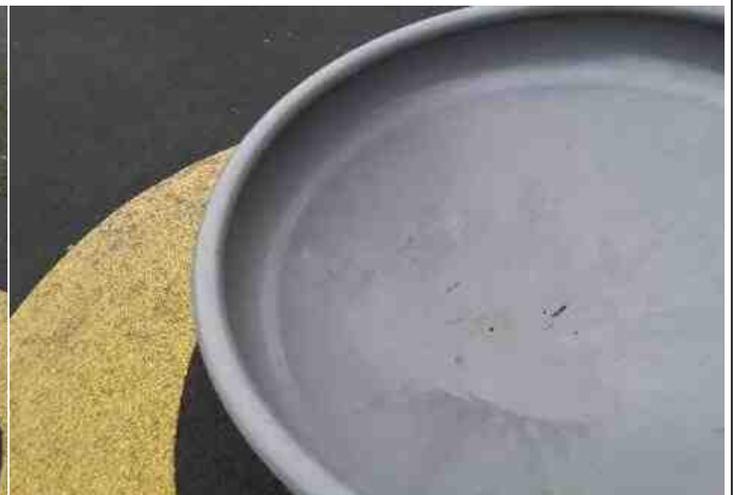
Item: Rotor Play - Dish Roundabout
Manufacturer: Action Play and Leisure

Risk Level: V - Very Low Risk
Surface: Wet Pour

Finding: There are a number of dents in the bowl surface

Action: Monitor for any further deterioration and repair as required
